# RMD 8x8 mm<sup>2</sup> APD with Spark Damage

B. Harrop  
Princeton University  
Feb. 28, 2017

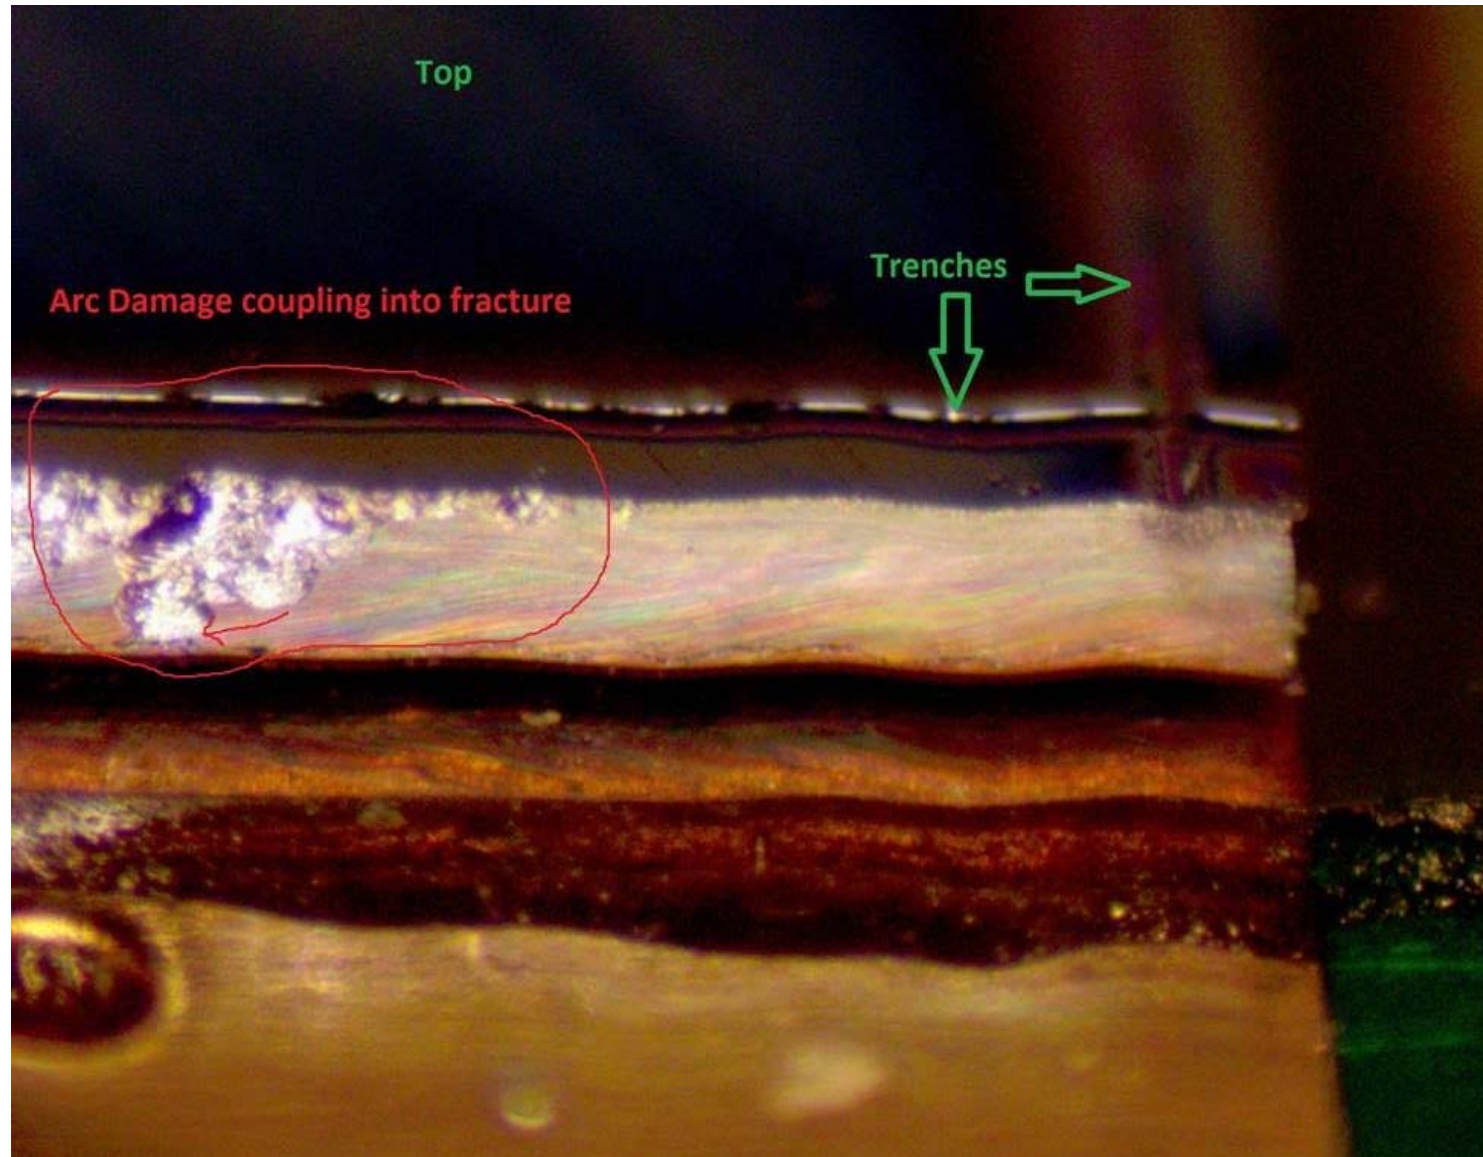
Various images of the APD, slides 3-8, show spark damage, perhaps due related to various fractures observed along the sides of the APD

Spark damage is visible along one side of the APD, with large cratering near the top (p-side) edge, and damage extending down to the bottom edge (n-side)

Chris Tully suggests using our laser dicer to trim the bare RMD APDs before packaging.

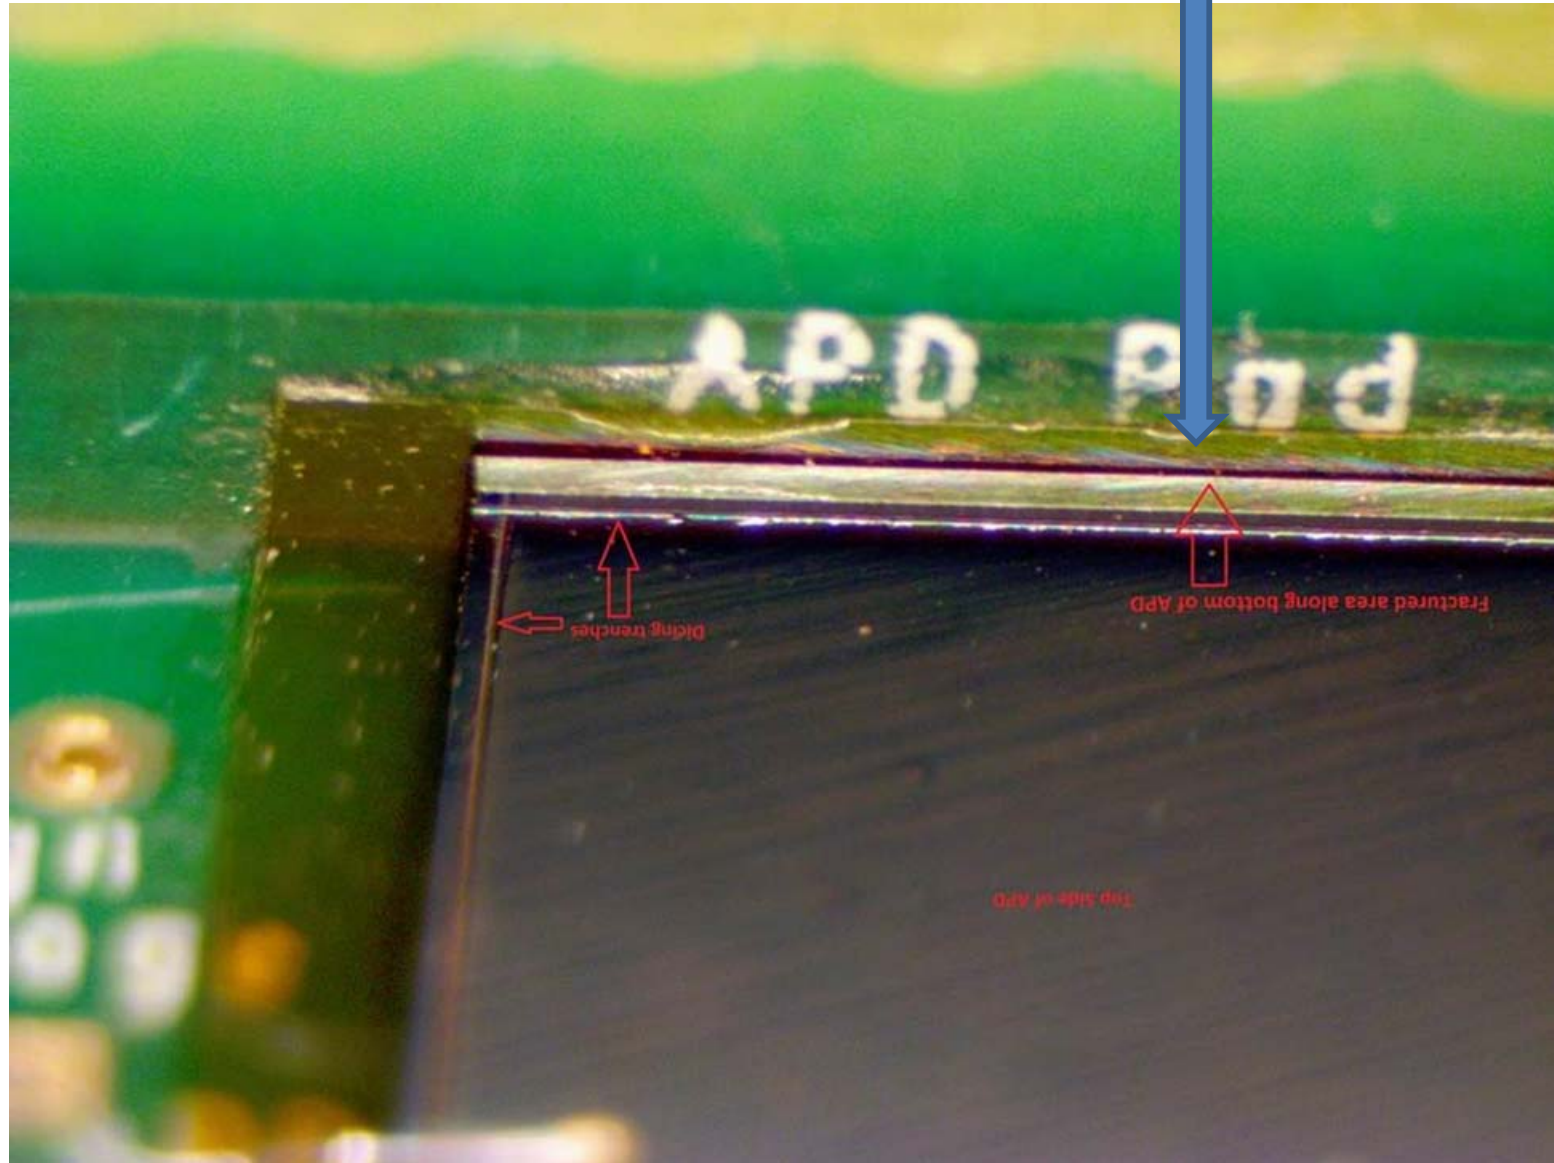
Location of the spark damage

For this image, the mesh on top of the APD has been removed.

The trenches in the top face are visible.

The damage occurred about 1 mm from an APD corner, but is not visible in this view.

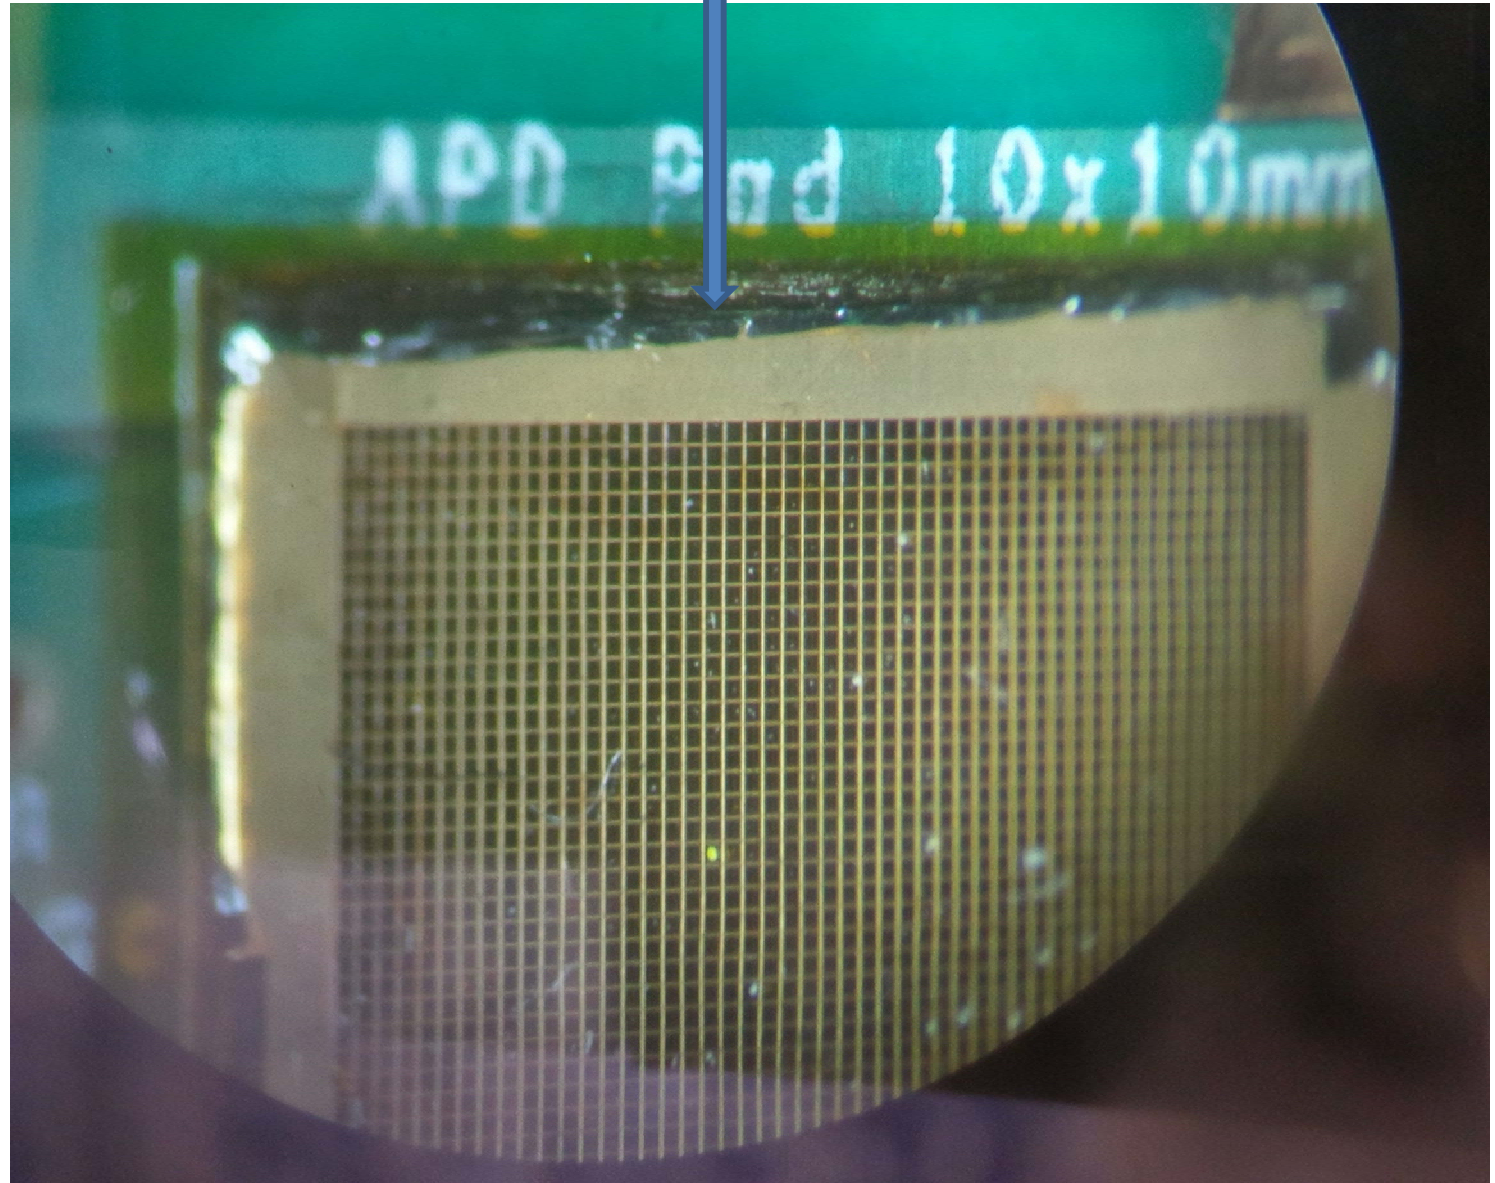
Location of the spark damage

This image was taken at U Penn, before the mesh on top of the APD was removed.

Lots of "dust" was visible on top of the APD,

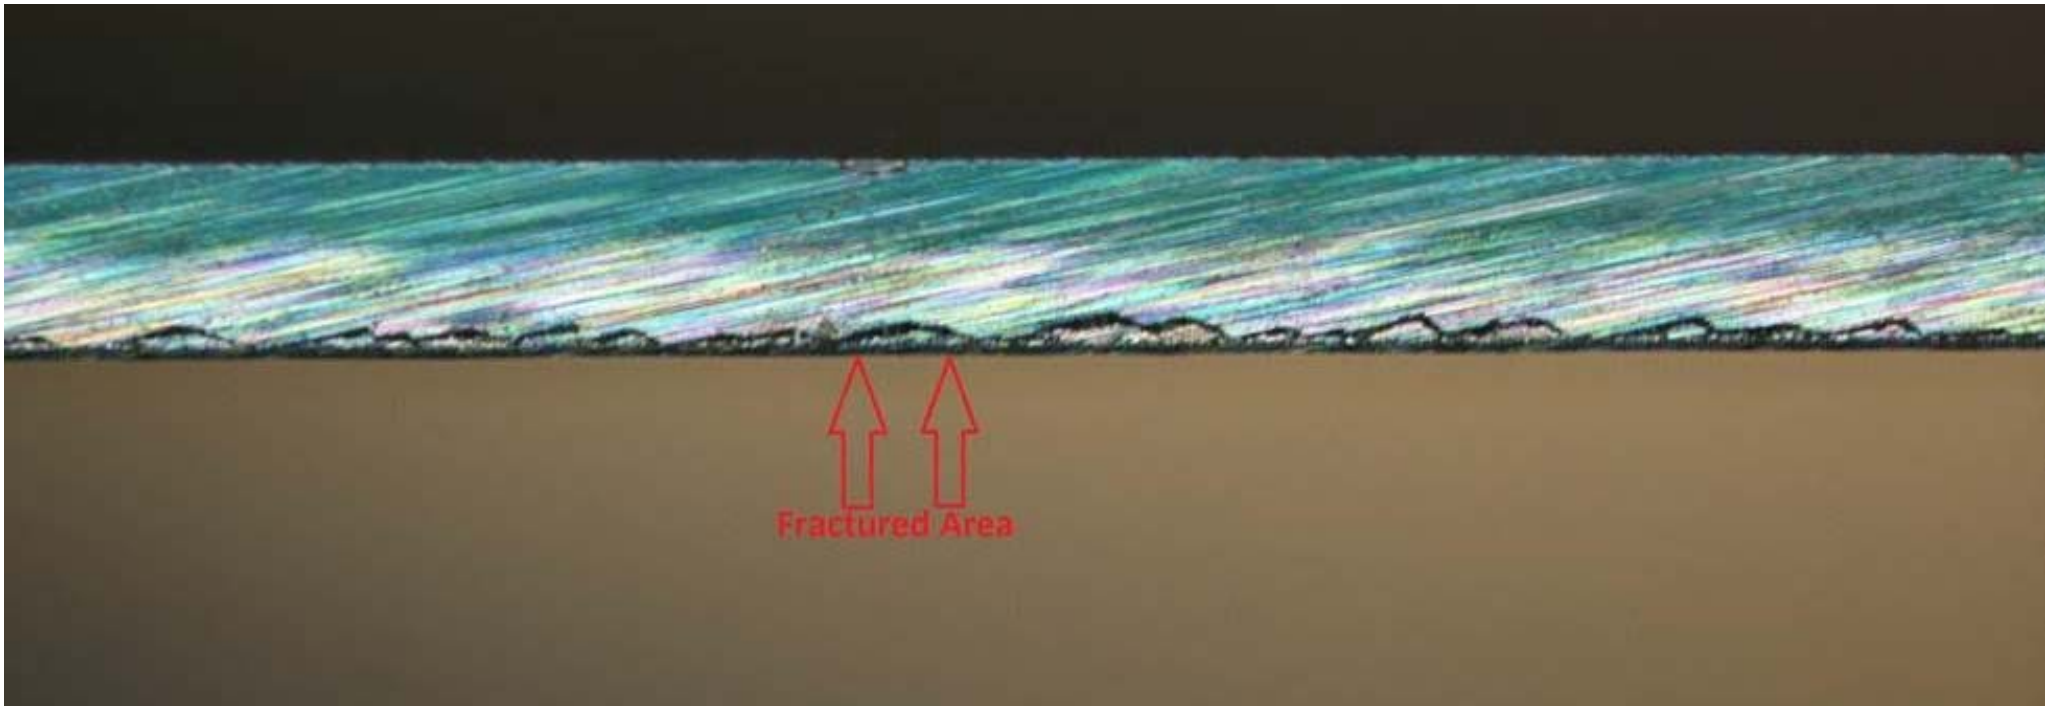
View of a portion of the APD side, away from the region of spark damage. Considerable fracturing is visible along the bottom (n-side) edge. Could such fracturing render the APD prone to spark damage?

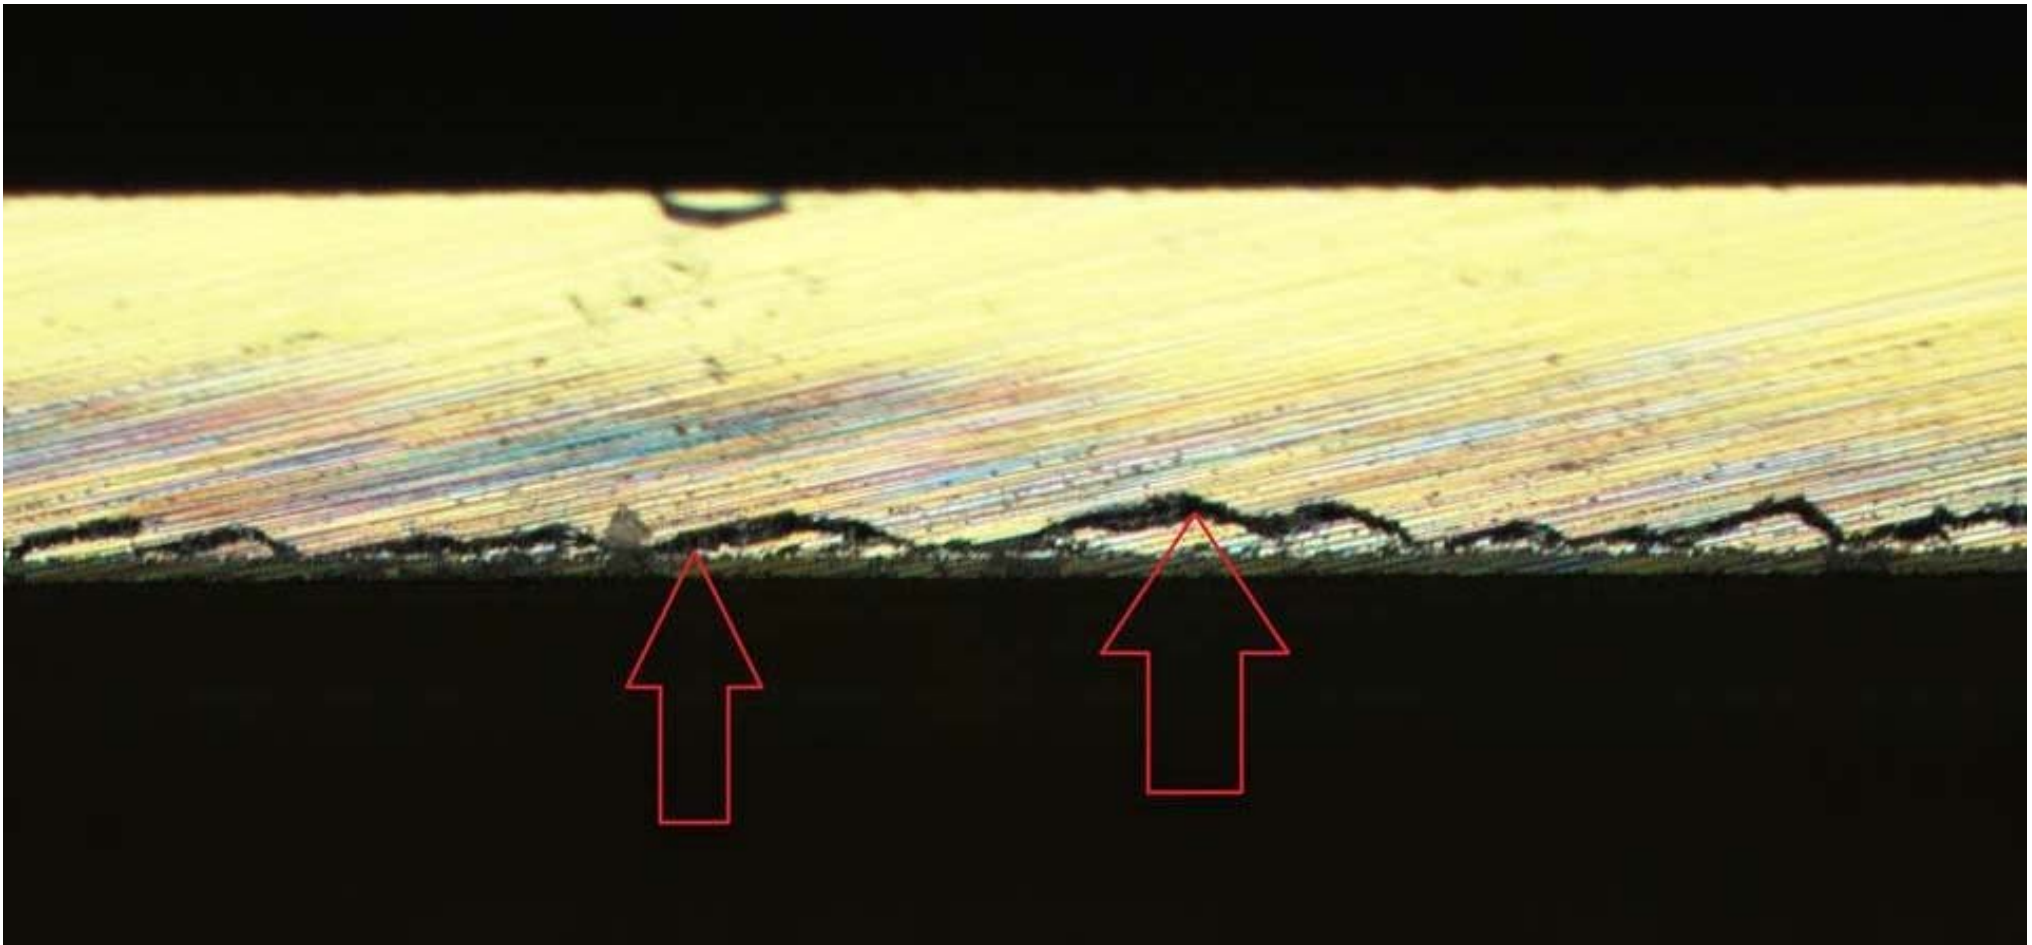
Closeup of the previous image, showing a fracture along the top edge.  
Was this combination of top/bottom fractures close to sparking?

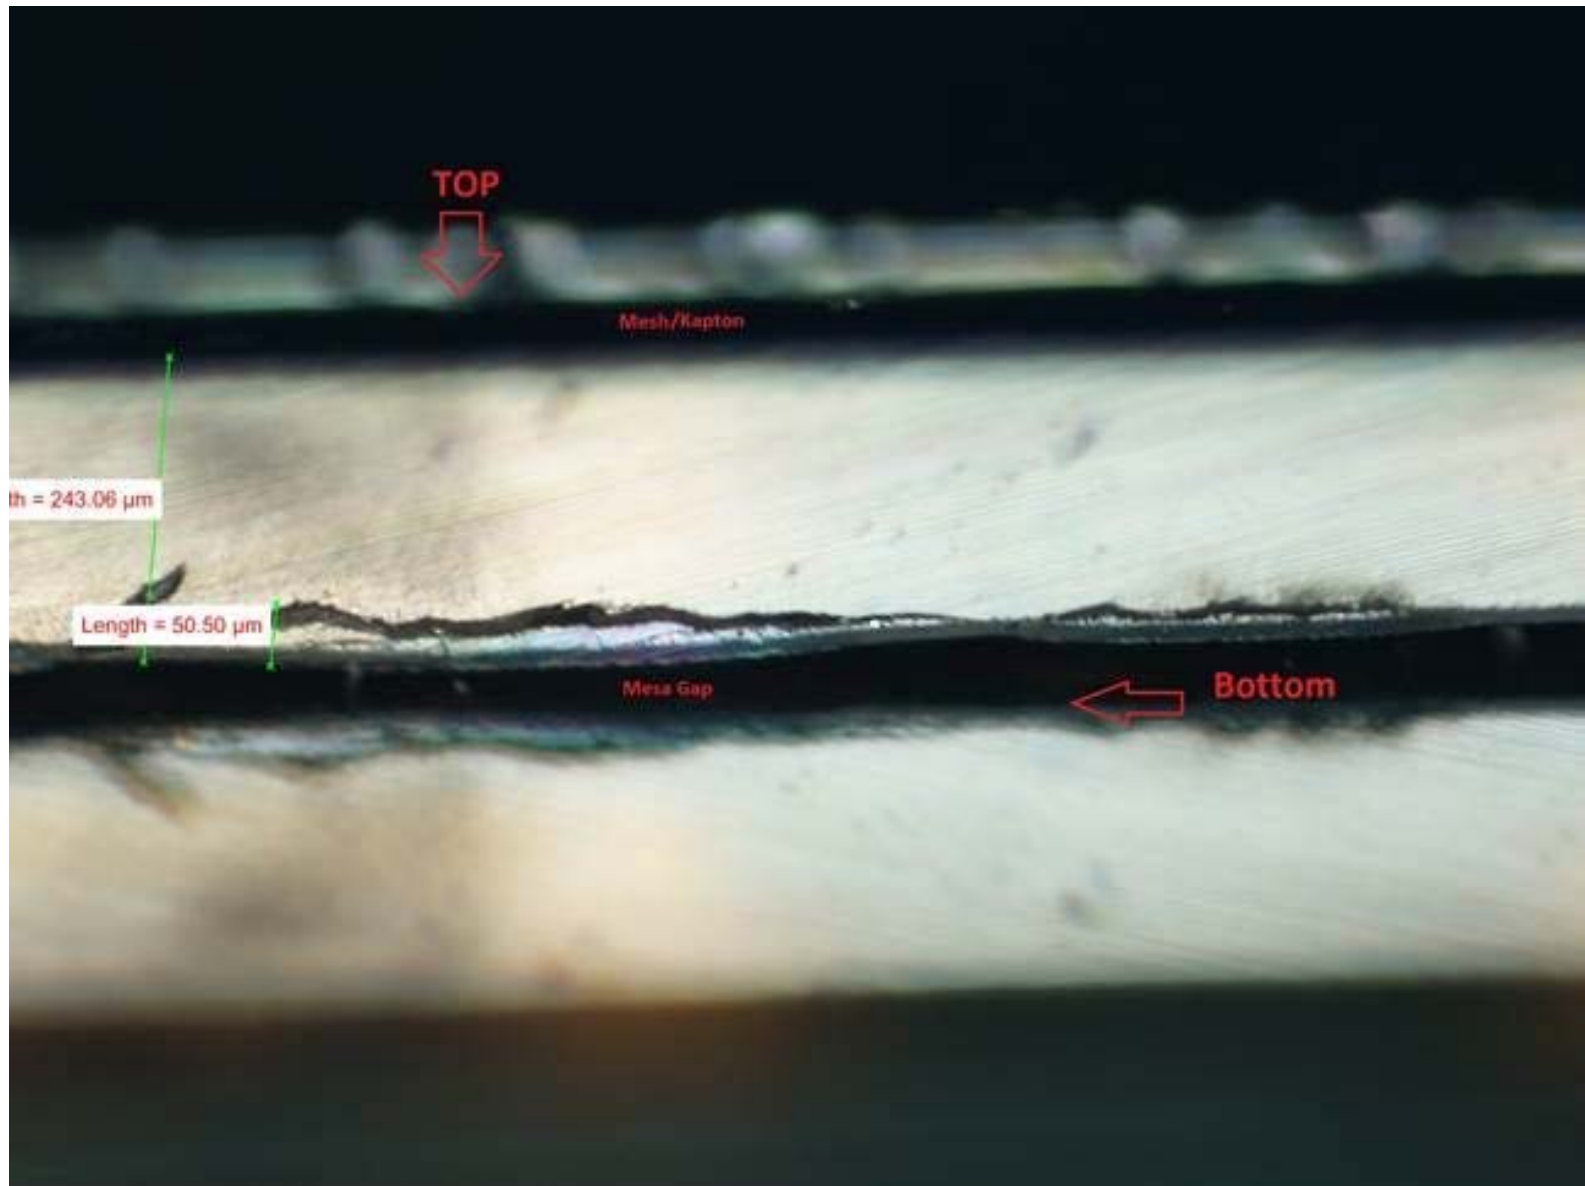
## View of another region of the side of the APD

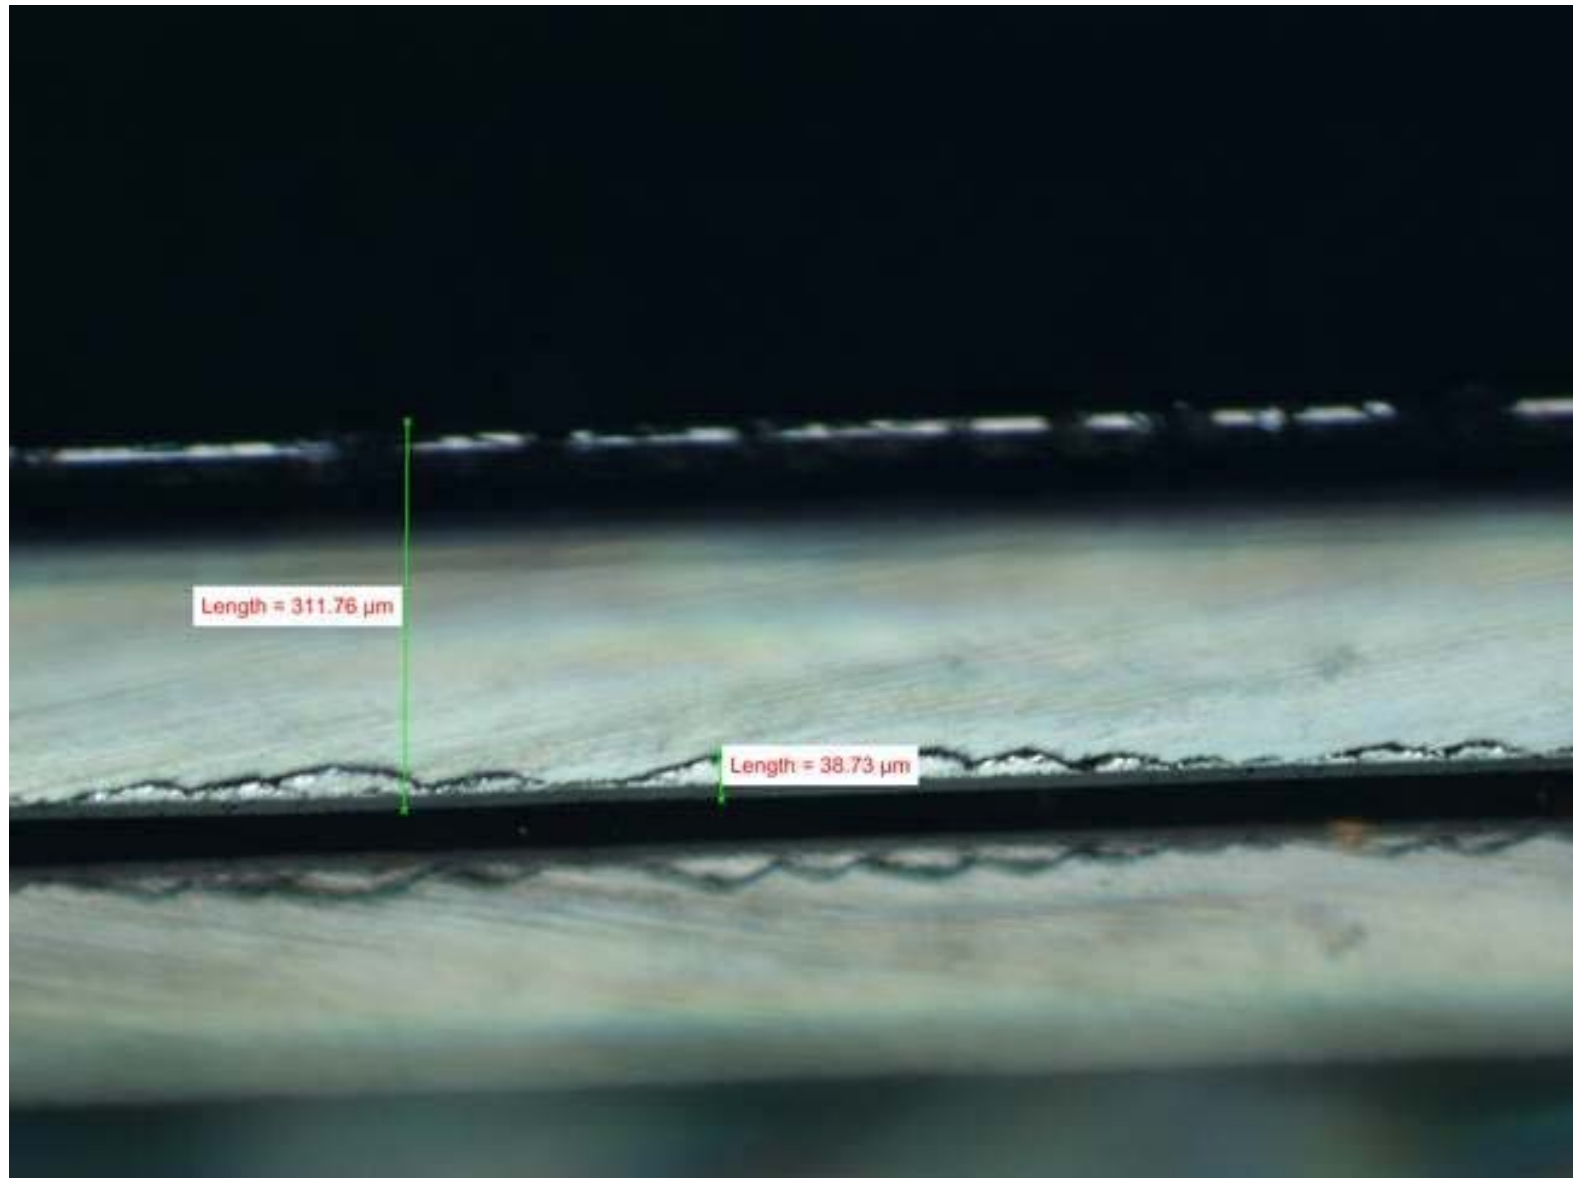
## View of yet another region of the side of the APD
