U-Penn ASIC Carrier Board

Inspection Images

B. Harrop

Date: 12/12/2018

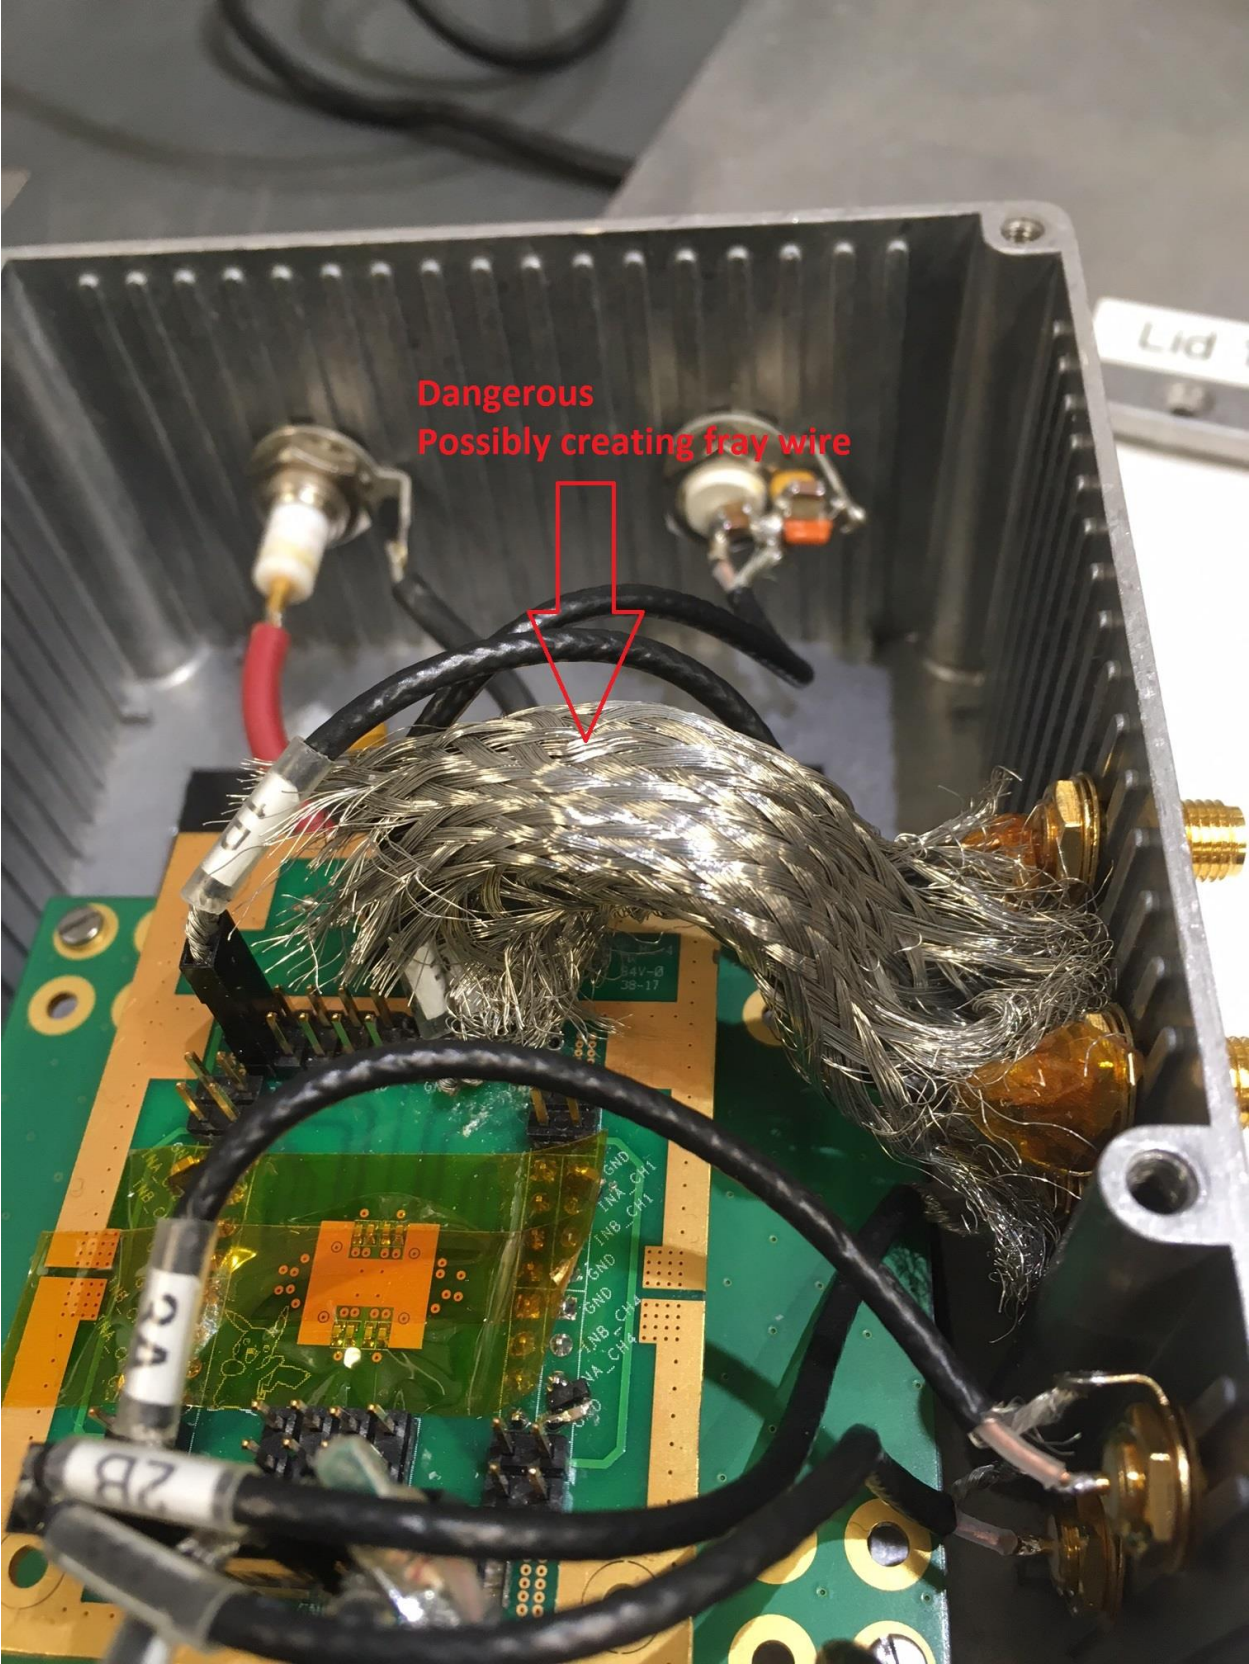
Dangerous
Possibly creating fray wire

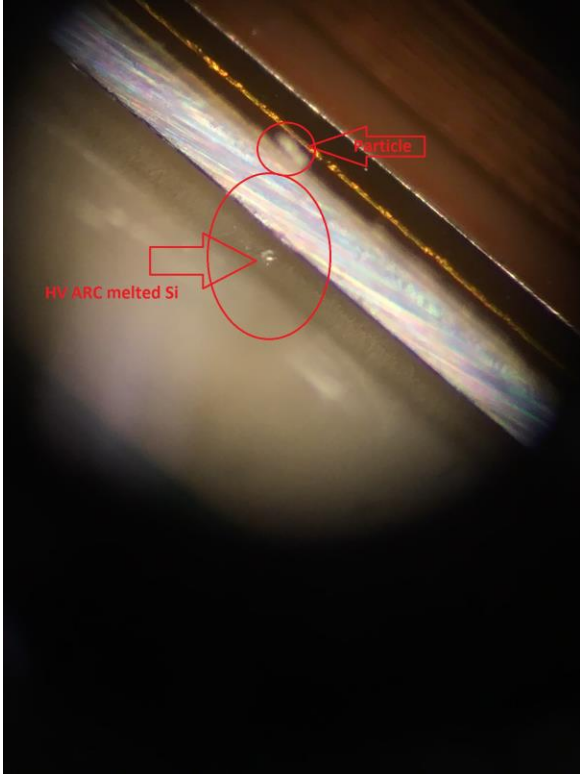
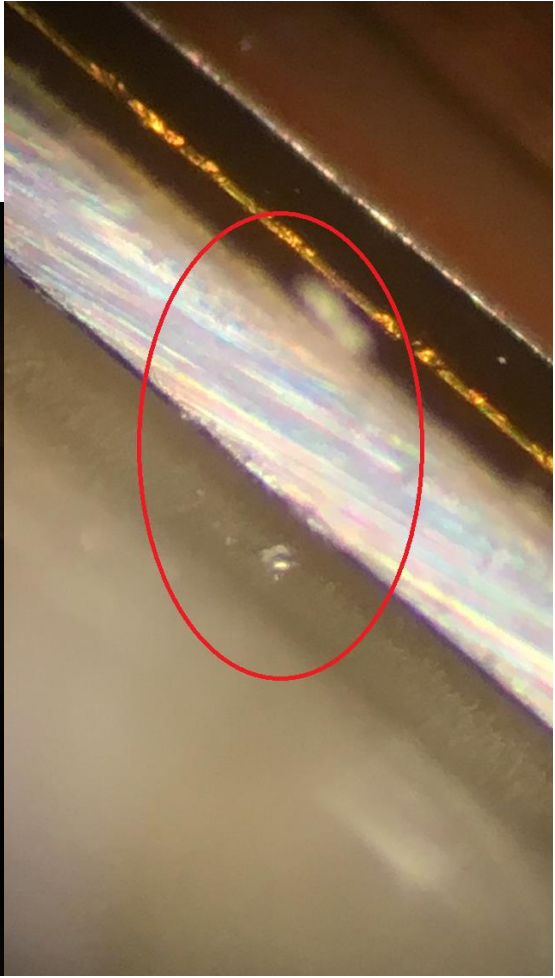
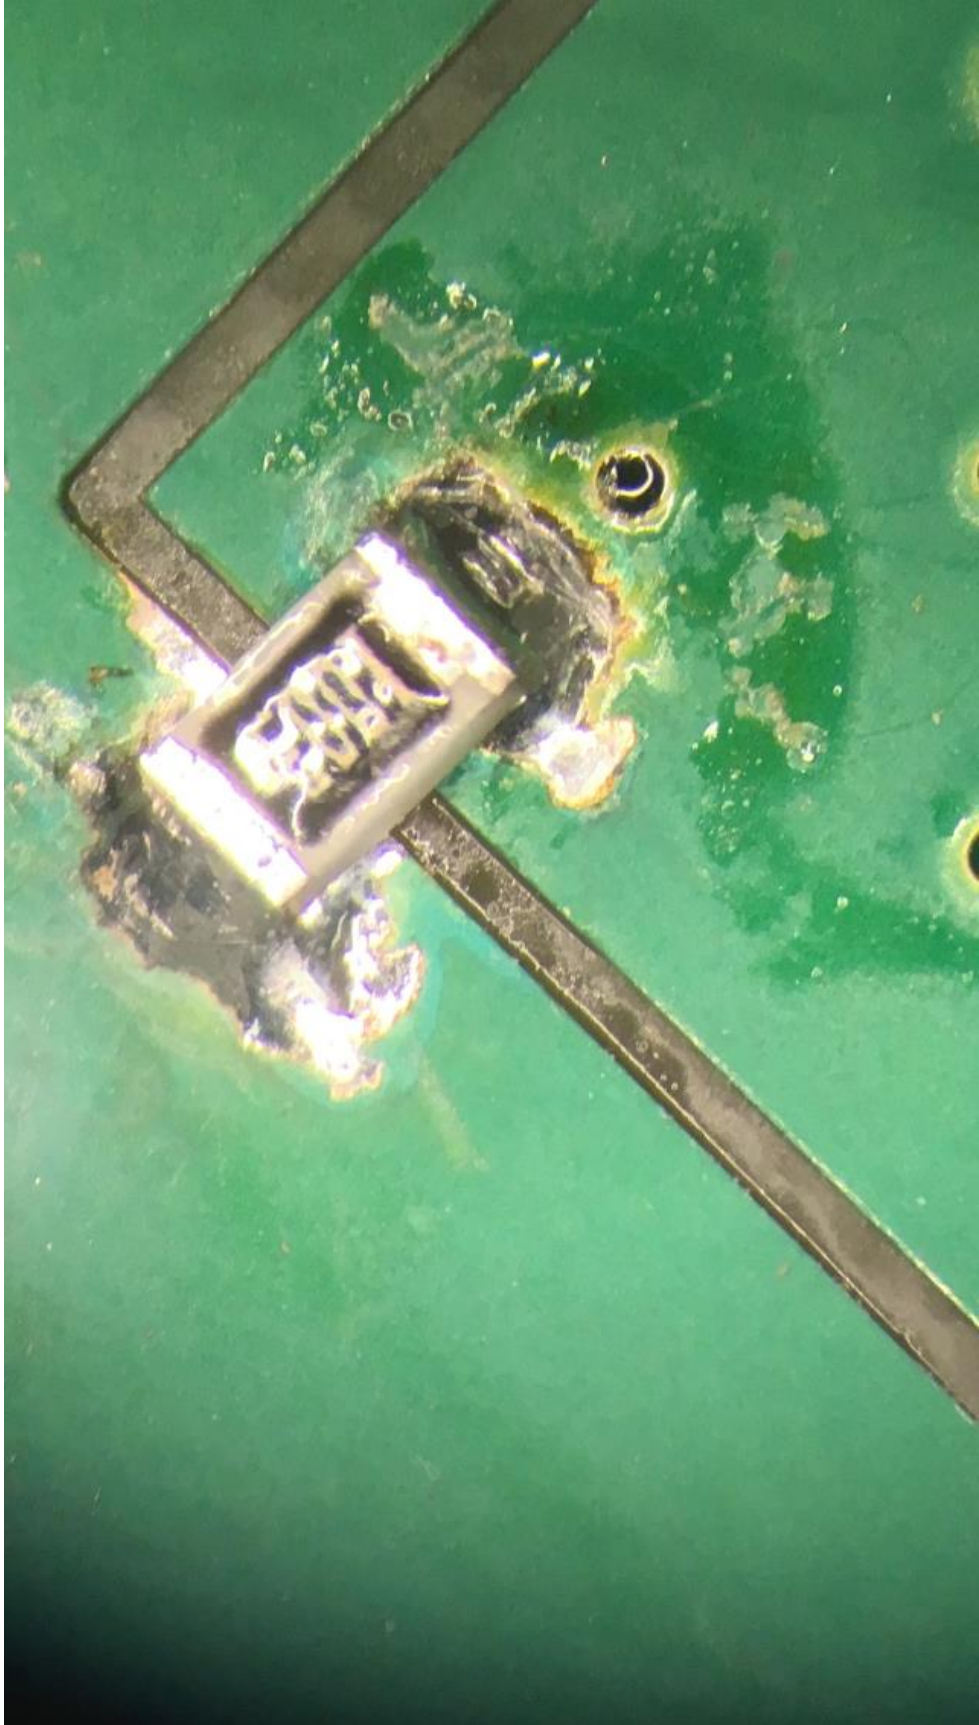
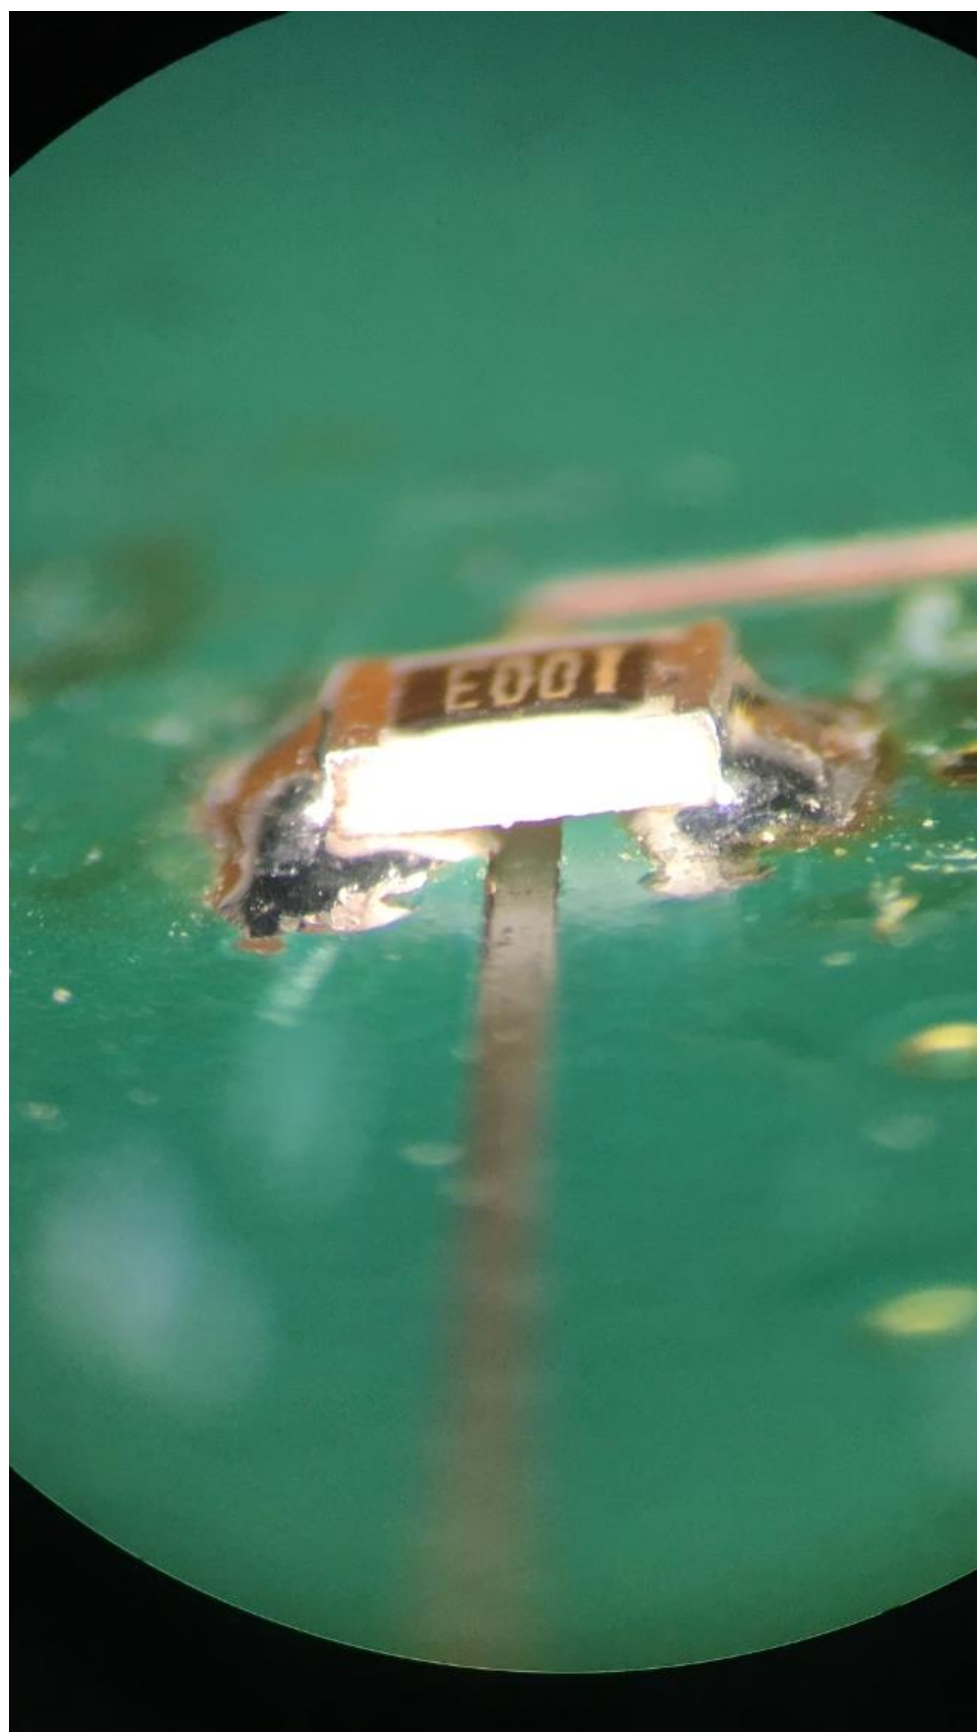
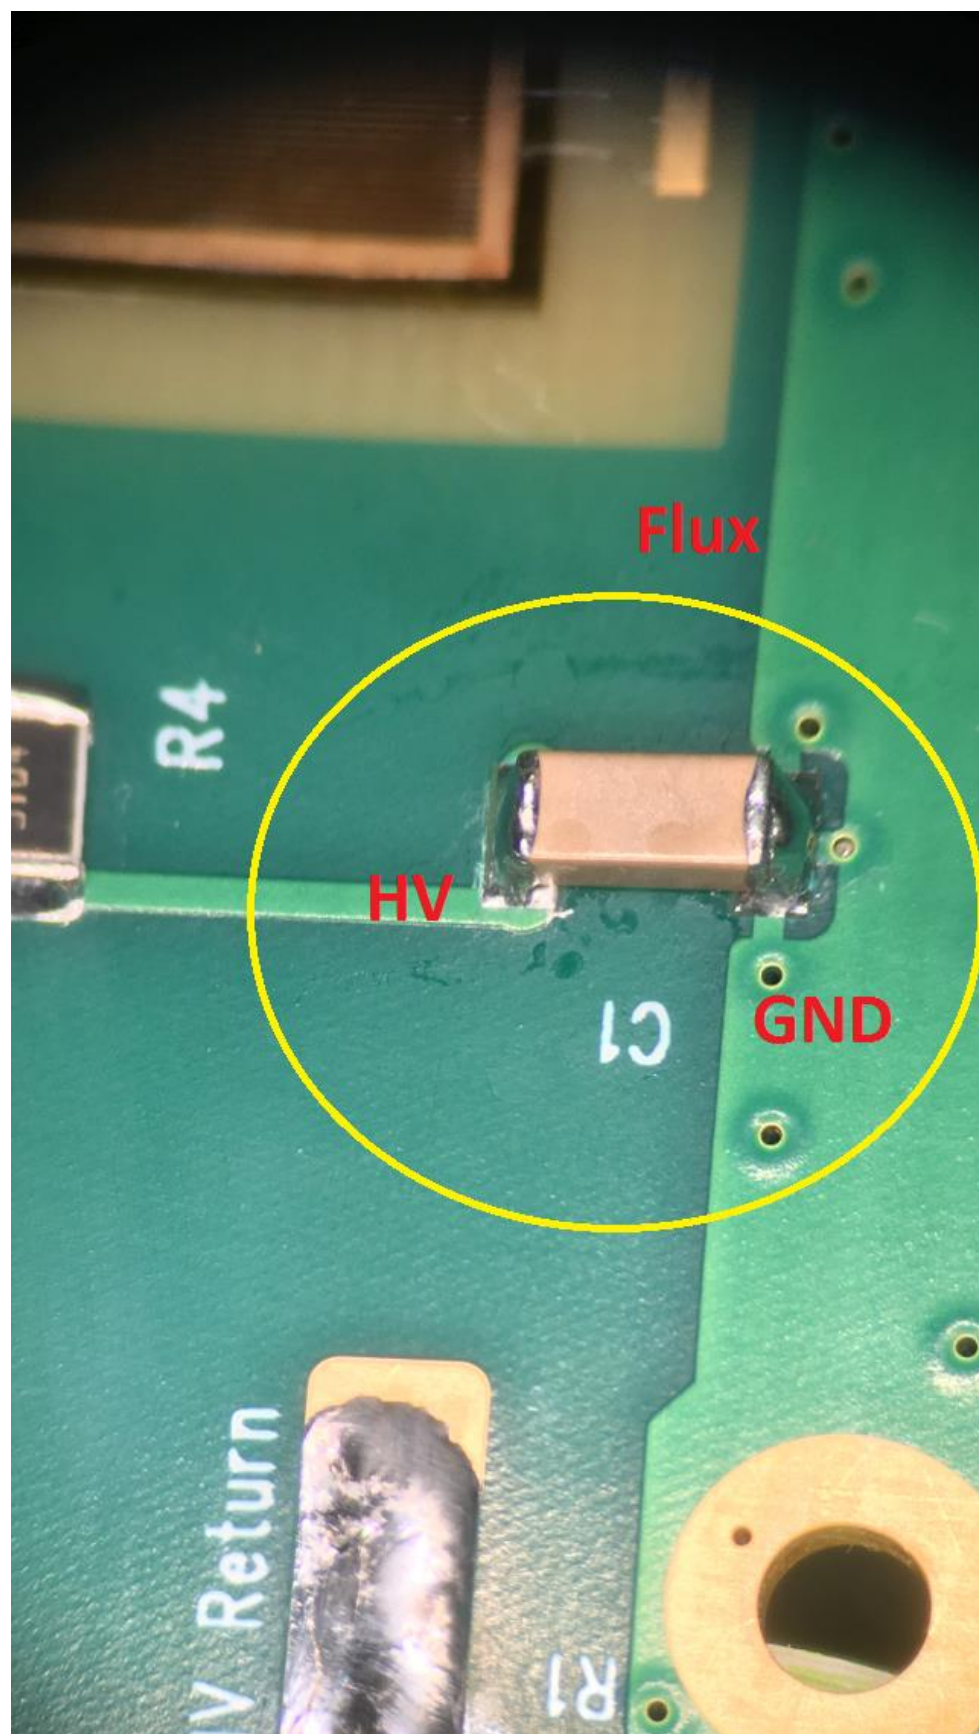
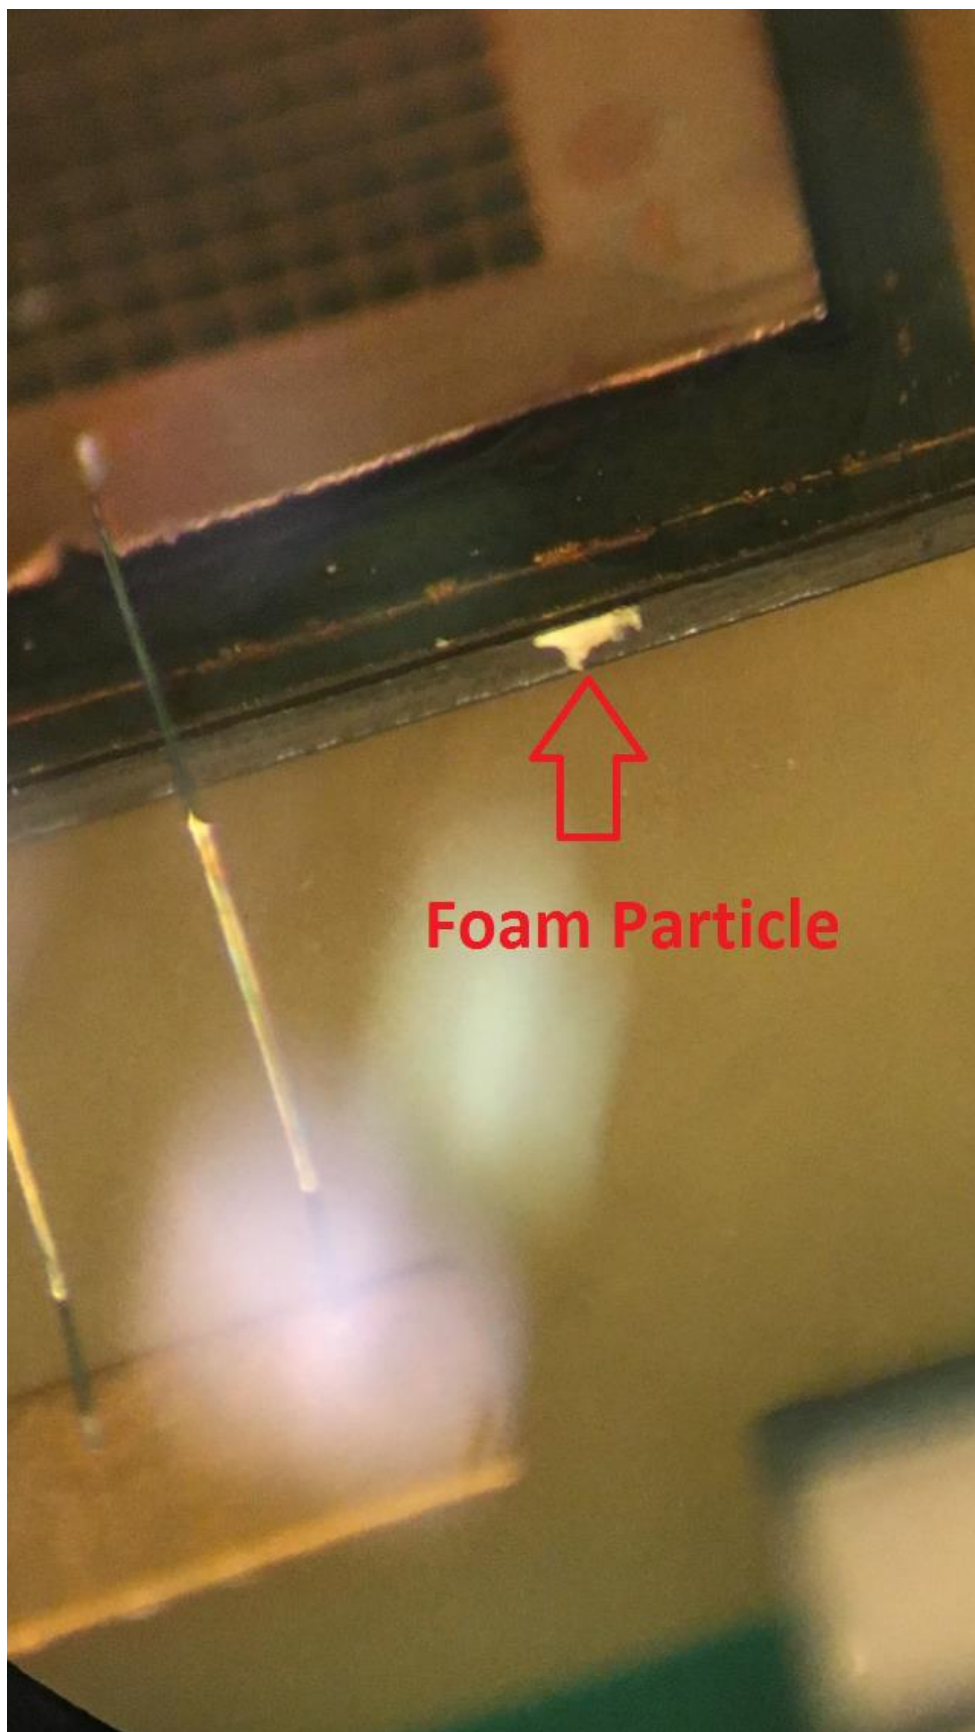
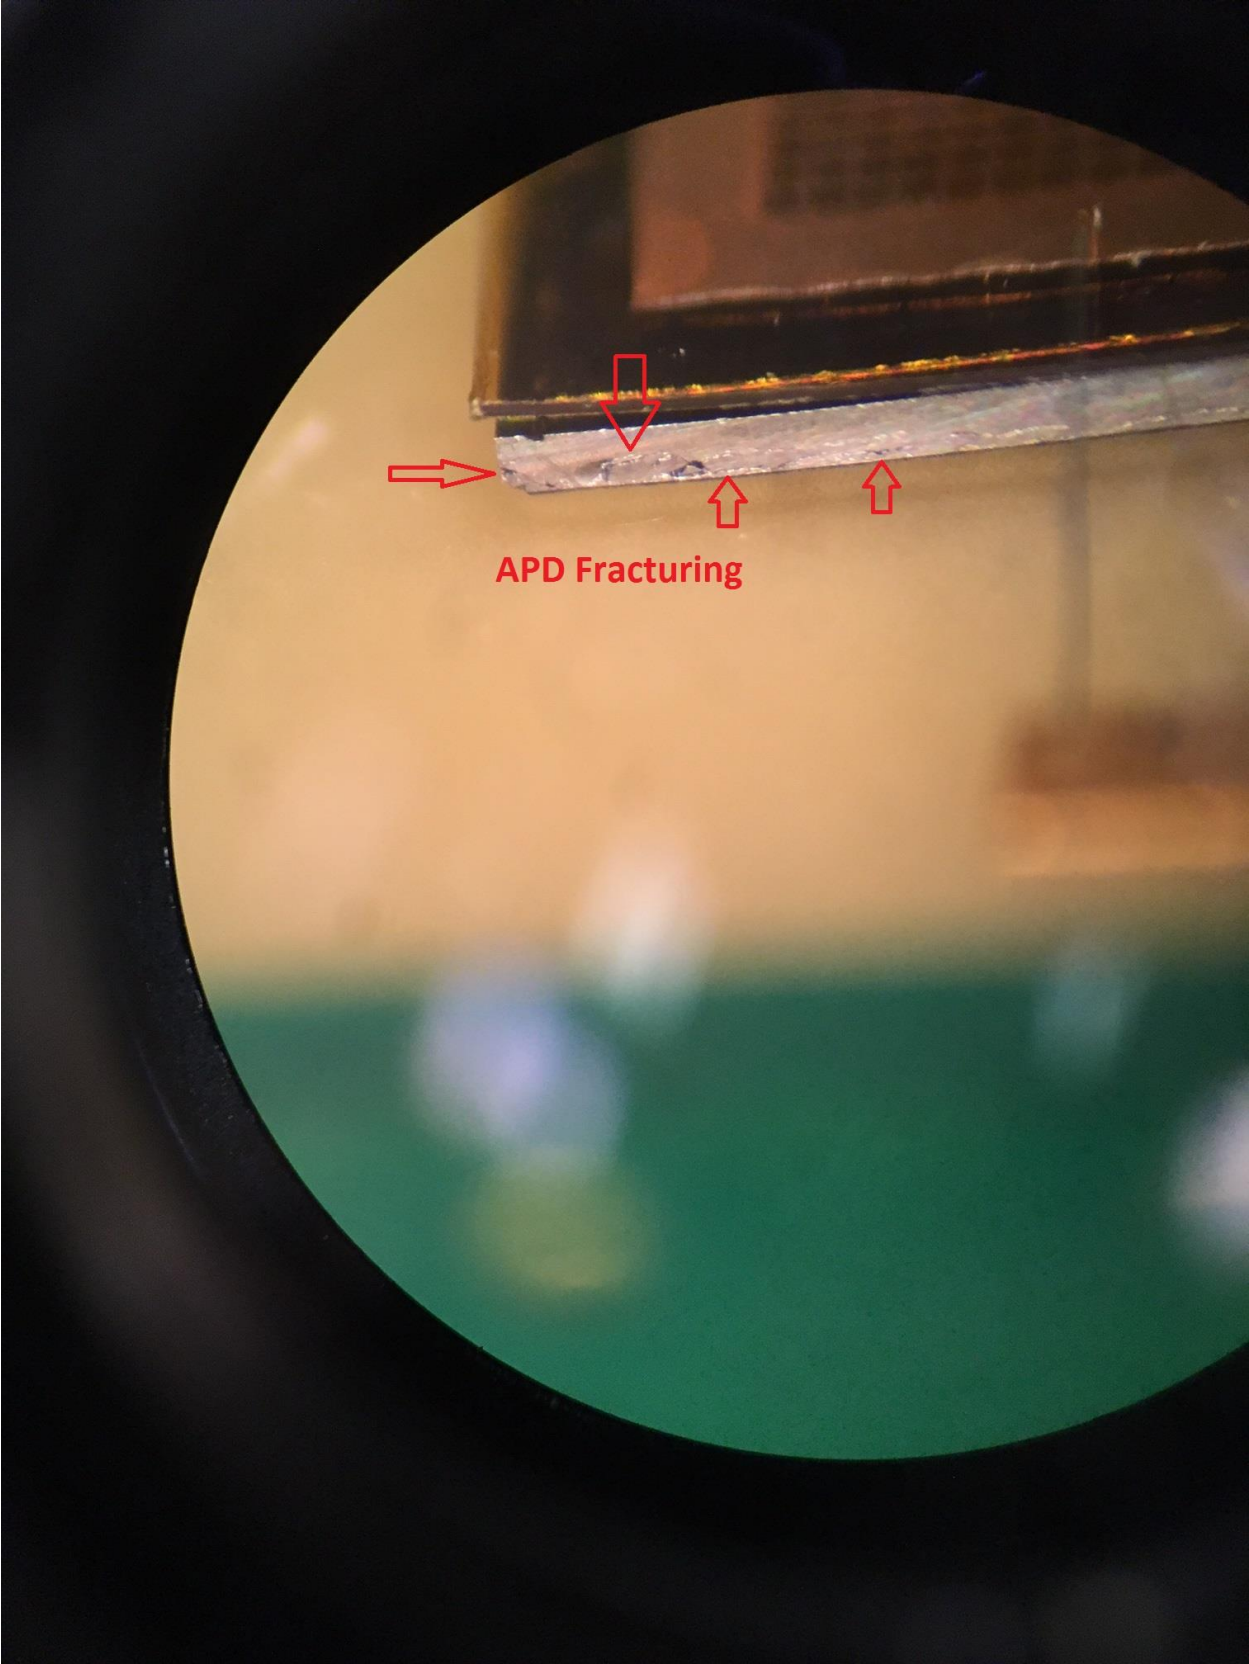
> Actually this 20Mohm is the sum of the (4) 5Mohm series R's. Probing
> the APD I measure a DC resistance of about 480K (very low). So the
> actual measurement from the HV connector was the 20M + 480K or 20.48M
> ohm. I managed to take several photos of suspicious concern before
> removing the wirebonds and mesh (I will share them shortly). After removing the mesh I
> isolated the APD and DC probed it and still measured the 480K. I then
> took the PCB up into my cleanroom and did an ultrasonic solvent clean
> with Acetone followed by an Isopropanol rinse. My last stop was in
> our barrel asher for a soft non-biased o2 plasma clean for 5 minutes.
> I returned to my lab and probed what now seems to be expected on
> the measurement of the APD (many meg ohm 20+). I will have to replace
> the screen and wirebond it before it can be retested. We may want to
> have Mickel coat it as the images I will share show quite a bit of

> hygiene concerns.
