# BESIII RPC Aging Study

Changguo Lu  
Princeton University  
Princeton, NJ, USA

# (1) Aging test on one new RPC prototype

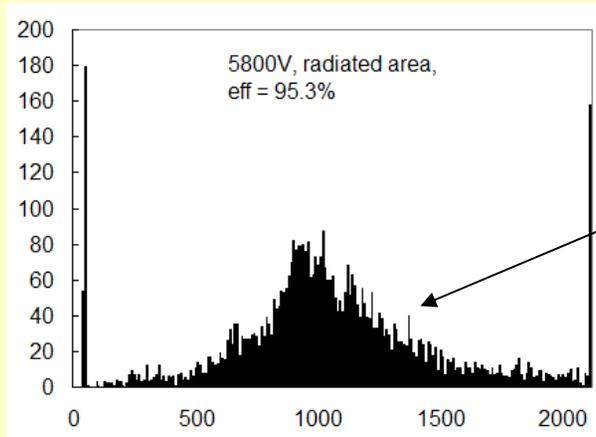
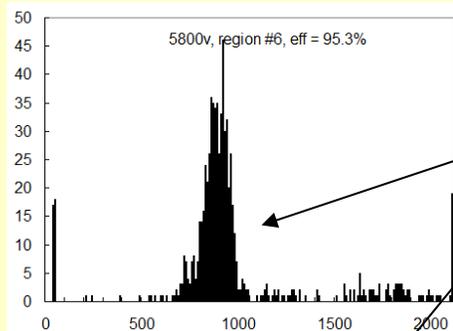
A noticeable spectrum distortion can be seen for the aged region #1. The spectrum on radiated region shows a very broad distribution, although the efficiency is still high, but the distorted spectrum may reflect the aging damage to the internal electrode.

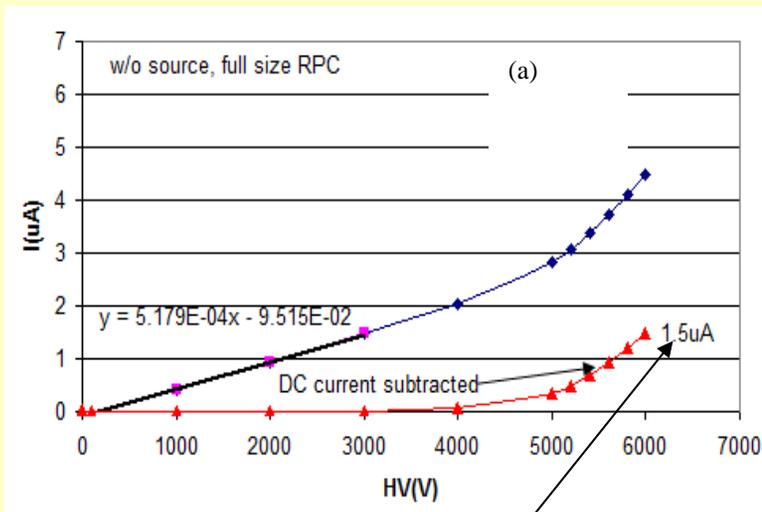
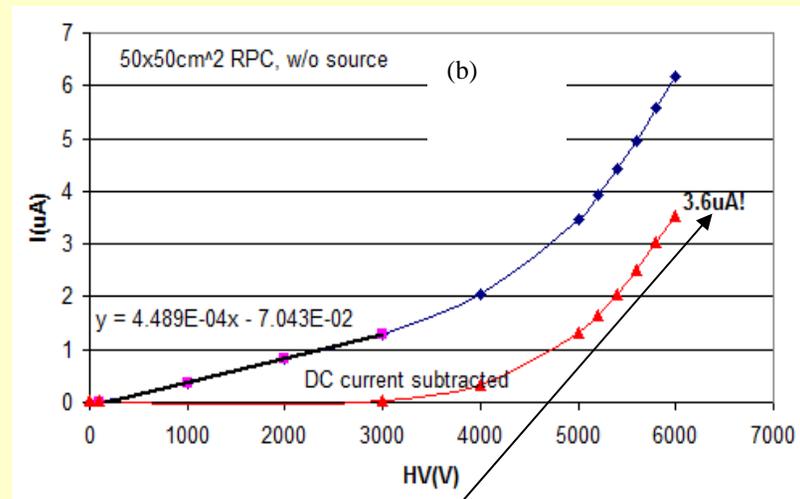
After only 16 days another aging effect took place: the dark current of the aged RPC became much larger.

Full size RPC, 1.5 $\mu\text{A}$  @6000V, w/o source.

Aging RPC, 3.6 $\mu\text{A}$  @6000V, w/o source.

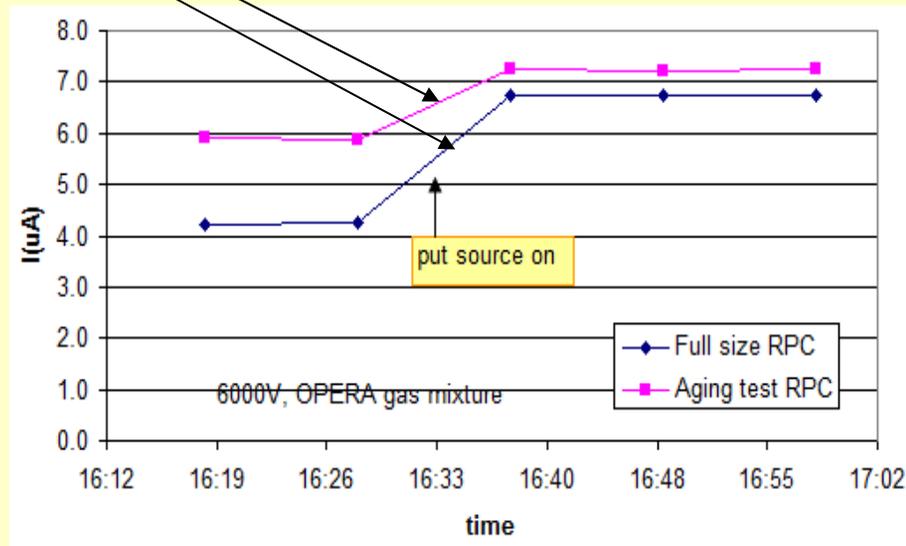
In addition, the current jump due to the source is smaller for the small RPC. On 9/3/2008, the 16th day in the second round of aging, the current in the small chamber jumped from  $5.89\mu\text{A}$  to  $7.25\mu\text{A}$ , so  $dI \sim 1.36\mu\text{A}$ , but the current in full-size RPC jumped from  $4.26\mu\text{A}$  to  $6.74\mu\text{A}$ ,  $dI \sim 2.48\mu\text{A}$ . On 9/22/2008, the 34th day, the current jumps were  $dI \sim 1.12\mu\text{A}$ , and  $dI \sim 2.27\mu\text{A}$ , respectively,

Apparently the aging RPC had higher background current, which was very much likely due to the damaged Bakelite inner surface.

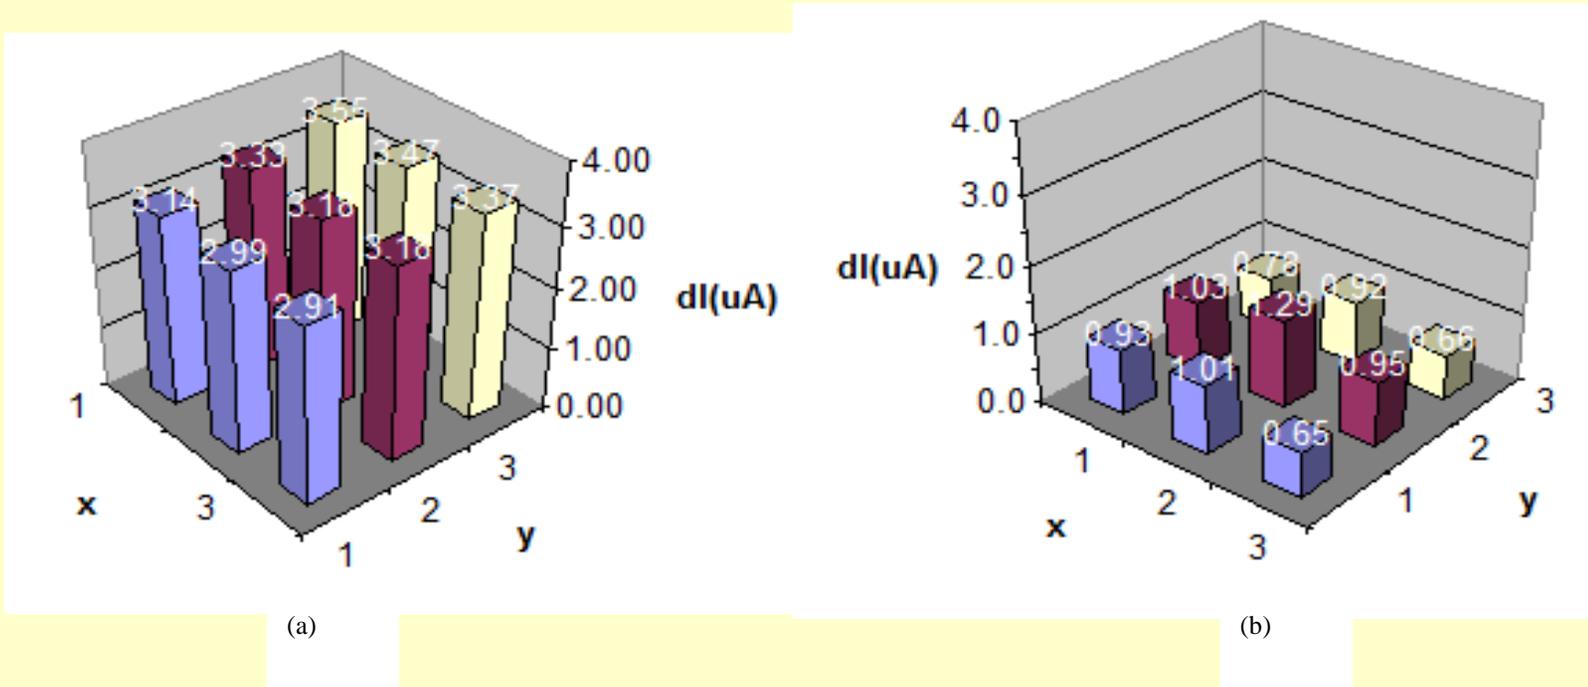
Full size RPC,  $dI$  larger, small relative variation.

Aging RPC,  $dI$  much smaller, larger relative variation.

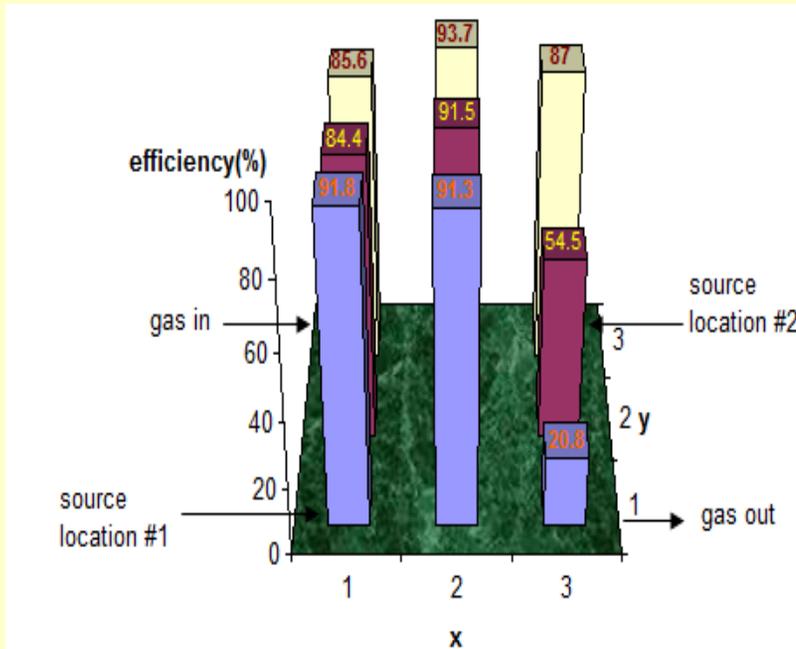
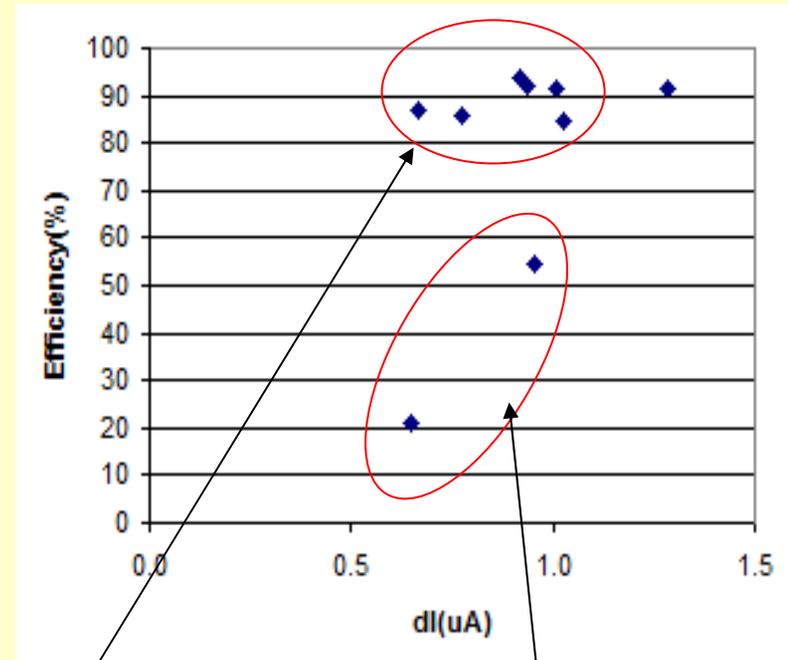
Efficiency survey results at the end of second round of aging tests.

Scatter plot of efficiency vs. current jump,  $dI$ , for 9 regions.

Two lowest-efficiency points show a correlation: lower efficiency related to lower current jump, but the other regions did not follow this trend.

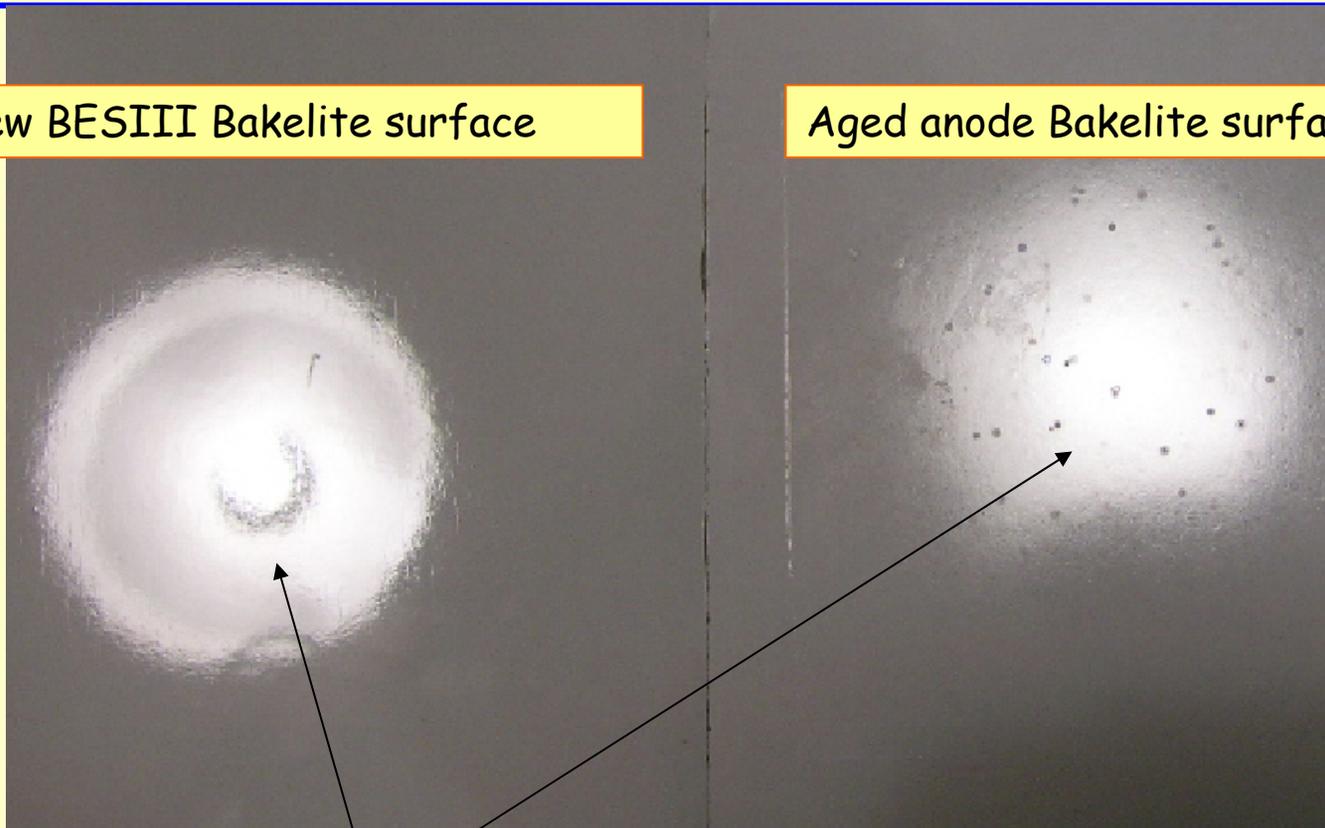
See a lot of spots, which apparently are due to the discharge. Are they produced during the Ar training or during the aging test?

The reflection images of the same ceiling lamp on two surfaces are quite different: the new Bakelite surface has luster looking, the lamp image can be clearly recognized; the aged surface lost the luster, the lamp's image can't be recognized.

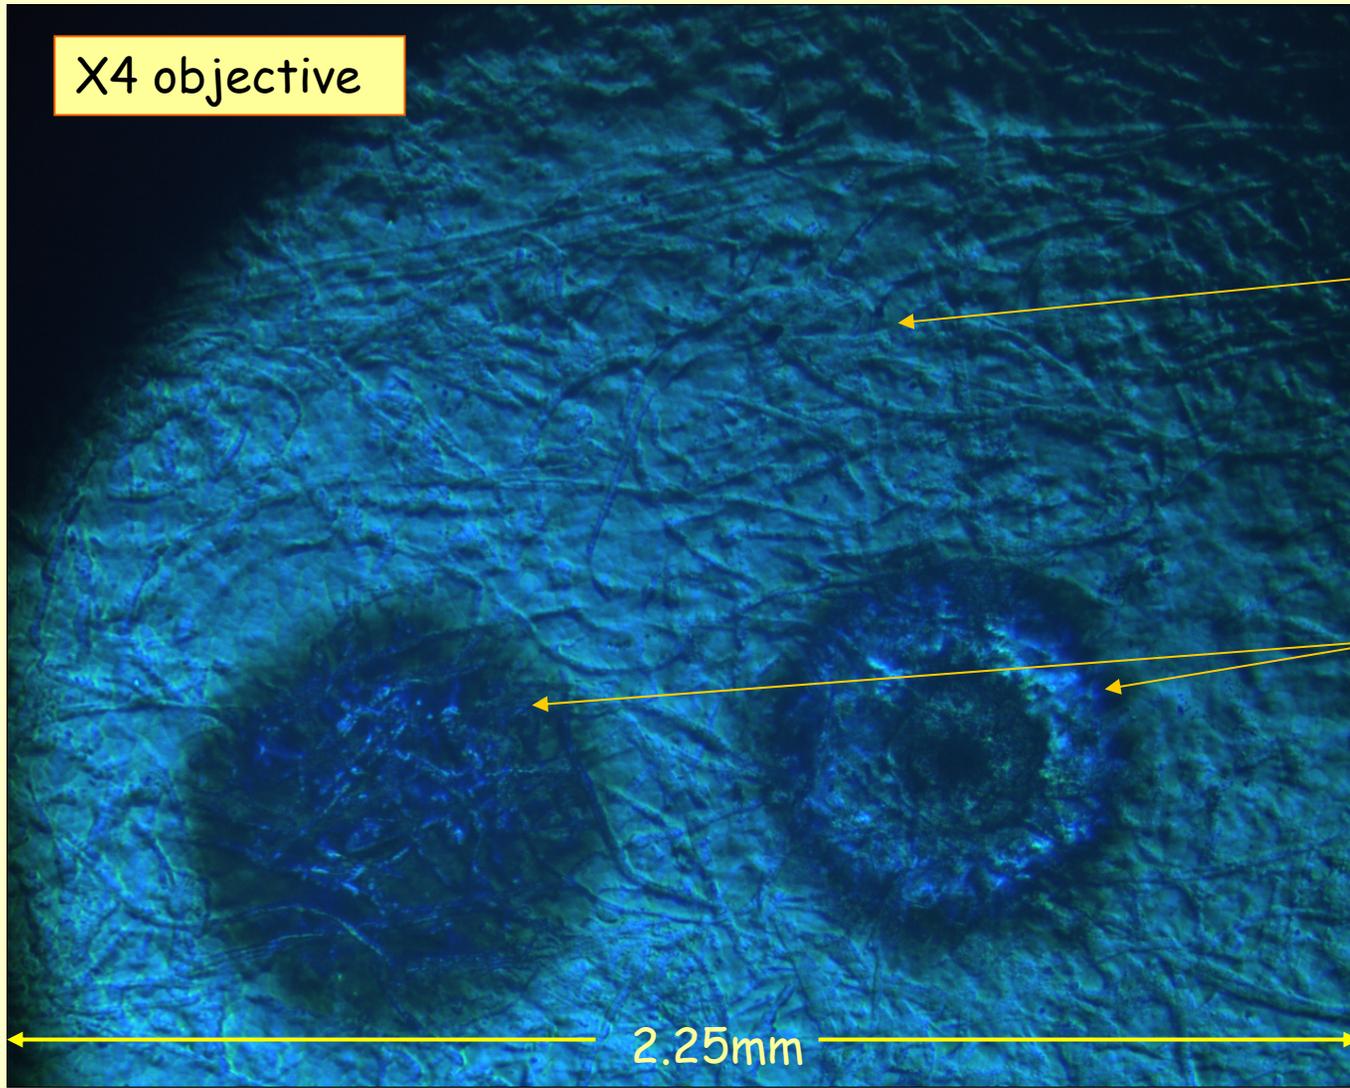
X4 objective

Etched surface

Discharge marks

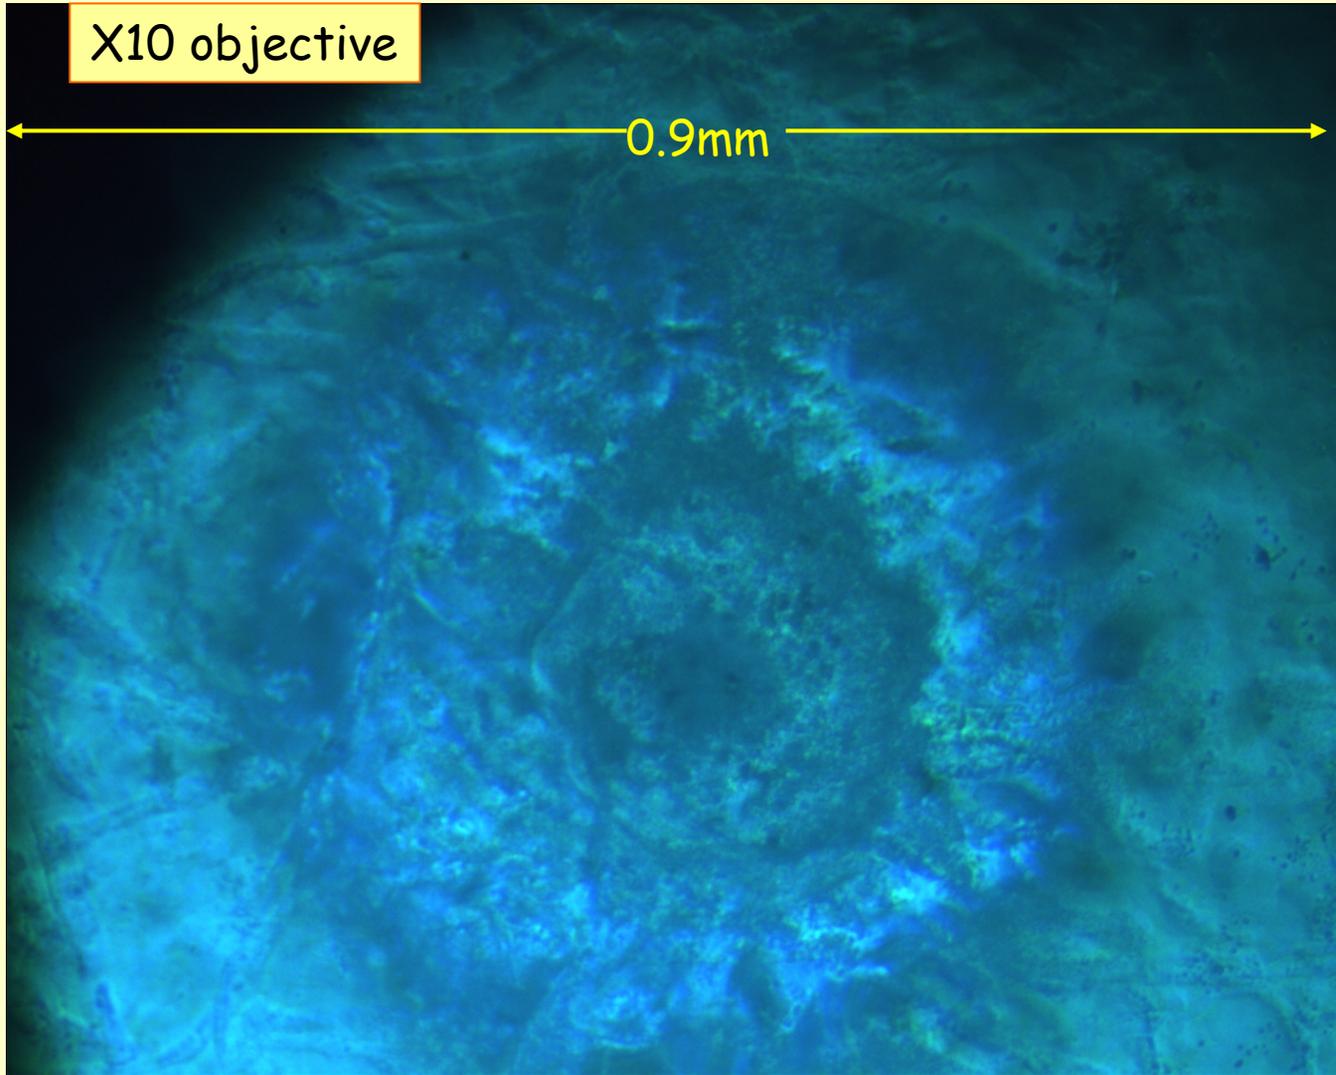
X10 objective

Same discharge spot as previous picture, but with higher magnification.

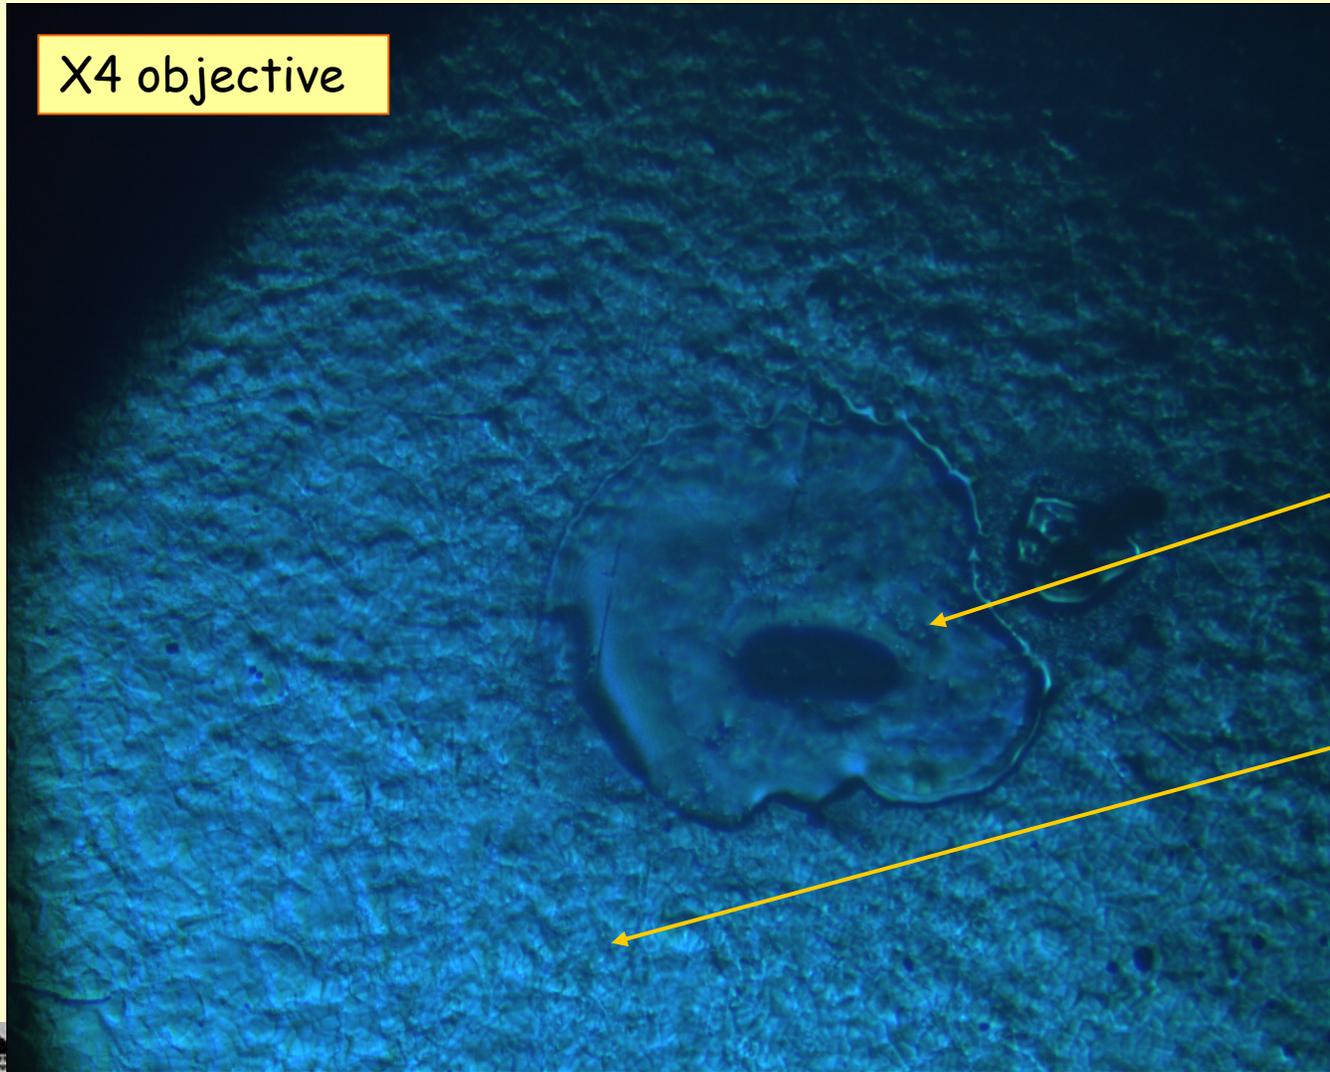
X4 objective

On cathode electrode the density of discharge spots is much less, but still can see some as shown in this picture.

Notice the etched surface similar to anode.

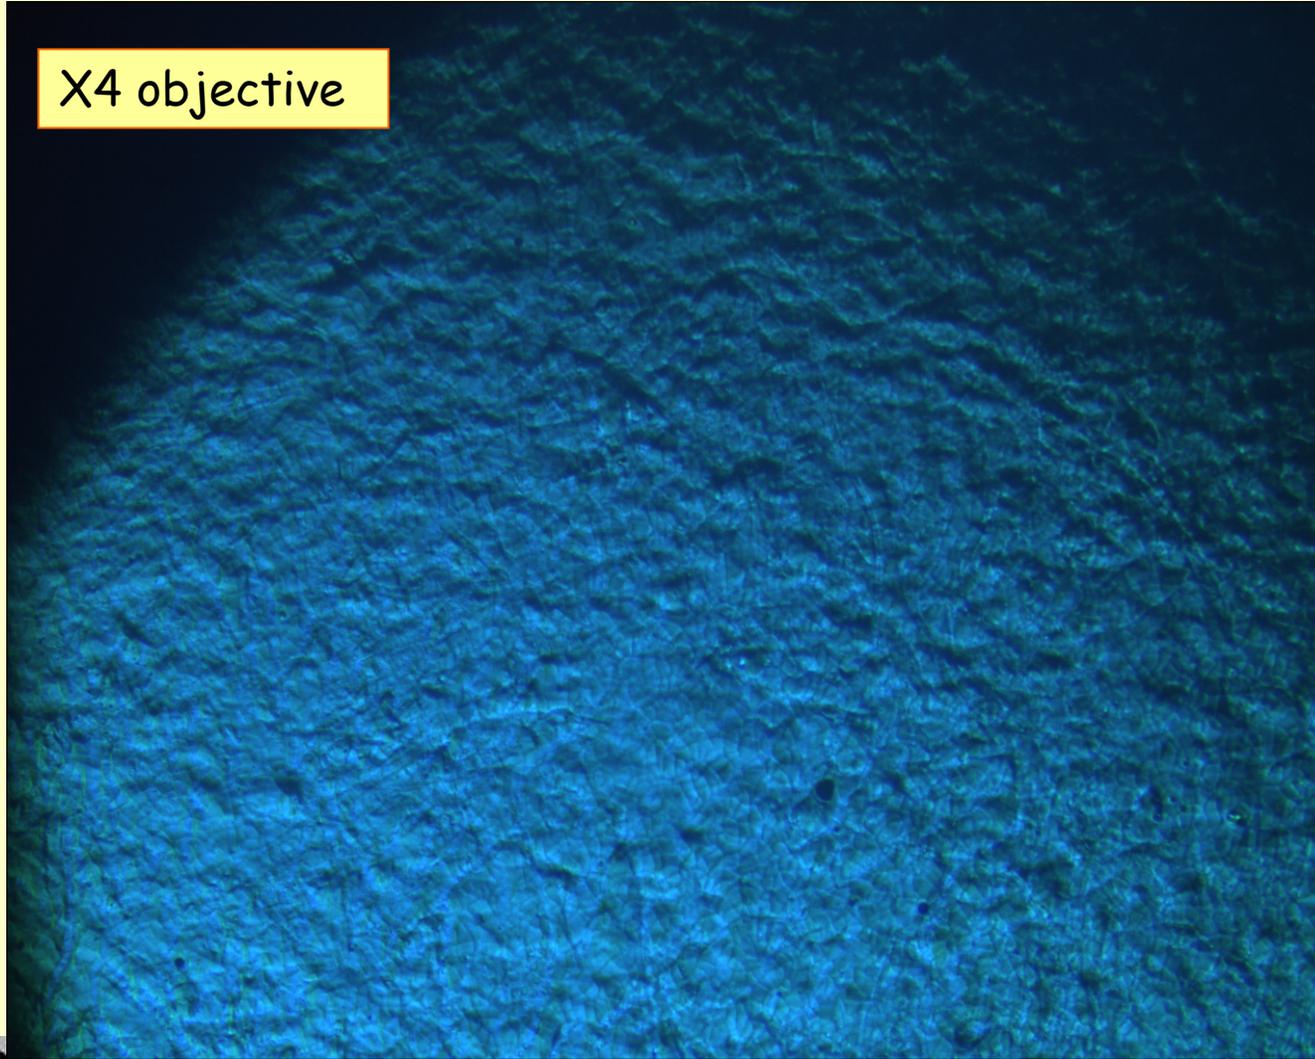
X4 objective

No discharge spot in this picture, but the surface has badly damaged. This is the reason why the aging chamber electrode inner surface lost their luster looking.

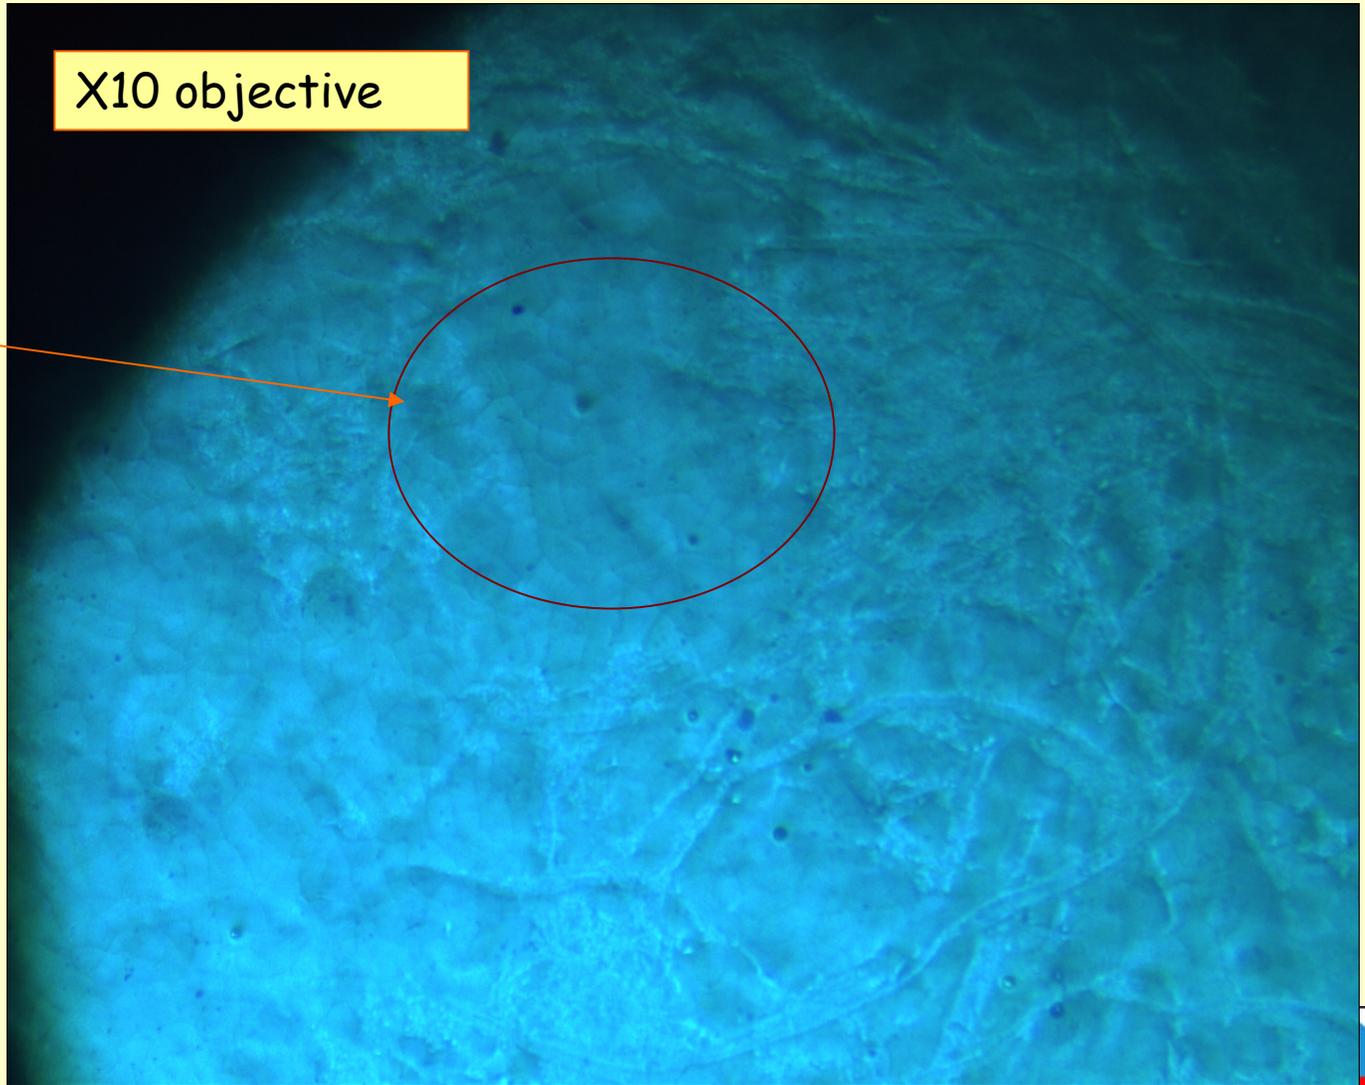
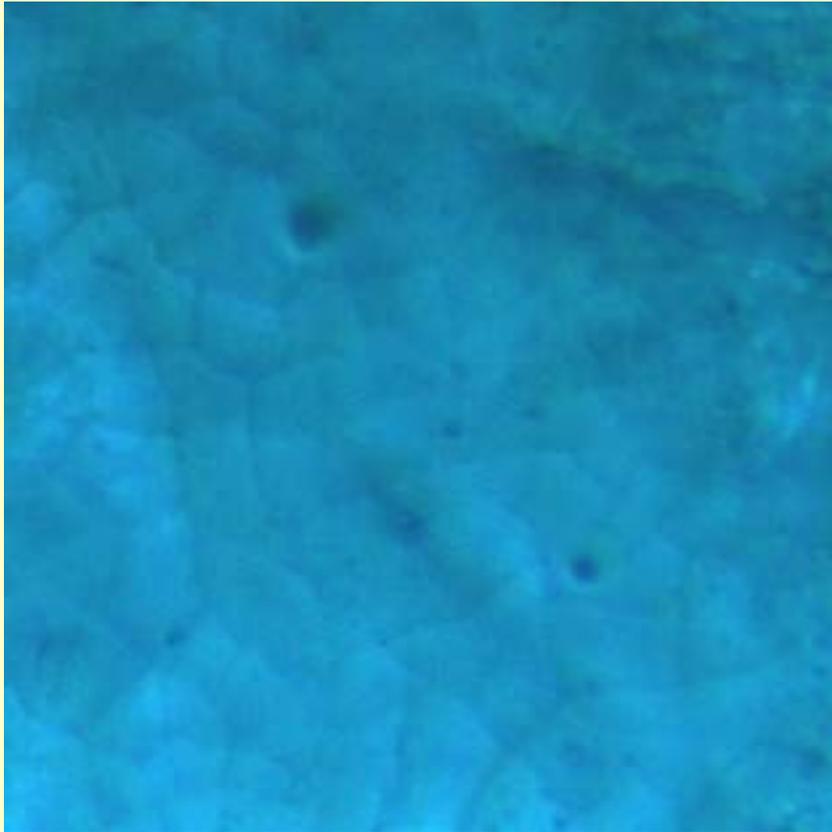
In the less severe damaged region, we still can see original "skin" texture (see next slide for enlarged picture of this region.)

Enlarged less damaged region of the anode surface, it shows "skin" texture.

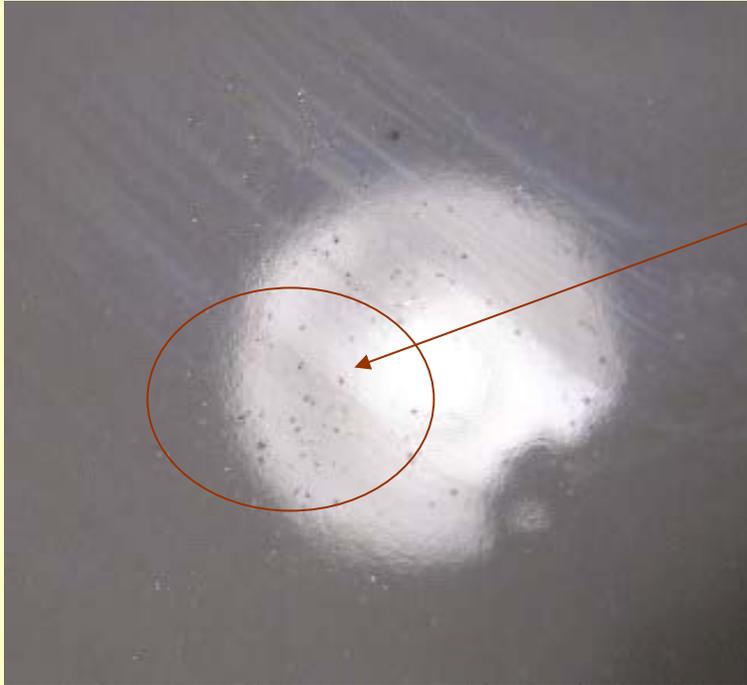
Cathode surface has a lot of dark looking spots, the density is not uniform over the entire surface. These spots do not appear on anode surface.

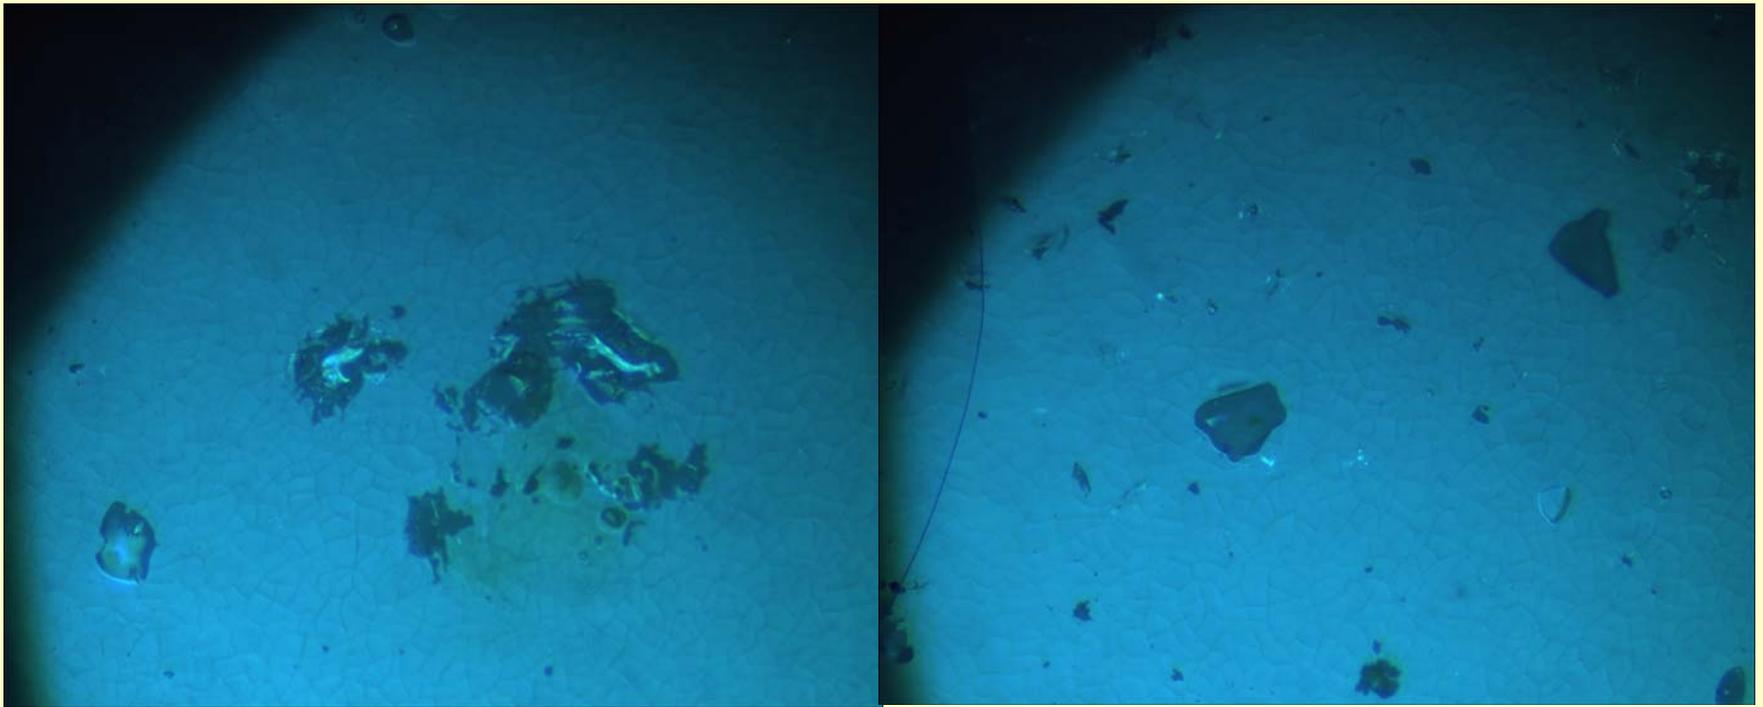
These spots appear on the cathode much more than on the anode. Rest of the region looks still like virgin surface, so it has luster looking.

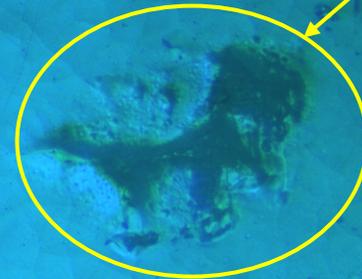
X10 objective

Although anode has much less damaged spots, but we still can find some, one is shown on left.

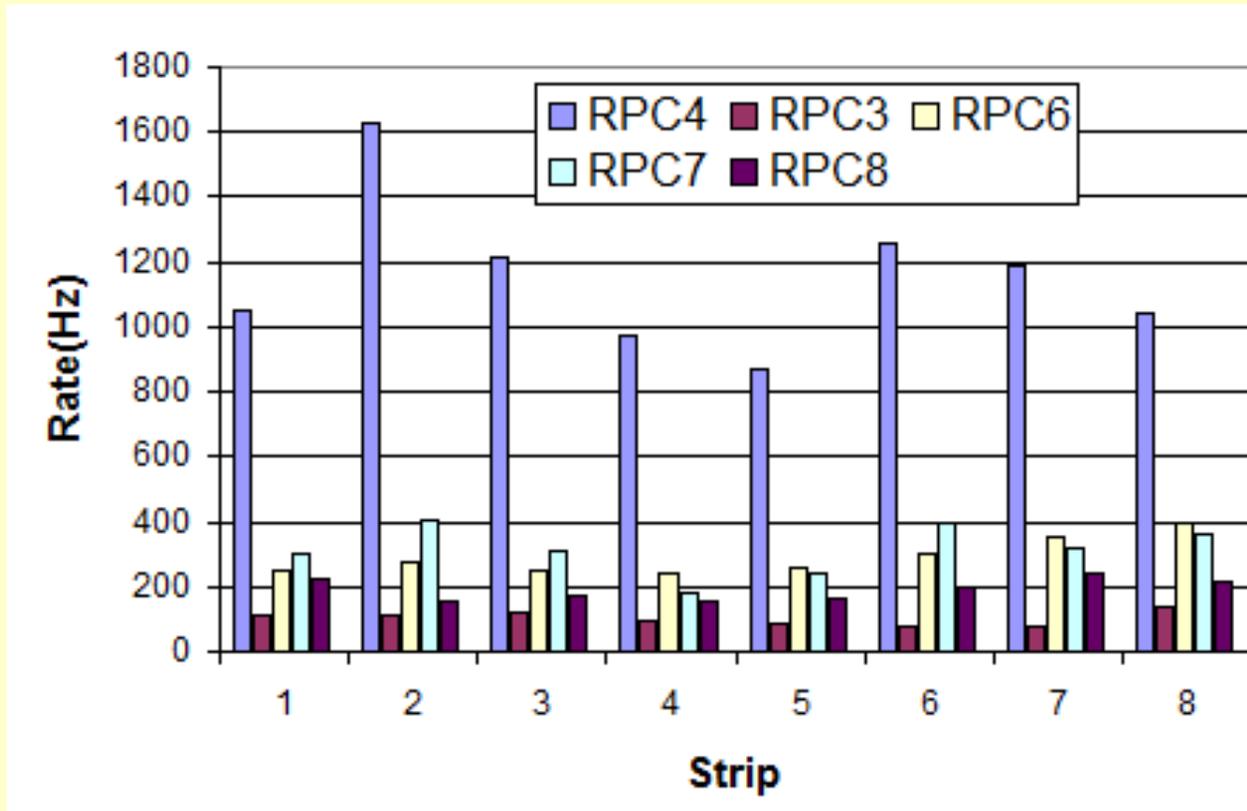
We can see that RPC4 is much noisier than others. All of them look noisy, probably not "trained" enough.

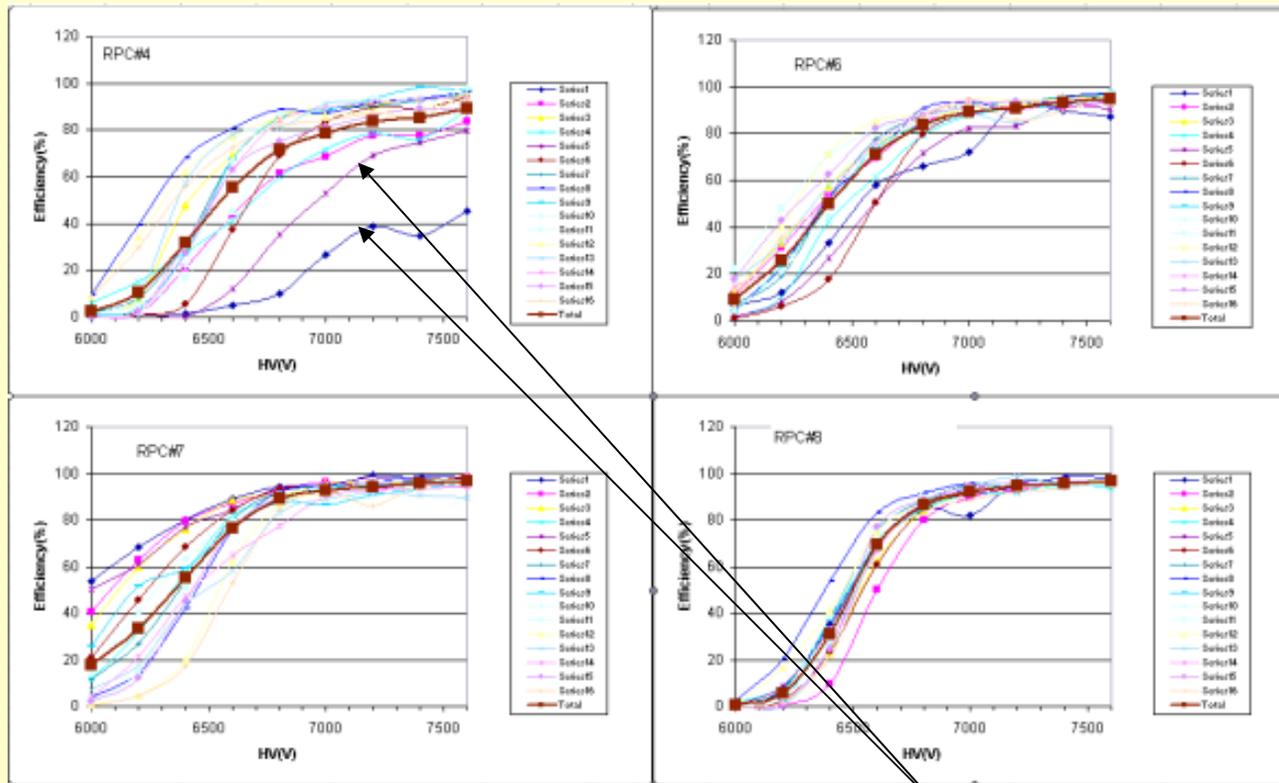
Most dramatic efficiency degrading regions are **#1 and #5** in RPC #4, they are just the radiated area. RPC #6, 7 and 8 are having some aging effect, but the seriousness is clearly correlated to the distance from the source.

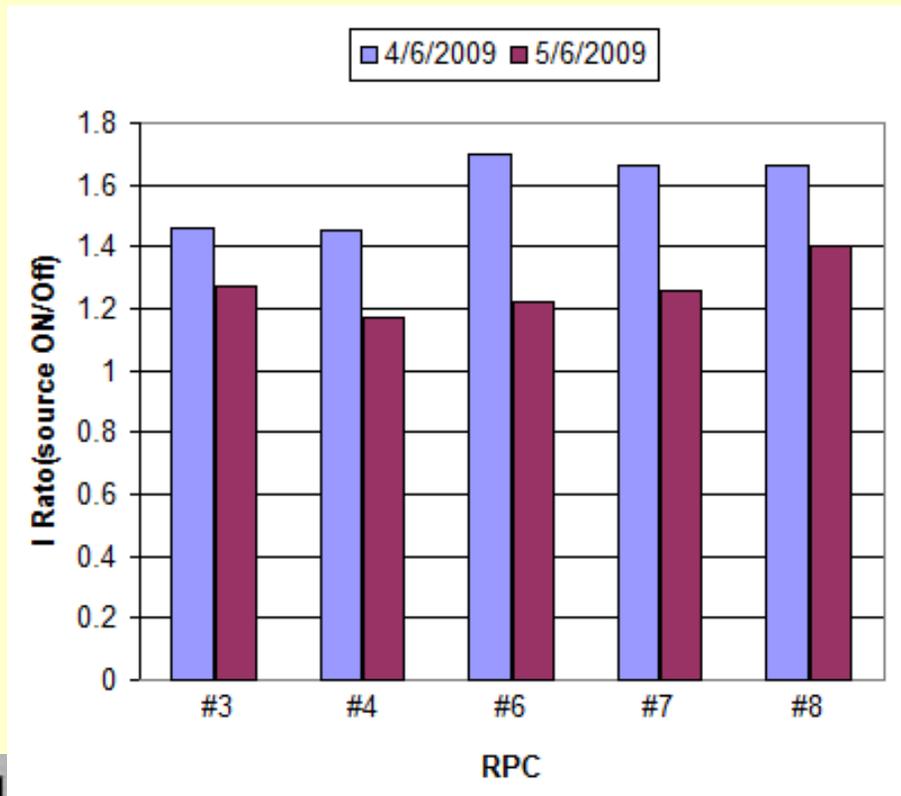
As we previously observed that the current jump due to the source is also degrading. We plot the ratio of I (source ON/OFF) at the begin and end of one month aging test. We can see that all five RPCs current ratios are dropped, which is an indication of aging.

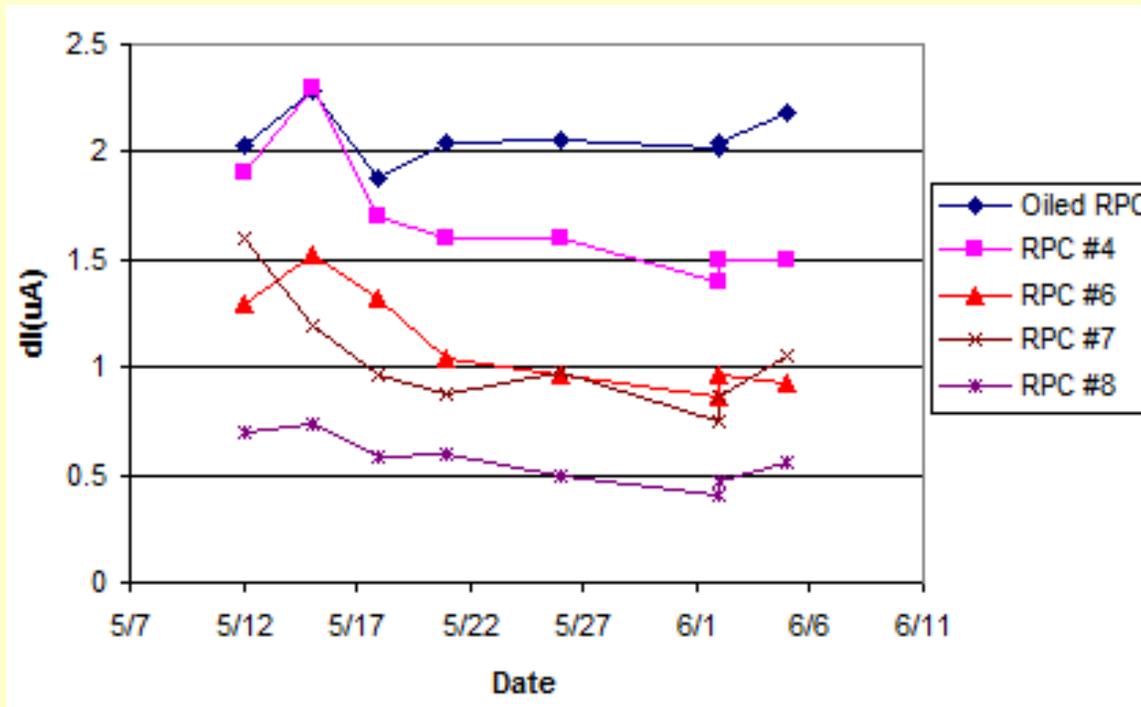
The overall trend of the current jump due to source for all other RPCs is decreasing with the aging days, but the oiled RPC is quite stable.

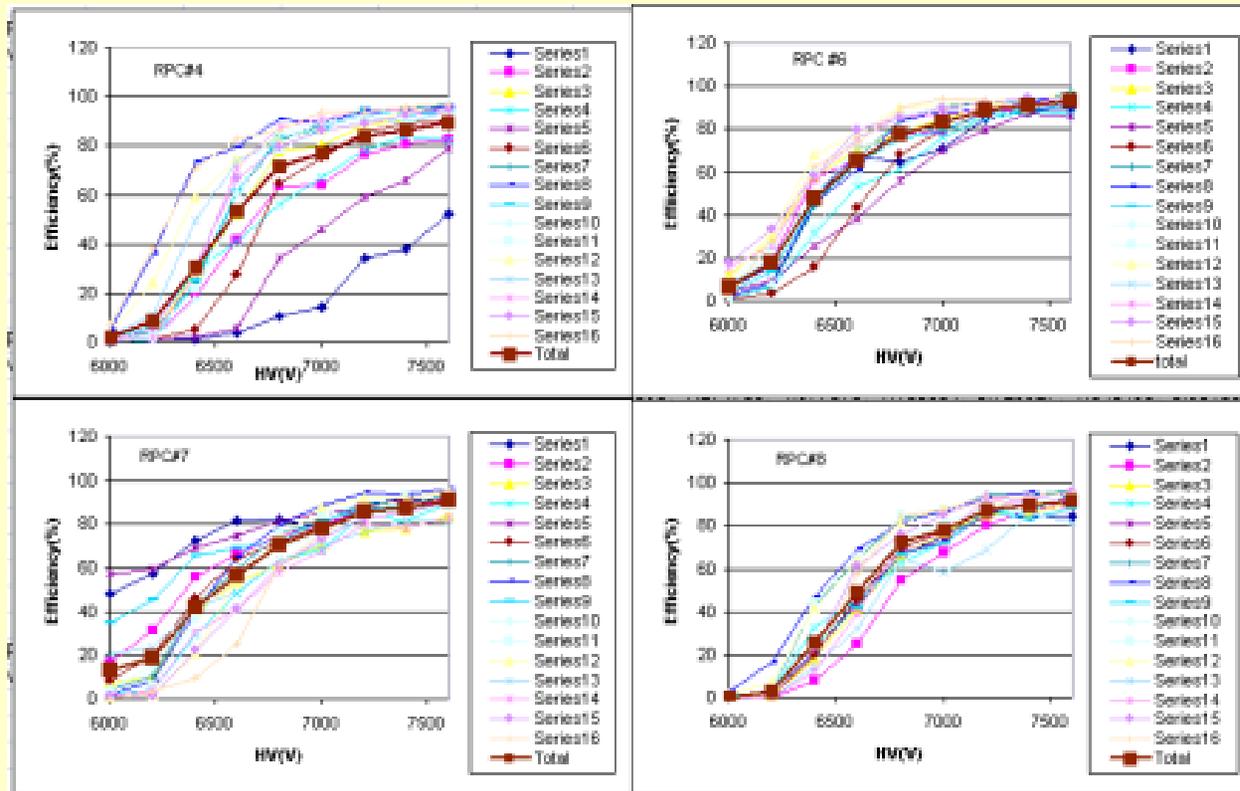
They show further efficiency degradation, but with slower pace.
