Wrong polarity signal study

Changguo Lu, Princeton University

How a wrong polarity signal formed – a hypothetic explanation

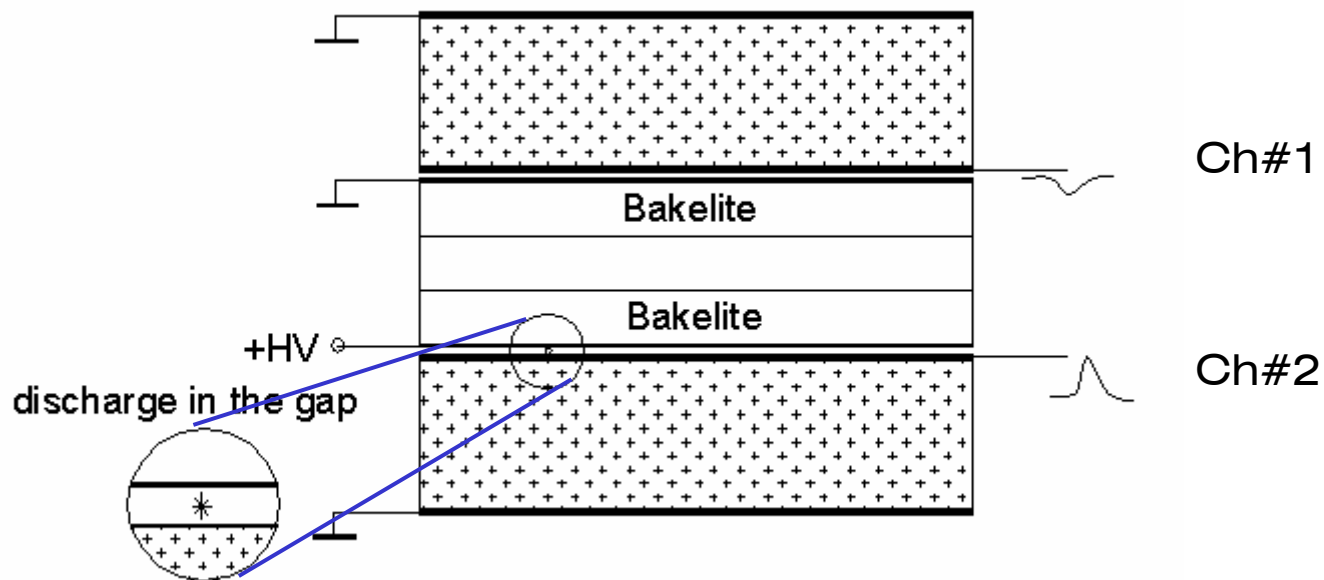
The air gap between HV side of the graphite coating and the pickup strip may produce discharge, the induced signal on the strips have wrong polarity and unsymmetrical characteristic.

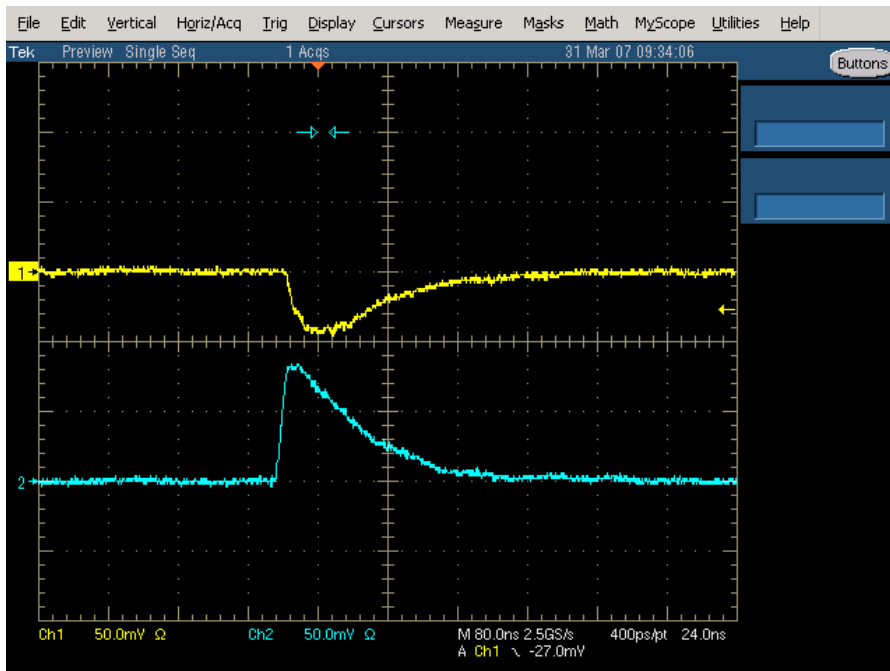
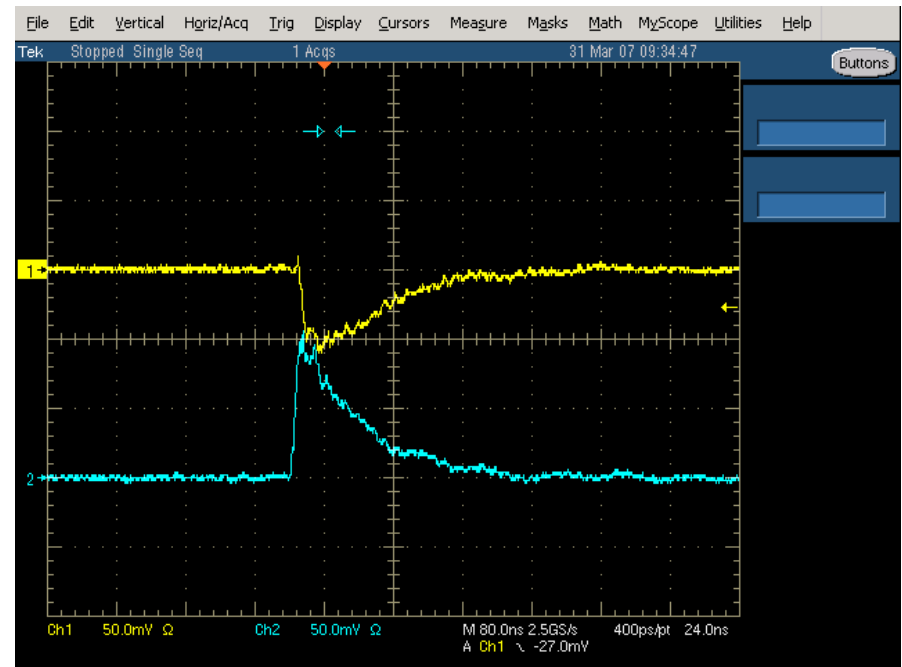
Channel #2 (bottom side): +HV side strip, normally should be negative going pulse; channel #1 (top side): ground side strip, normally should be positive going pulse.

Wrong polarity pickup signal is not coming from the RPC streamer, it might be due to the discharge between HV graphite coating layer and the pickup strip (there is insulating film and air gap).

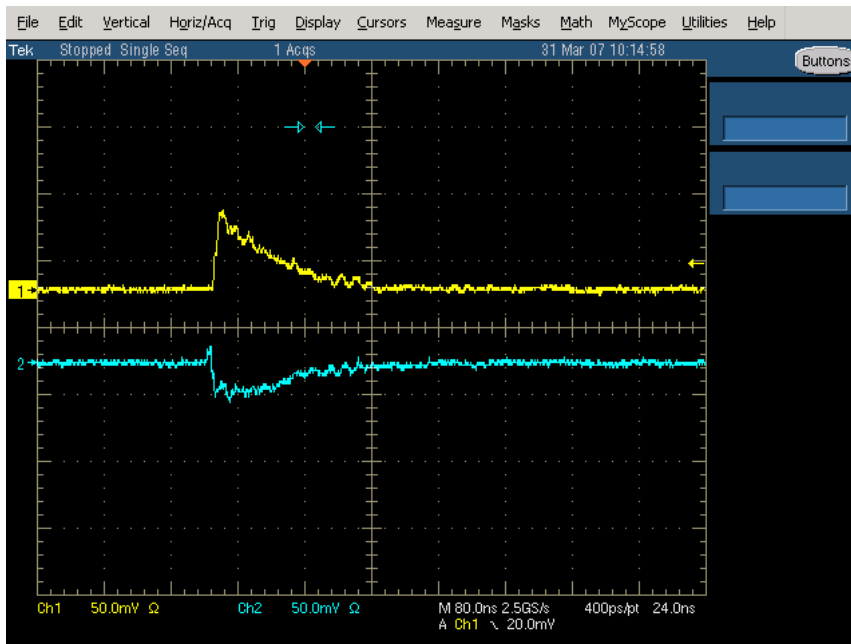
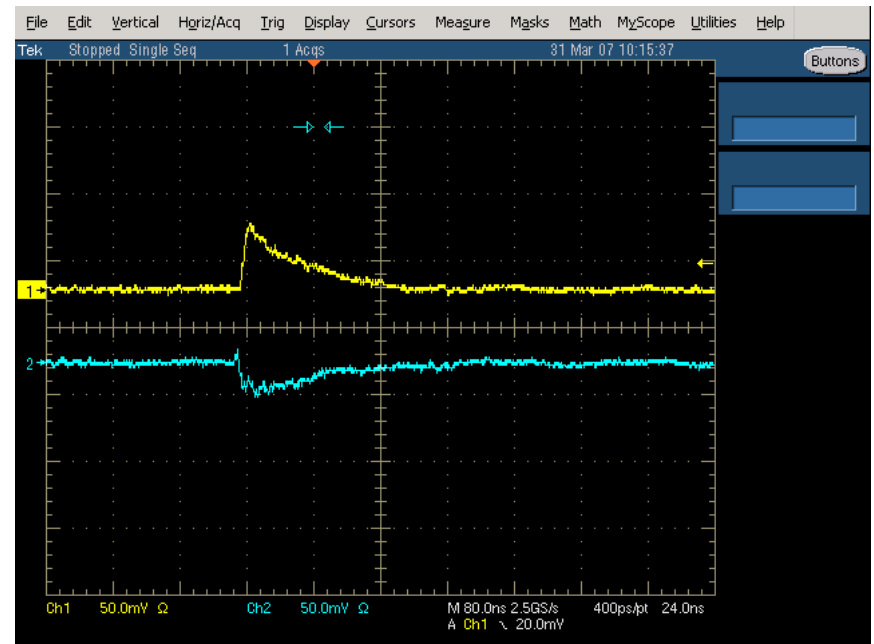
Swap +HV and ground side: +HV connect to top side, ground to bottom side.

Channel #2 (bottom side): ground side strip; channel #1 (top side): +HV side strip. This unsymmetrical pulse shape is still there.

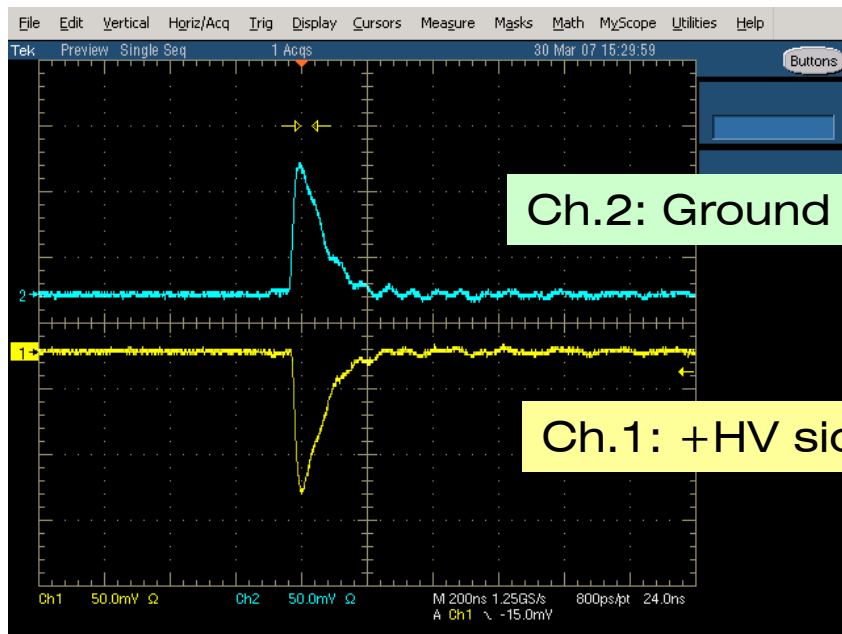
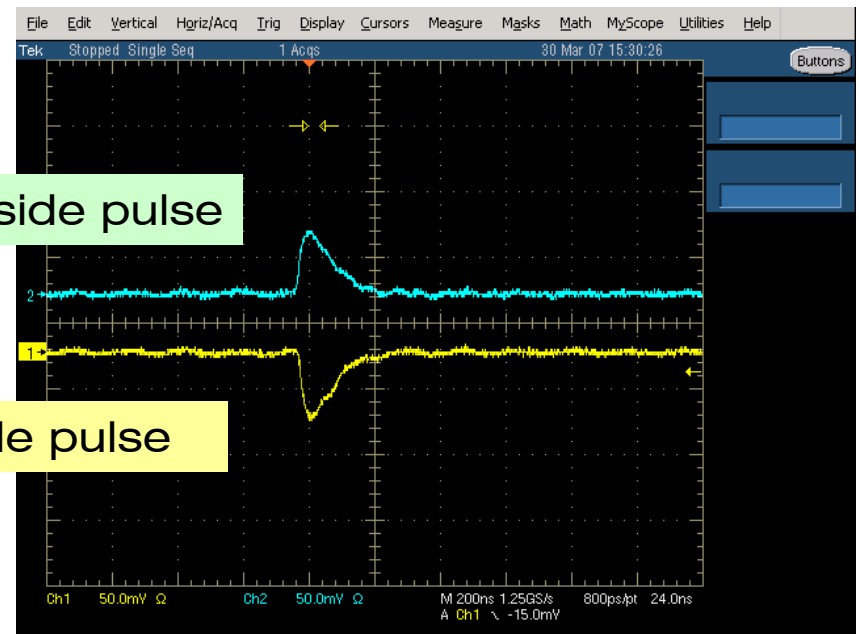
If the source of the induced signal is coming from RPC gas gap, two sides should have same shape and opposite polarity signals.
+HV side: negative pulse, ground side: positive pulse.
