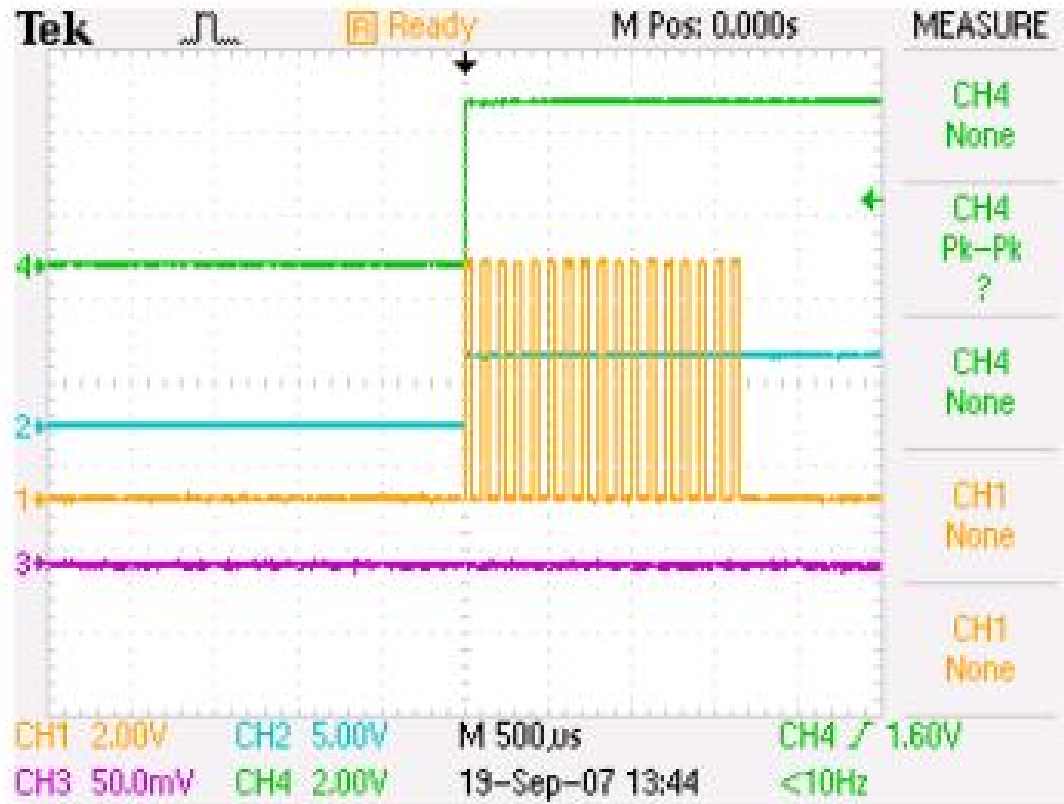
# Scope Trace

**CH1 : B,  
AvTech LD pulse input**  
**CH2 : A,  
SMD trigger**  
**CH3 : Scintillating fiber**  
**CH4 : To,  
Master trigger**

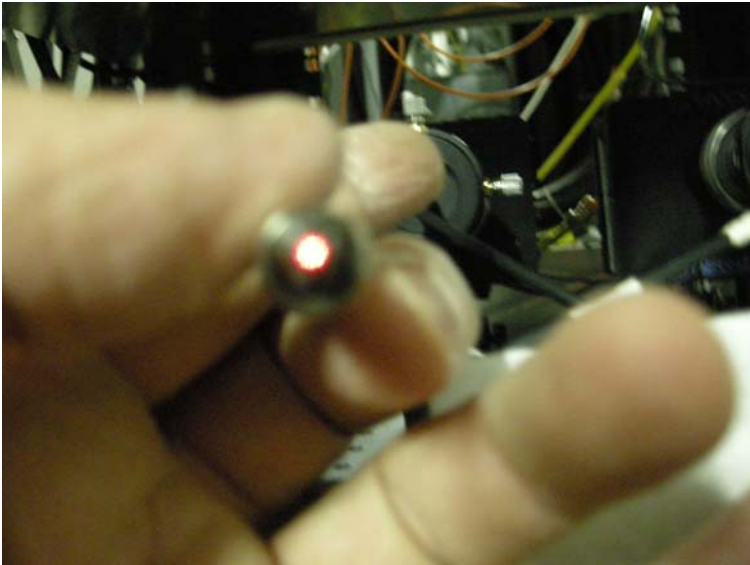
## Viewport #2, fiber continuity check

Red laser pointer used  
Was able to see red circle through  
Imaging fiber, but weak.

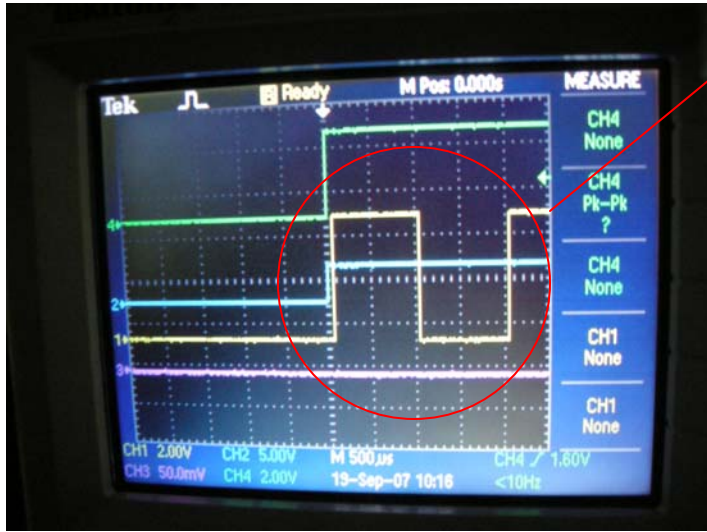
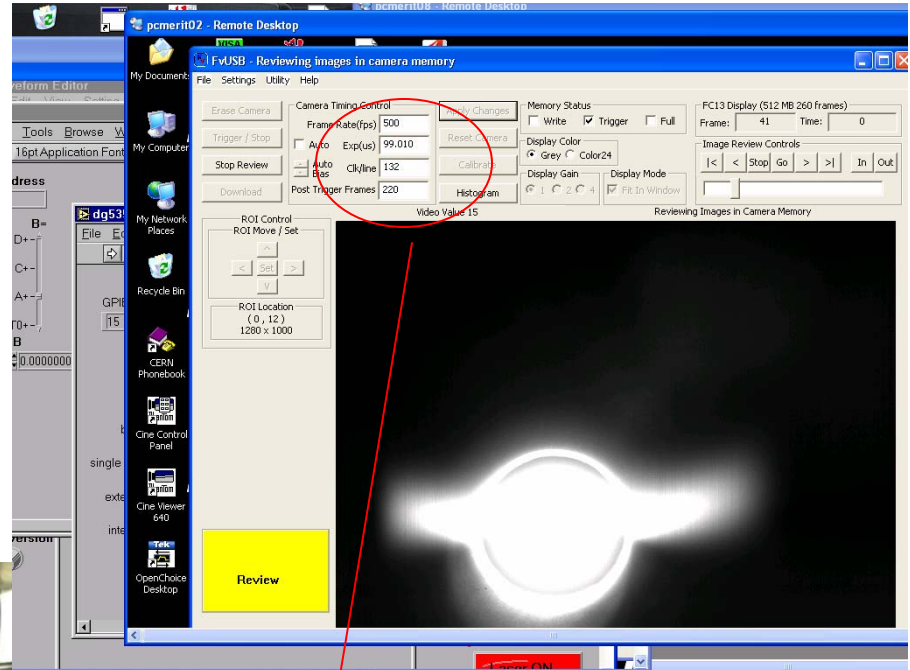
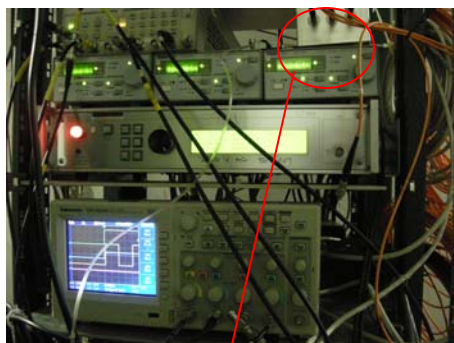
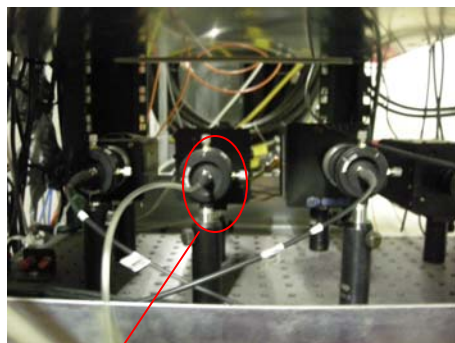
# 25W Laser Check

Connect 25W laser to FV#3

2ms fps, 0.1 ms exposure  
Laser amp. : -10 V

**Confirmation**  
**25W Laser is OK.**

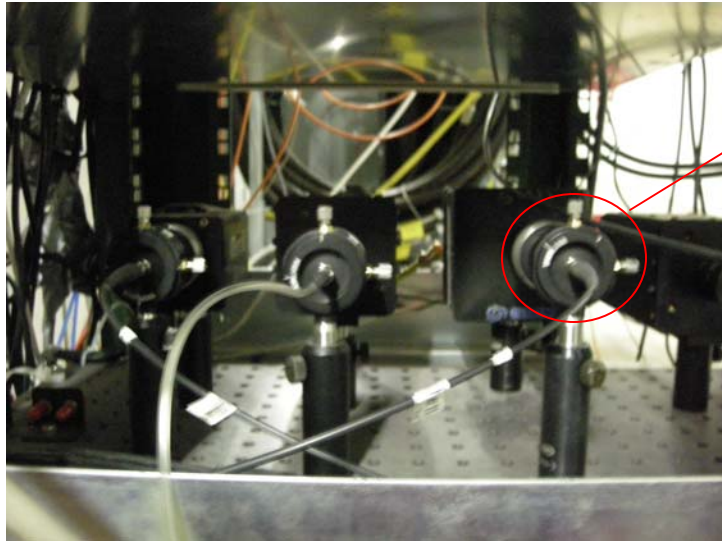
Aligned lens mount again.

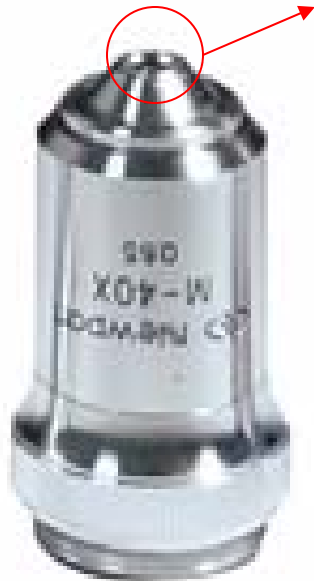
Visually inspected.  
Surface is AR coated.  
Lens is not extruded but protected by surrounding metal housing.  
XY stage will not touch the objective lens.

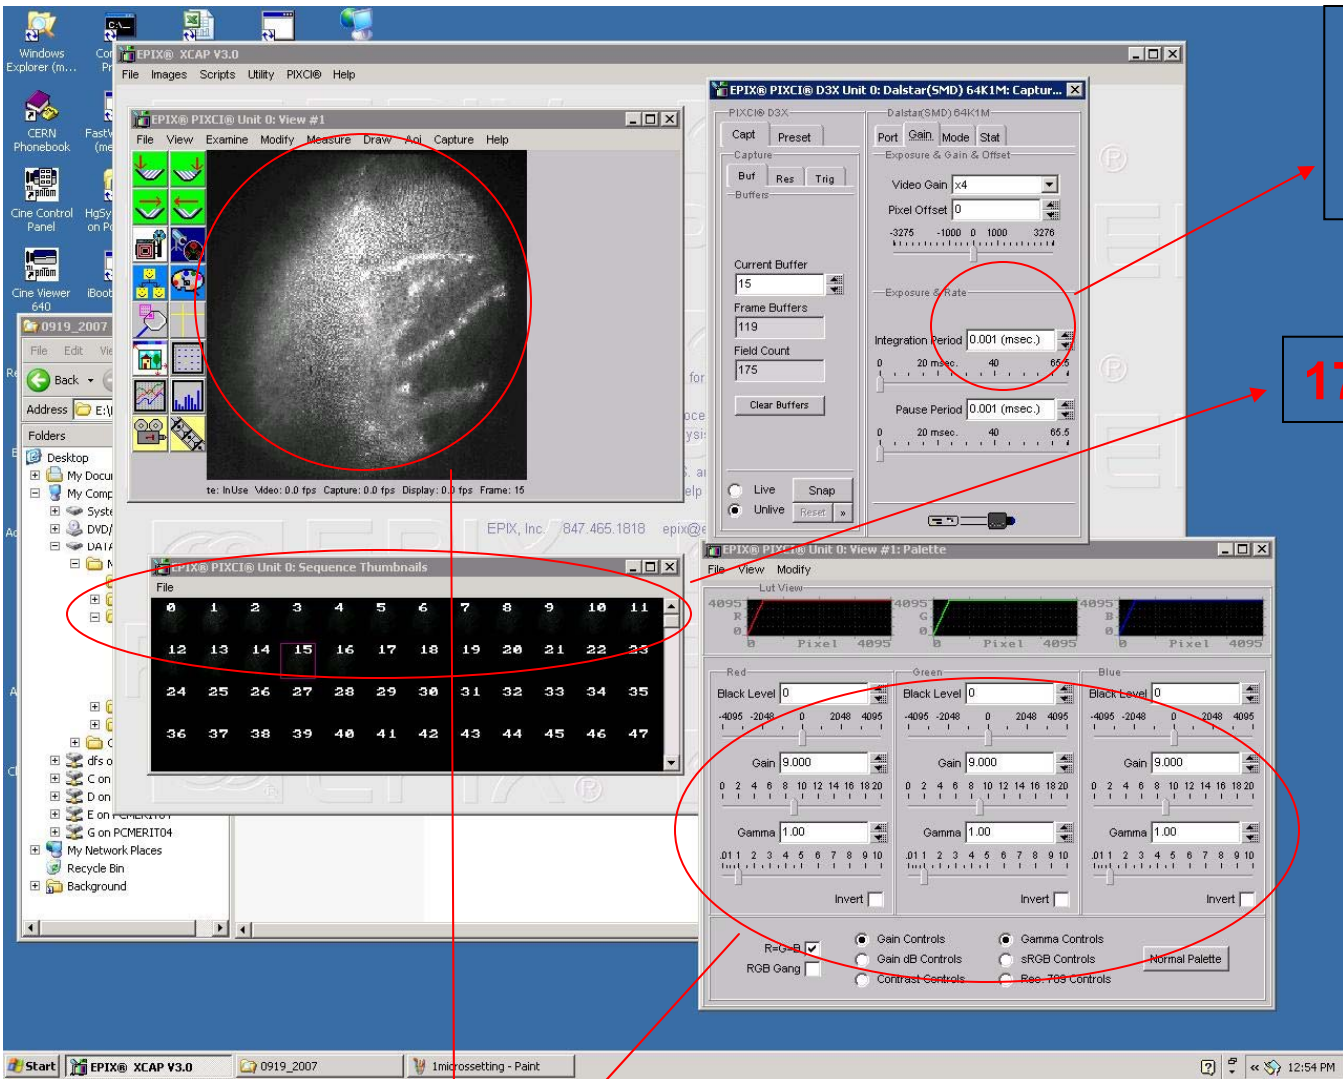
**0.001 ms fps  
"External Camera  
Trigger In"**

**17 frames Read Out**

**Viewport #4,  
Able to make it brighter or darker  
by setting RGB gain.**

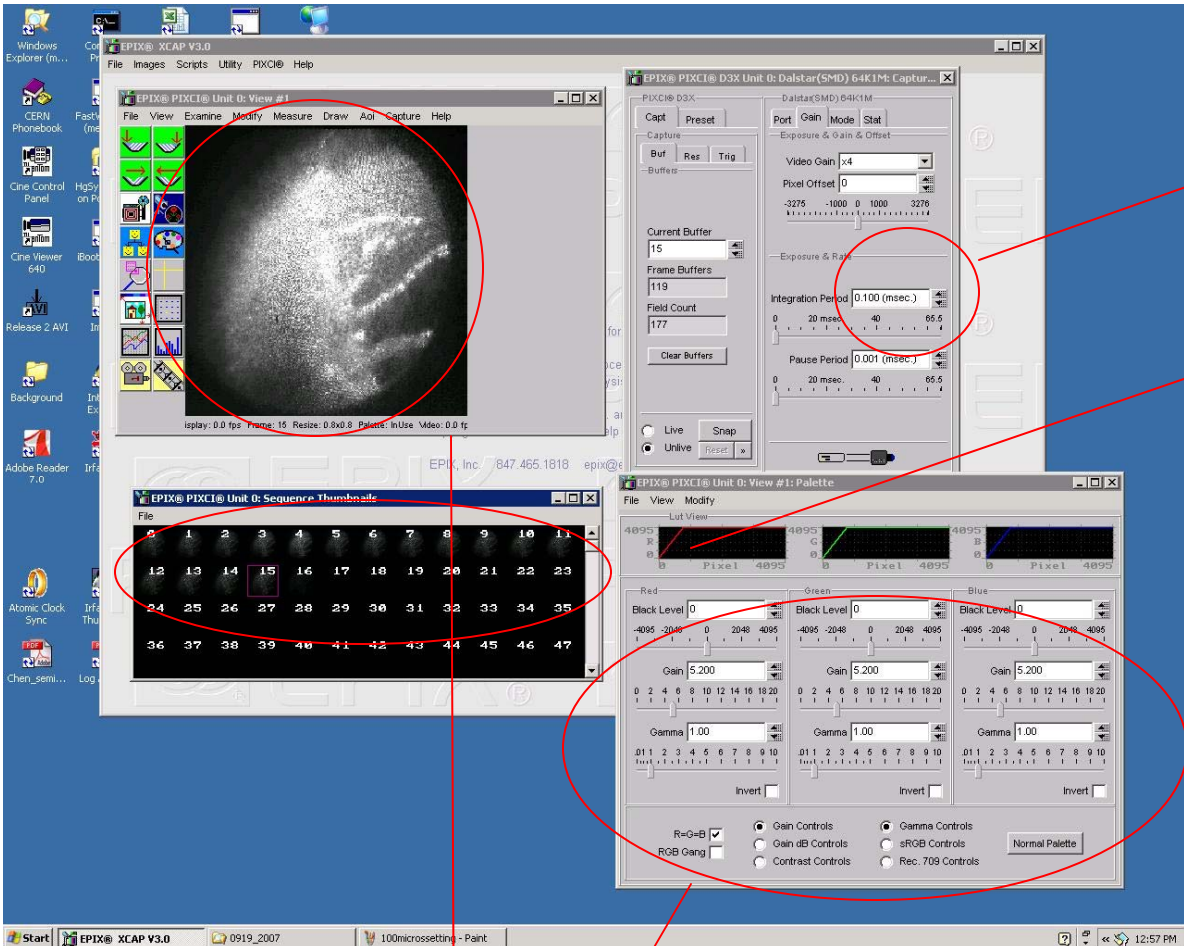
**0.1 ms fps  
“External Camera  
Trigger In”**

**17 frames Read Out**

**Viewport #4,  
Able to make it brighter or darker  
by setting RGB gain.**
