# MERIT Primary Containment Inspection

MERIT Video Conference  
October 13, 2010

# Mercury Primary Containment Inspection 17 Aug - Viewport 2

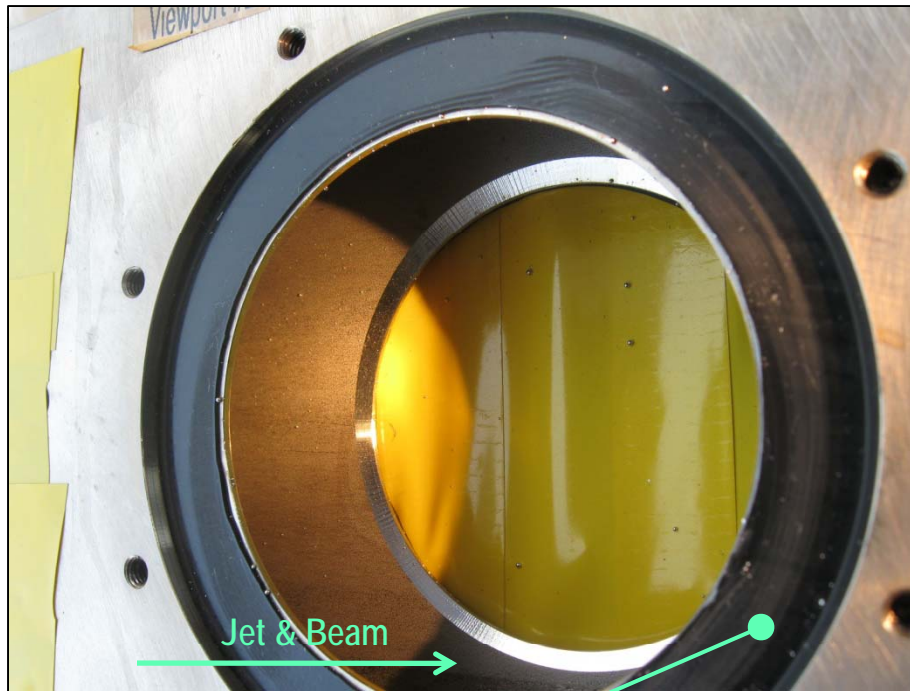
Sapphire Window Gasket

- Sapphire windows removed
- No obvious surface damage noted
- Higher quality photographs to be obtained

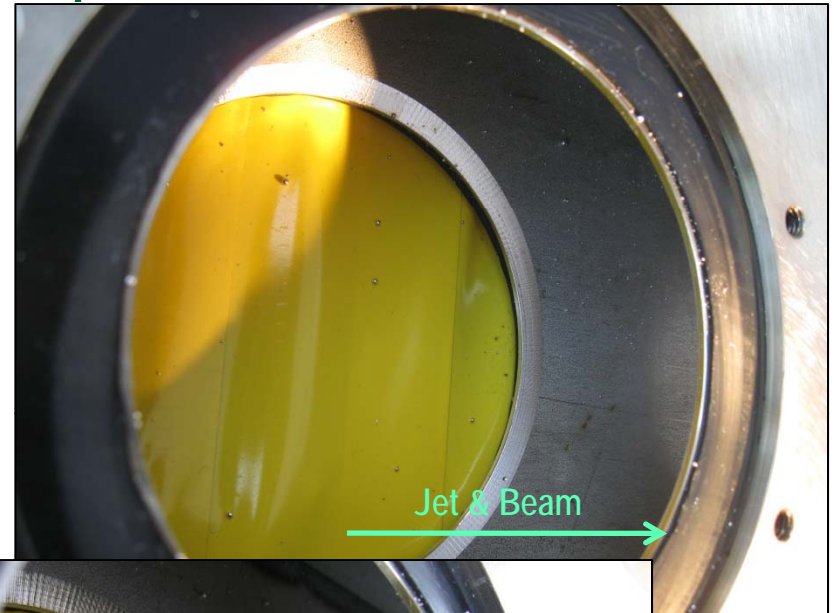
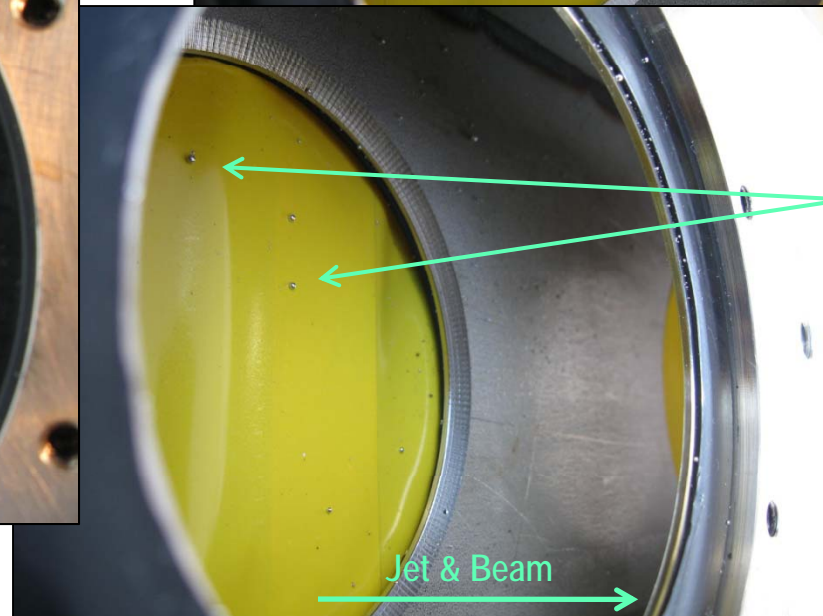
Mercury Beads

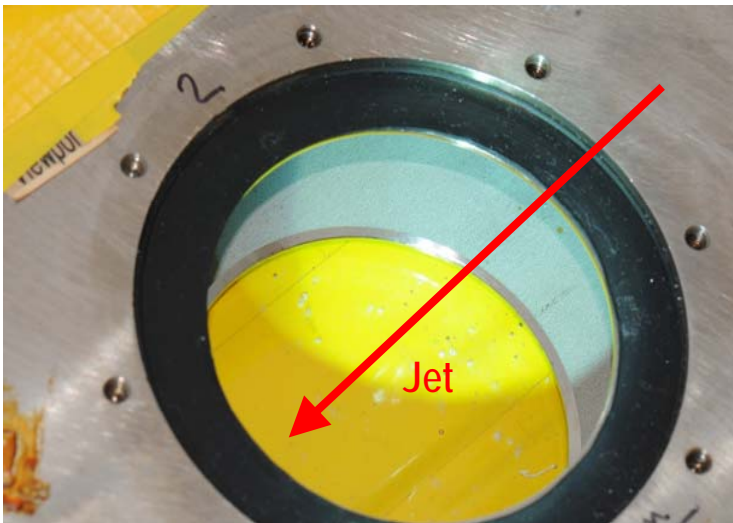
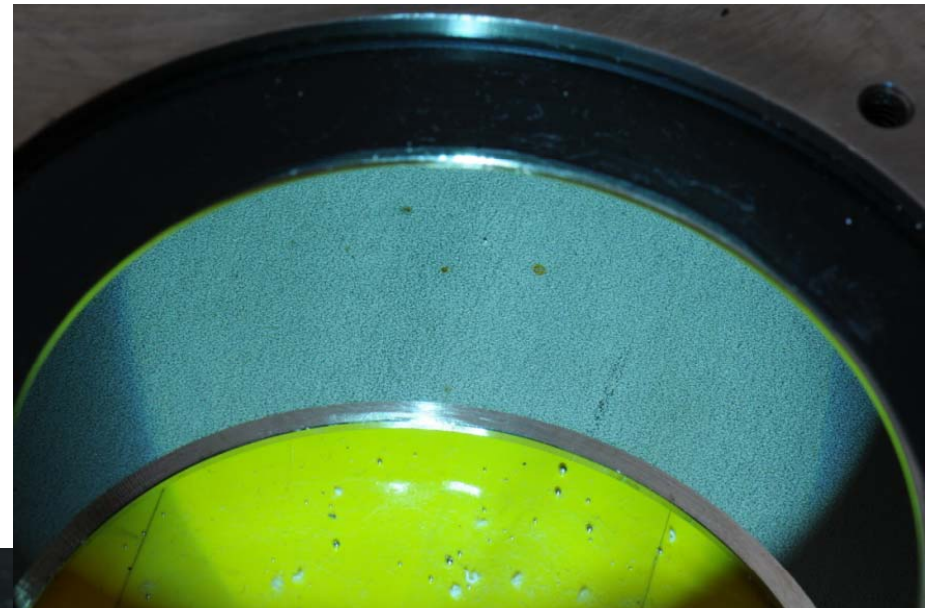
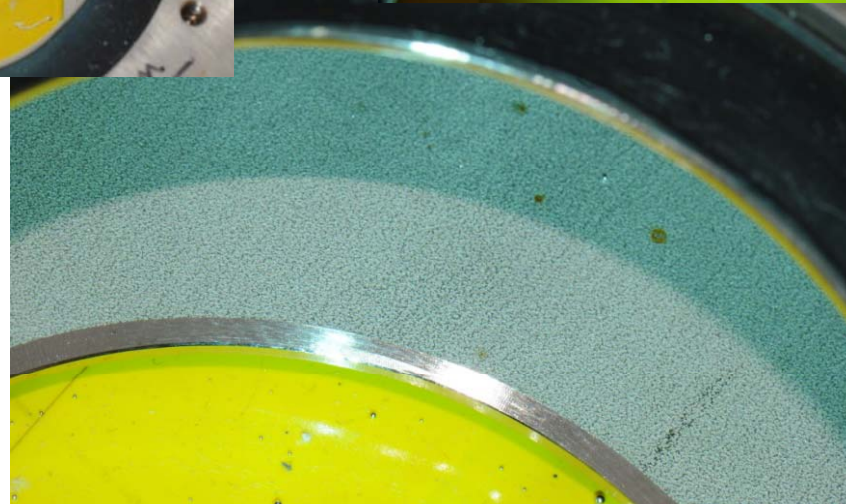
# Viewport 2 Upstream Side

- General surface appearance is uniform

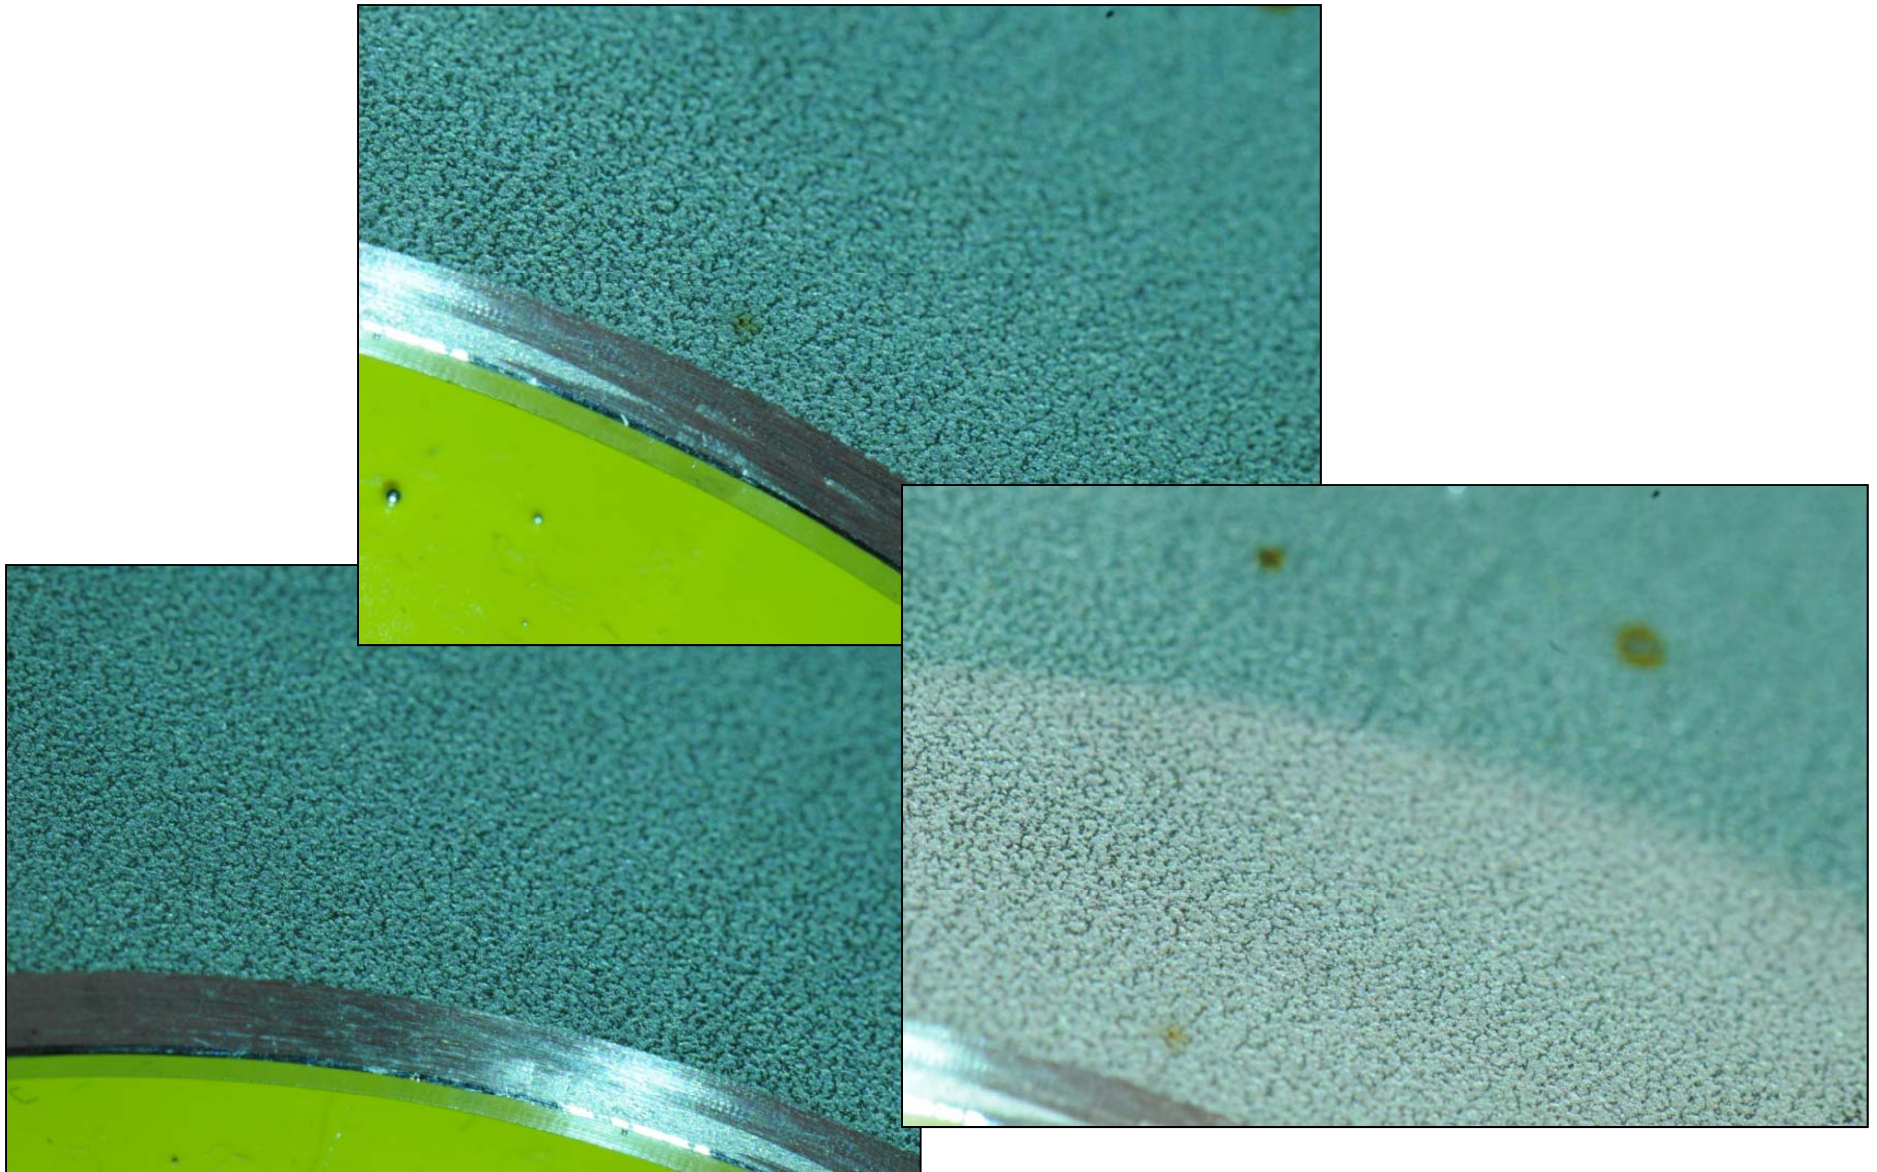
# Viewport 2 Upstream Side Close-Ups

- Surface appearance consistent throughout interior of primary containment – standard, un-machined surface texture
- Higher resolution images do not support theory of mercury bead pitting, at least on a macroscopic level
- Further investigation possible by sectioning chamber, decontaminating and viewing pieces with microscope

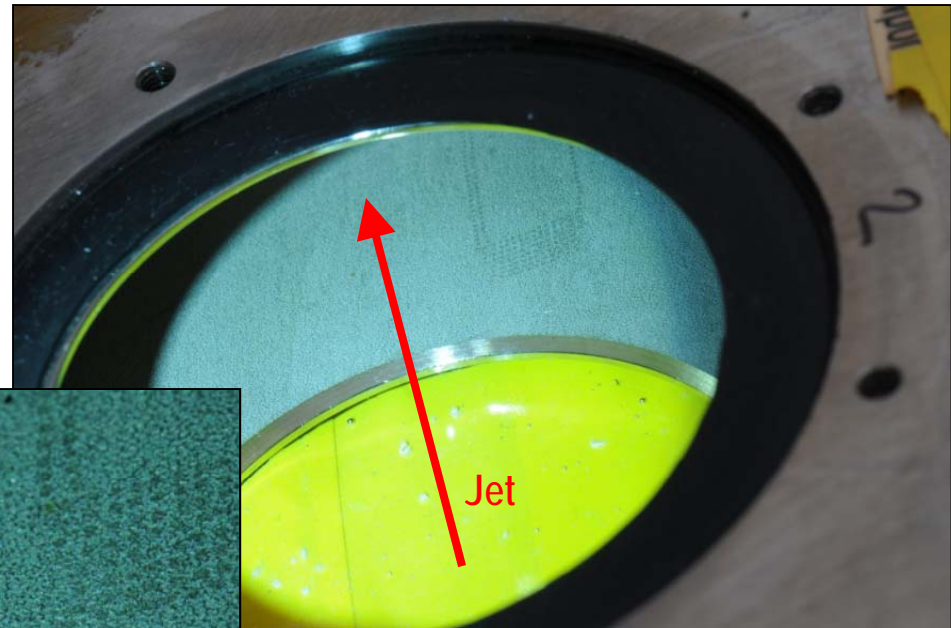
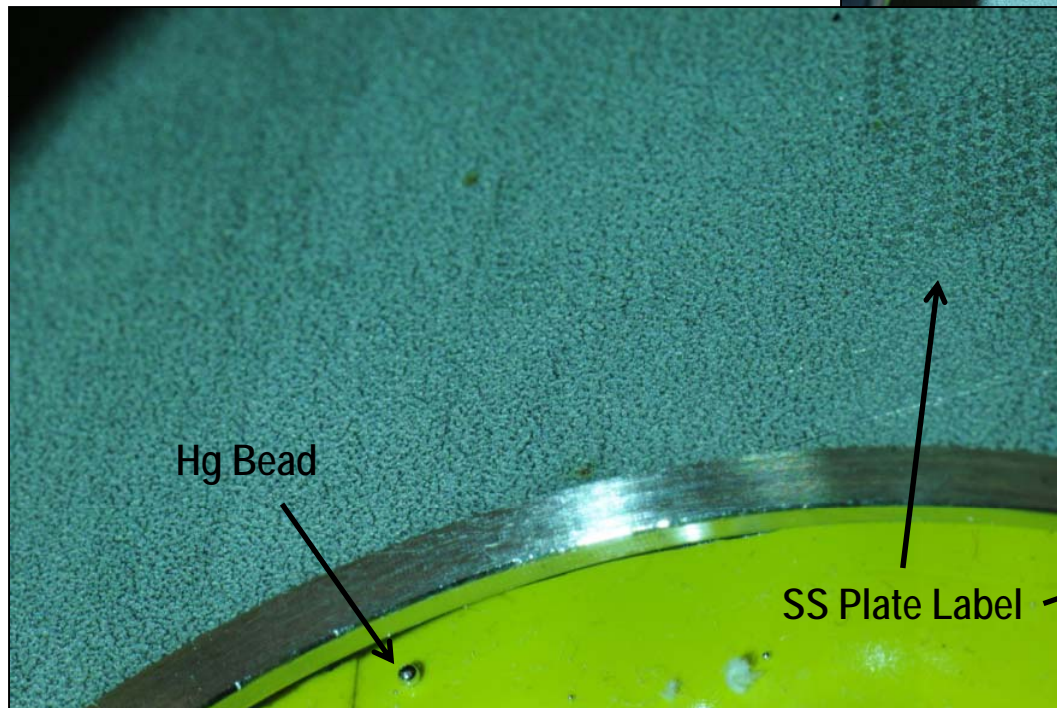
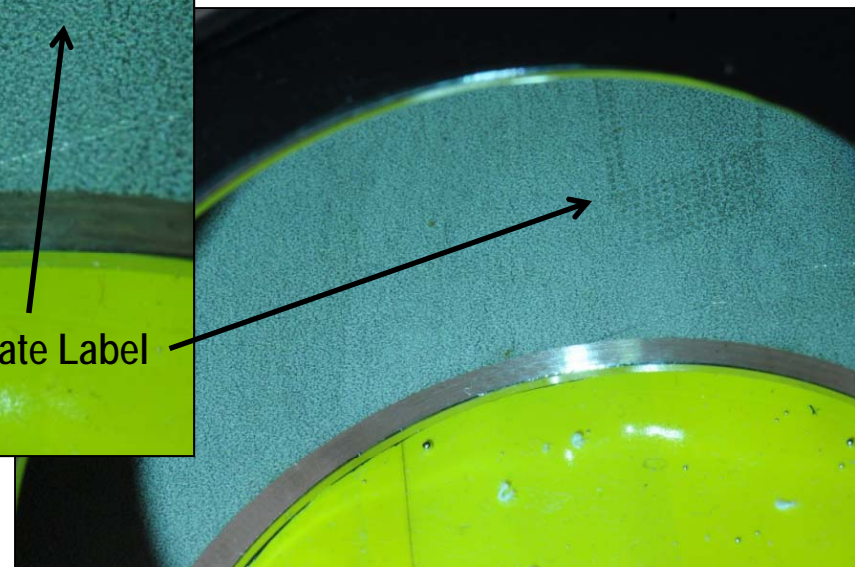
# Viewport 2 downstream side

- Raw material labeling intact

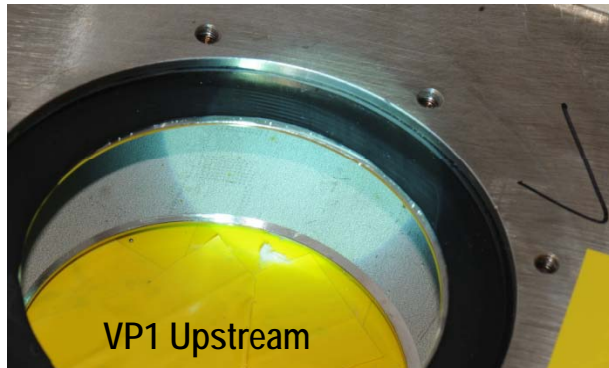
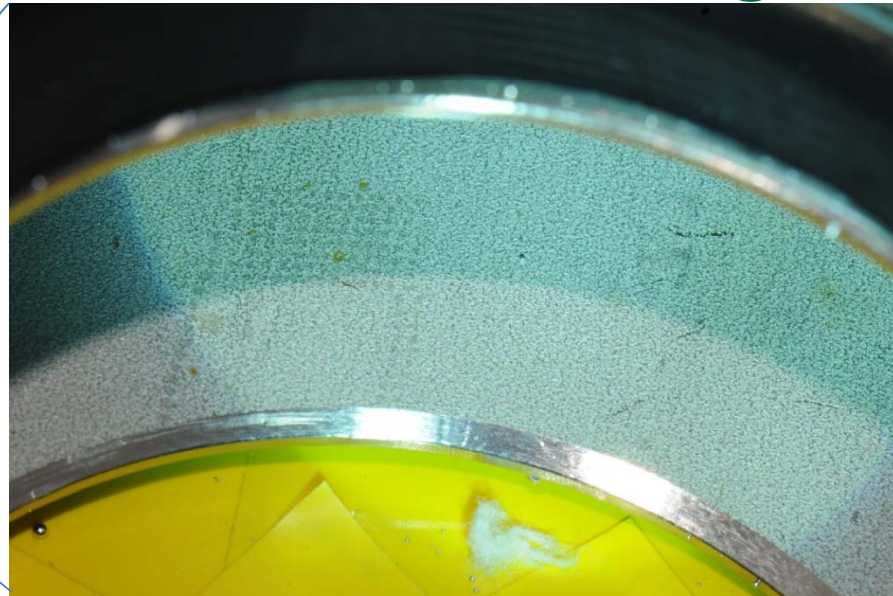
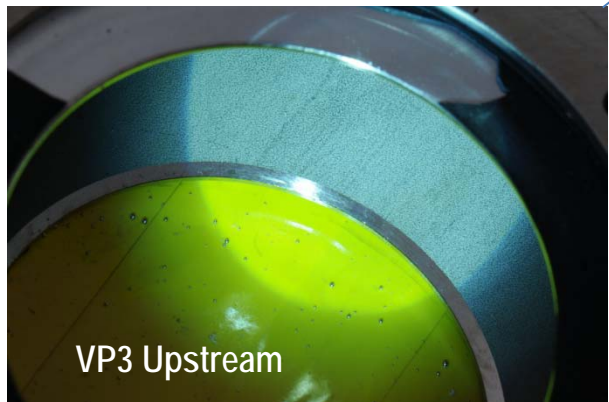
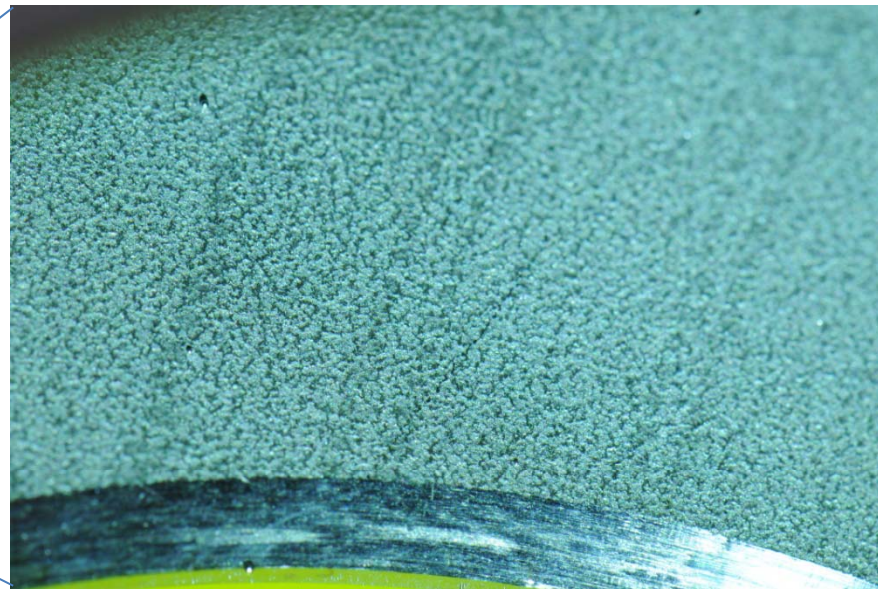
# Other Viewports Have Similar Images
