# Post May 23 VRVS History

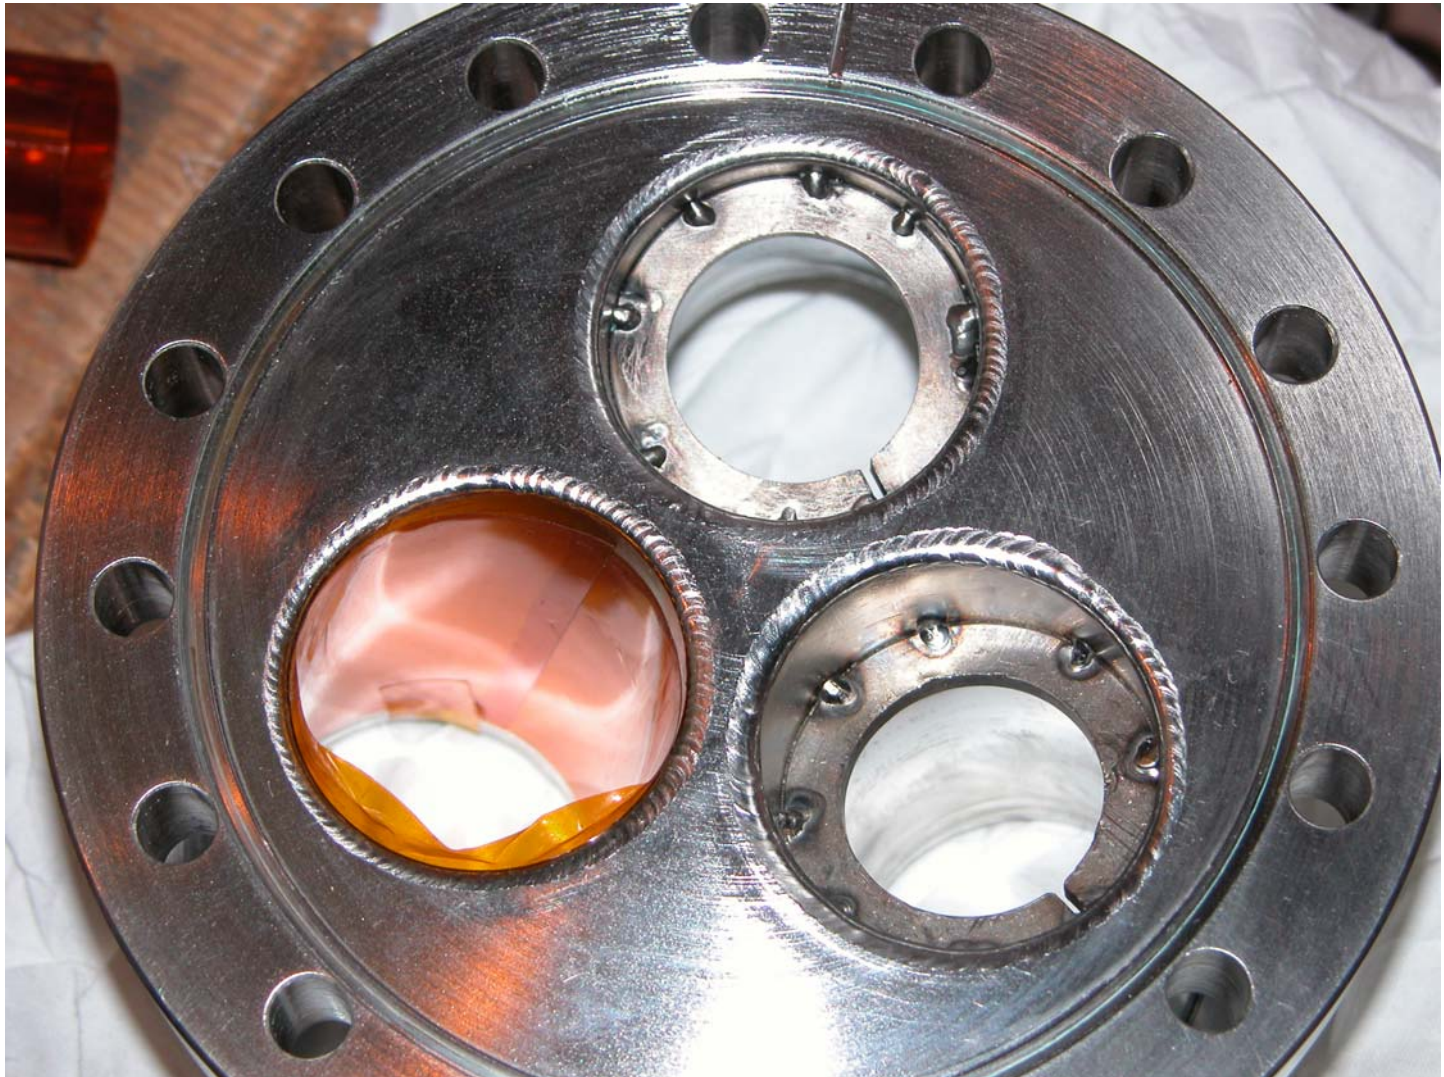
# View of center Triport tack welds

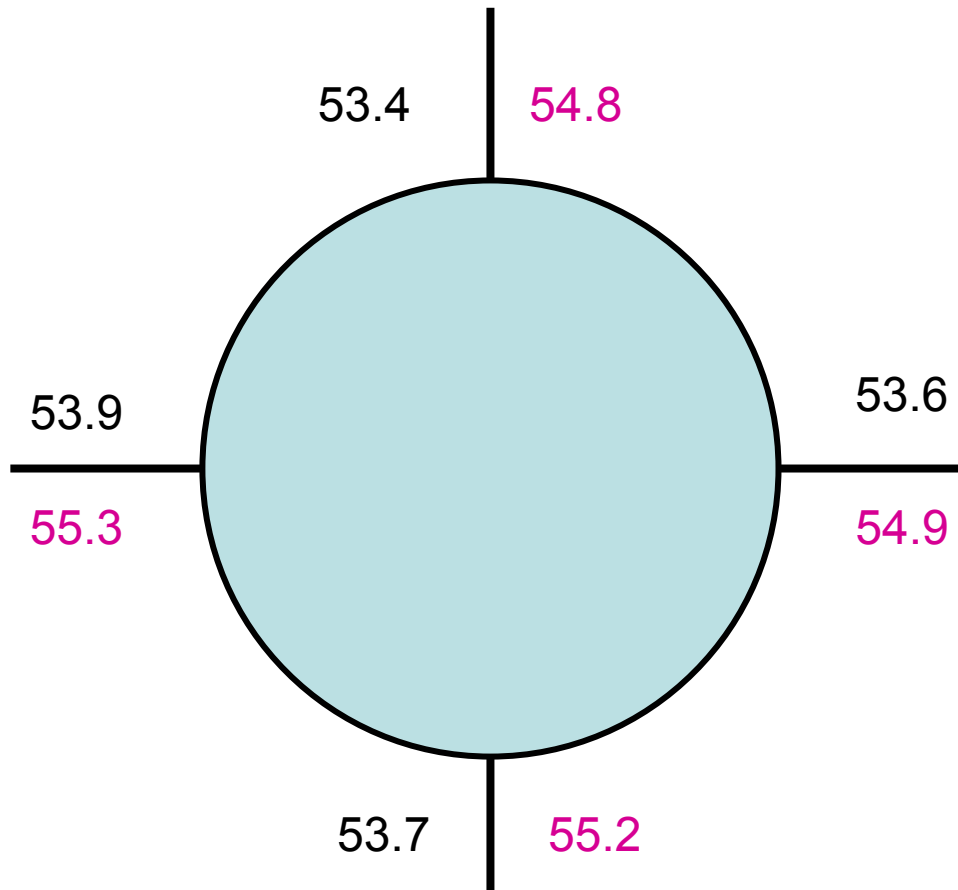
# Depth Measurements After Rewelding

- Pre-compression
- Post-compression with 14 nt-m torque

**$\Delta Z \sim 1.4\text{mm}$**

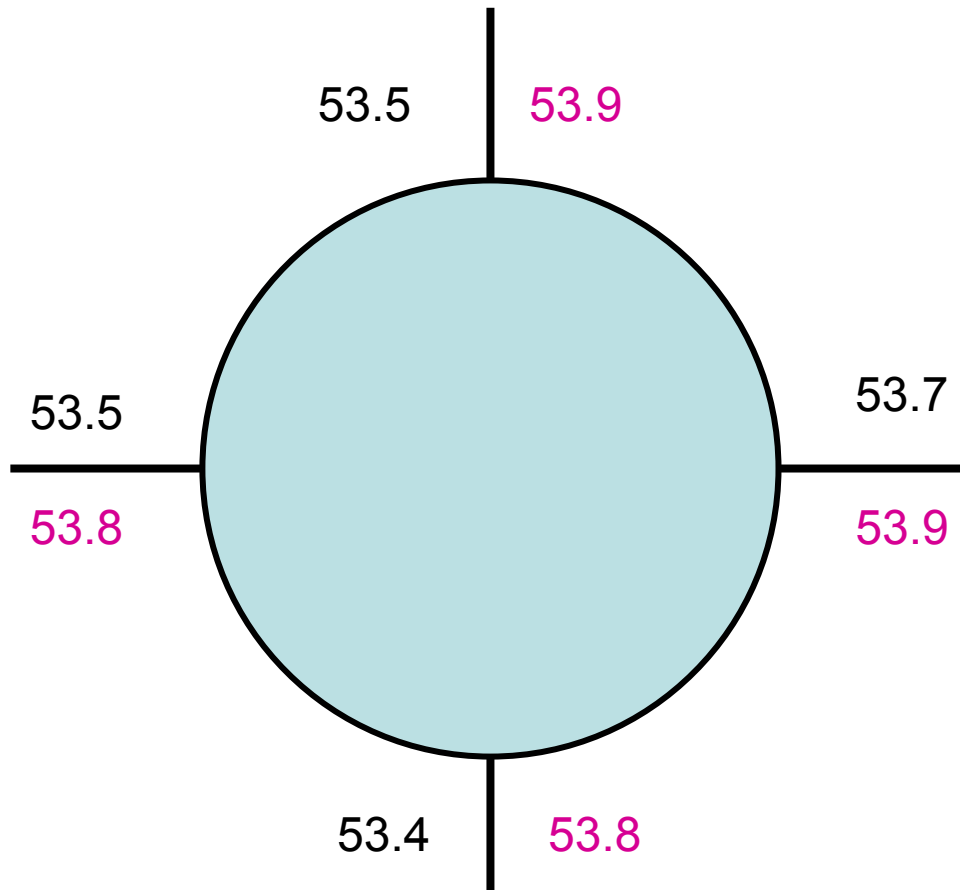
# Depth Measurements - I

- Pre-compression
- Post-compression with 14 nt-m torque

**$\Delta Z \sim 0.3\text{mm}$**

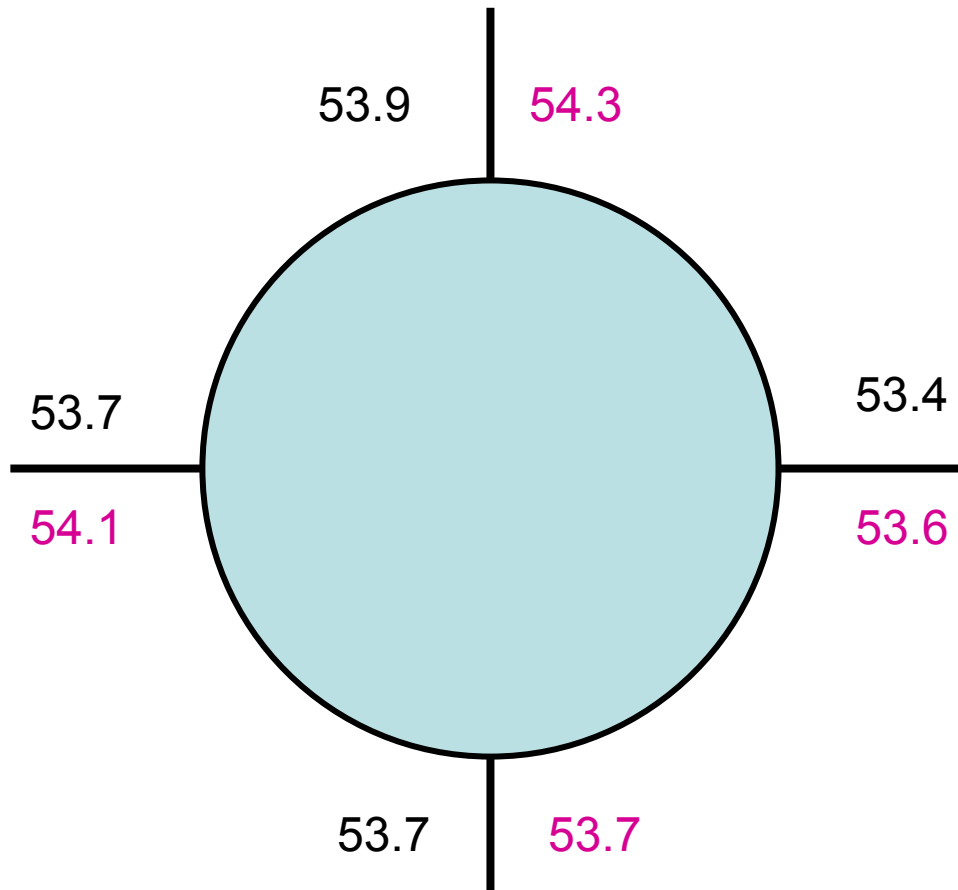
# Depth Measurements -II

- Pre-compression
- Post-compression with 14 nt-m torque

$\Delta Z \sim 0.3\text{mm}$
