Microscope Study of BESIII-type RPC Aging Phenomena

Changguo Lu, Kirk T. McDonald, and A. J. S. Smith

(September 8, 2010)

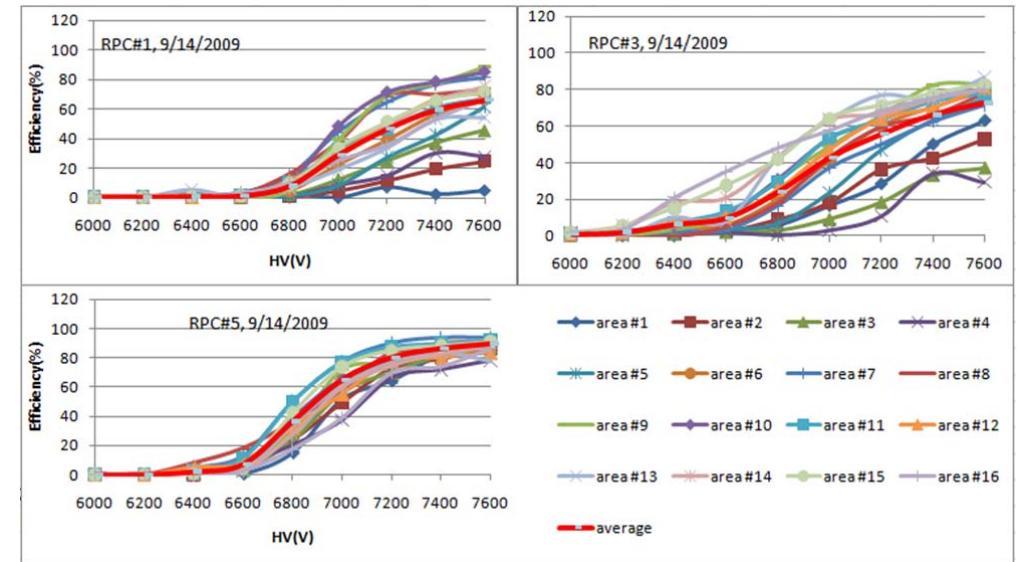
A 0.1mCi Co-60 source is placed on top of the RPCs through an 18mm thick stack of copper plates (region #1, see Fig. 1). At the end of aging test the efficiency plateaus for all five chambers are tested, three of them are shown in figure 2. The severe efficiency drop on RPC #1, #3 can be clearly seen, RPC #5 shows mild efficiency degradation. The order of severity of efficiency degradation is roughly as follows: #1, #3, #4 and #5, which is consistent with their distance to the source.

Figure 2. Efficiency plateaus at the end of aging test.

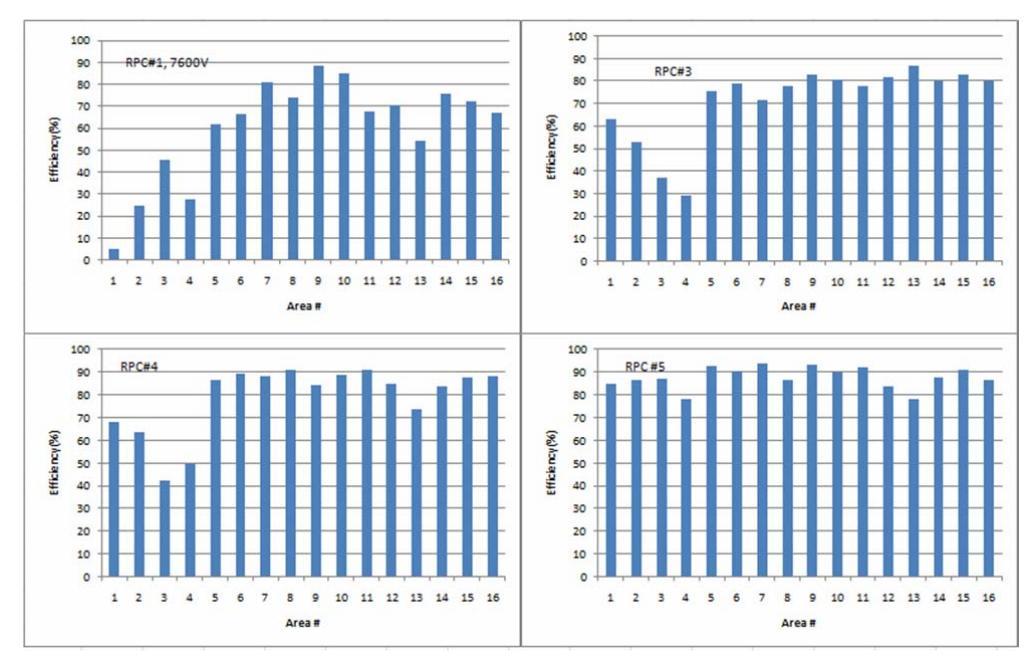
Figure 3. At the end of aging test, efficiency distribution among 16 areas, HV = 7600V.

A very interesting observation is that the worst efficiency area for RPC #3, #4 and #5 is not the area #1, the area direct underneath the source, but is area #4. However the worst area for RPC#1 is area #1. From figure 1 we can find that these areas are located near the gas inlet ports, where the HF concentration density is assumed to be the highest. We'll compare the surface of area #8 to area #4 for RPC #3 later to see if there is correlation between efficiency drop and surface corrosion.

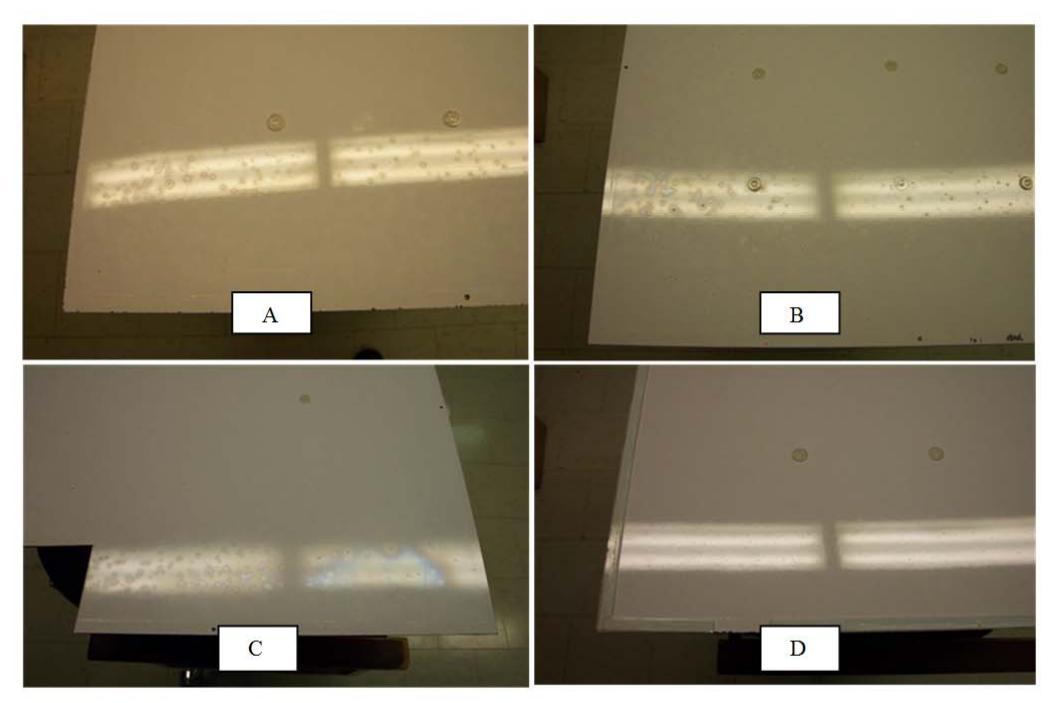
After opening the aged RPCs we found a lot of sparking marks all over the surface for both anode and cathode. Figure 4 shows some typical images. The distribution density of the marks varies and shows a correlation between the severity of efficiency drop and the density of the sparking marks. RPC #1 has suffered the highest aging dose, and shows the highest sparking density, see figure 4(A). RPC #5 has the least aging dose and shows lowest sparking mark density, see figure 4(D).

Figure 4. Aged RPCs anode electrode's image, (A) RPC#1; (B) RPC#3; (C) RPC#4; (D) RPC#5.

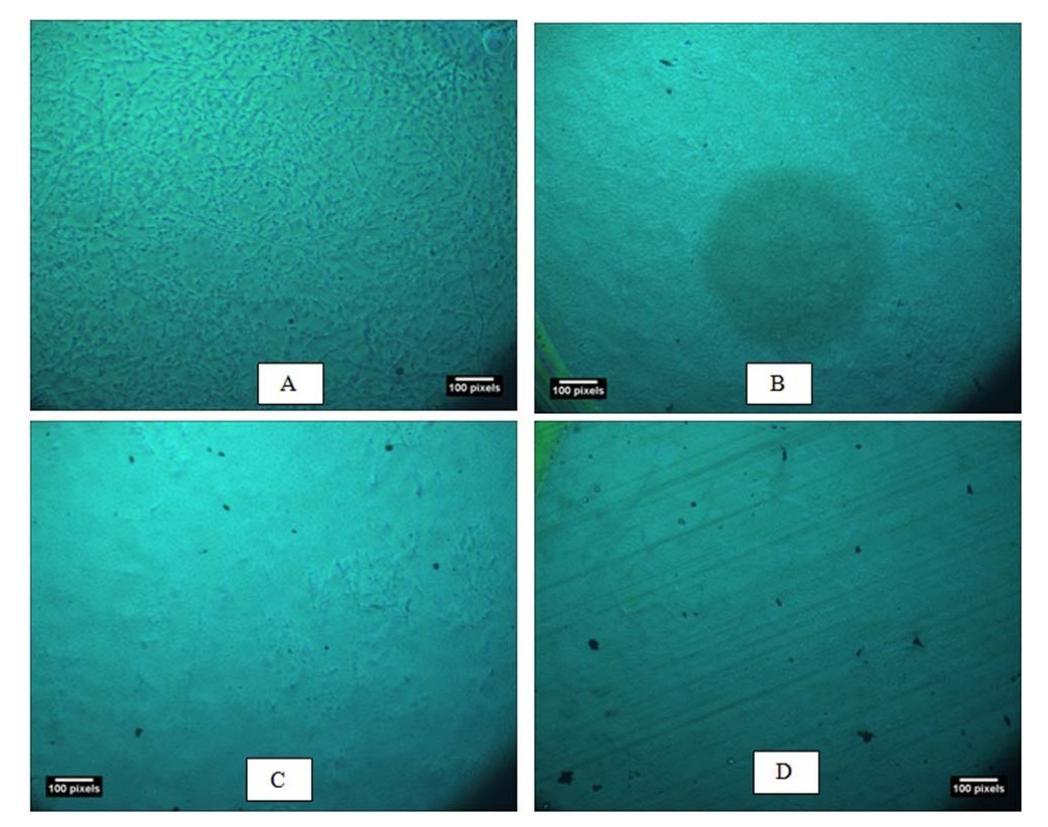
Figure 6. Microscopic images, (A) RPC #1, (B) RPC #3, (C) RPC #4, (D) RPC #5.

The sample for RPC #1 is from area #1, where the source is located and the gas inlet port is nearby. This region suffered most intensive aging dose, the efficiency at the end of the test is almost zero. Figure 6(A) shows severe eroded surface, no more "skin-like" texture can be seen. Figure 6(B) shows RPC #3, area #4 that is near the gas inlet area. This area is less damaged, so the surface looks better than (A), but we start to see the "veins" on surface, which is the first step of the HF corrosive effect. We'll have more discussion latter. Figure 6(C) is the fourth RPC in the stack from the source. The sample is from area #4 too, that is near the gas inlet area. The Surface also shows "veins", however the original "skin-like" texture is still can be seen. Figure 6(D) is from RPC #5, area #1. The efficiency test confirms this area is having very mild aging, the microscope image shows very faint "veins", and the "skin-like" texture is well preserved.

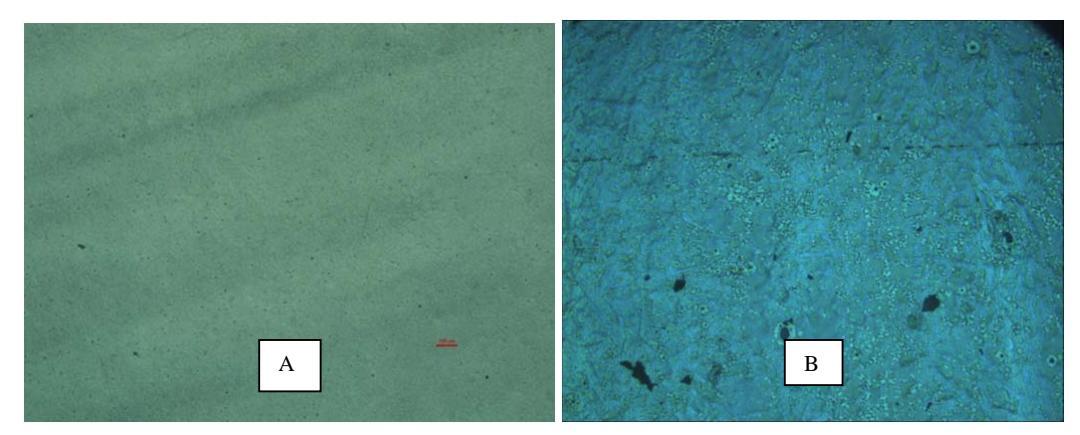
Figure 3 shows that the aged RPC's efficiency varies on different areas. With the microscope we can study if this variation related to the severity of the surface corrosion. In figure 7 two different areas are shown, (A) shows the area #8 anode and (B) shows the area #4. According to figure 3 area #4 has much worse efficiency degradation then area #8, the reason for this difference is exactly revealed in figure 7(A) and (B). Figure 7(A) shows reasonable smooth surface for area #8, but figure 7(B) shows badly damaged surface for area #4.

Figure 7. RPC#3, (A) area #8; (B) area #4.

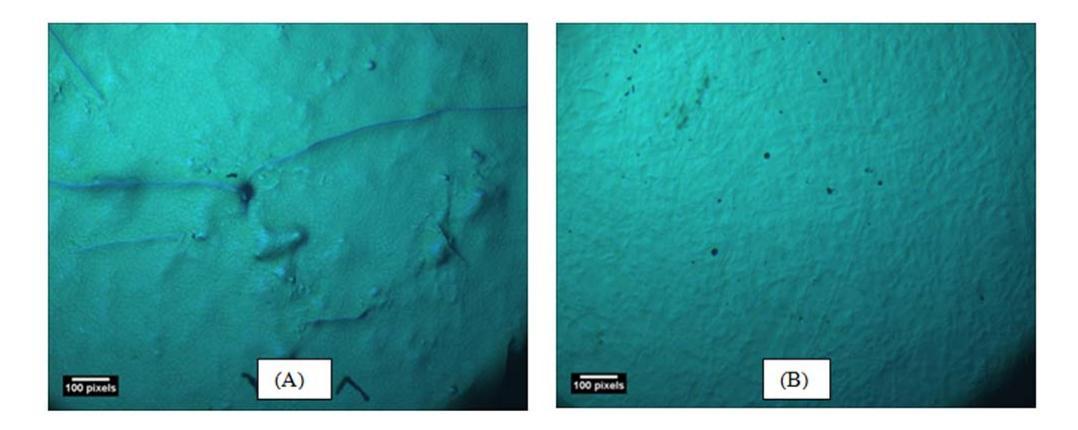
To make sure if the eroded surface is due to the HF corrosive effect, we made an additional test. The test setup is shown in figure 8. We drop 90 μ L HF (40% of concentration) into the container, then cover the container with the samples/cover plate as shown in the figure. The inner surface of the test samples are then exposed to the HF vapor. The equivalent dose of 90 μ L HF is a $2m^2$ RPC operated at 5 μ A for 12.4 years [2]. After 24 hours the cover is opened, the test sample's surface shows corrosion. In figure 9 we show their microscopic images. Compared to the virgin sample surface the HF vapor exposed surface apparently shows "bumps" and "veins". The bumps are vulnerable to the discharge that may be the origin of the sparking marks we saw on the aged RPC electrode. The "veins" have very similar looking to the aged RPC electrode surface. In figure 9(A) besides the "bumps" and "veins" we still can see the "skin-like" texture for most of the area, but on figure 9(B) there is no such "skin-like" texture leftover, it means that the entire surface has been eroded by HF vapor.

Figure 9. Two BESIII-type Bakelite samples exposed to HF vapor.

Based on the above observation we propose the following aging mechanism for BESIII-type RPC: with the gas mixture of Freon and others, the gas avalanches will produce HF molecules [2]. These HF molecules are adsorbed on the inner surface, form HF acid with the water molecules released from the Bakelite electrodes. The corrosive action will take place on the inner surface as shown in figure 9. As the results the bumps may help to initiate the sparks, some samples of the sparking marks are shown in figure 10. With the progress of the HF corrosion the inner surface is getting worse and worse, it would destroy the Bakelite surface completely as shown in figure 9 (B), the characteristic "skin-like" texture is therefore completely disappeared.

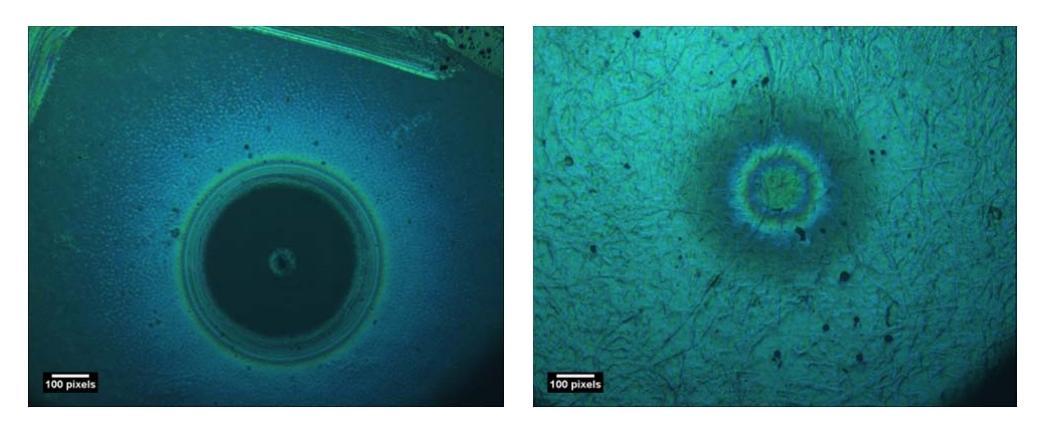
Figure 10. Sparking marks on the anode surface.

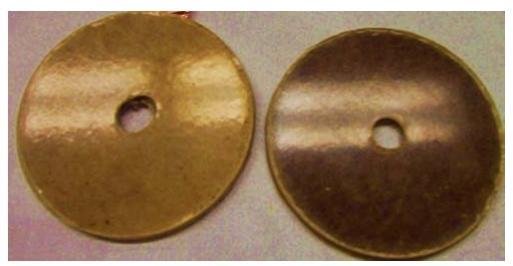
The sample disc from the high flux central region shows a highly discolored surface with an "orange peel" looking texture. Some samples show no Linseed oil coating on the surface. The disc from the lower flux region is less discolored, its Linseed oil coating film looks smooth, and a cotton tip with ethanol easily removes the oil film, revealing a shiny Bakelite surface. It seems that the high dose of radiation and resulted erosion from high concentration of HF has "eaten" the Linseed oil coating and caused the dye in the surface layer paper to discolor; and also caused the "orange peel" texture on the surface. Figure 12 shows a comparison between high dose and low dose BaBar samples.

Fig. 12. The left disc is high dose sample, it shows discolored "orange peel" texture on the surface; the right disc is low dose sample, its surface looks reasonably smooth and darker.

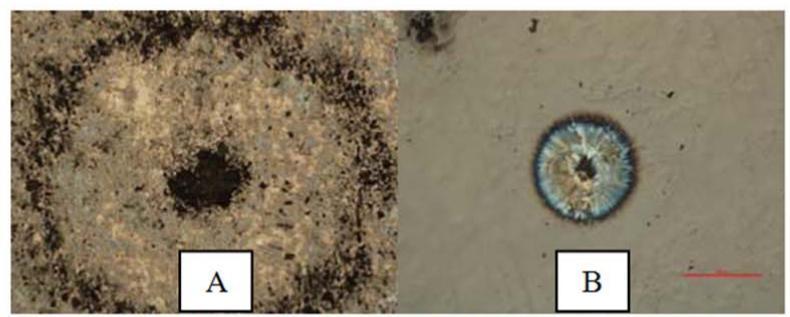
Compared to the BESIII RPC we notice that sparking marks are very rare on BaBar RPC samples. We did find one and its microscope image is shown in figure 13, quite different looking from BESIII-type RPC.

The different appearance of the sparking marks for Linseed oil coated BaBar RPCs and oil-free BESIII-type RPCs might be related to their different surface material. The Linseed oil coating, when it is completely cured, has a long carbon chain, as shown in figure 14(A) [6], and the melamine structure, which is the surface material of BESIII Bakelite, is shown in figure 14(B) [7].

Fig. 13. Sparking mark, (A) BaBar sample; (B) BESIII-type aging test chamber #8 sample. The red microscope scale (0.5mm) is shown in (B), it should be same for (A).
