Proton Irradiation Damage Assessment of Carbon Reinforced Composites: 2-D & 3-D Weaved Structures

Nick Simos BNL November, 2006

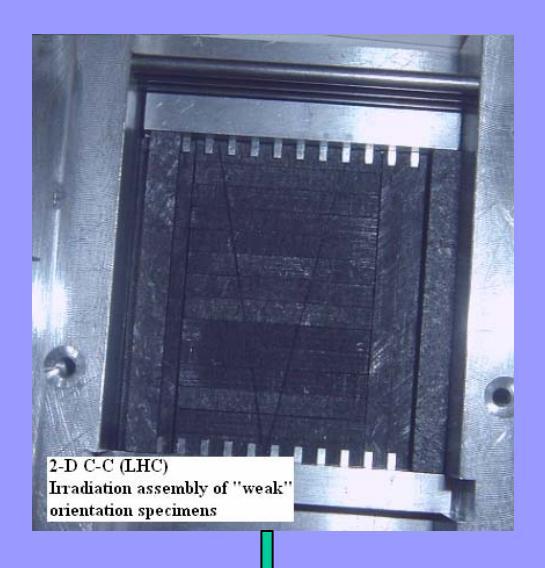
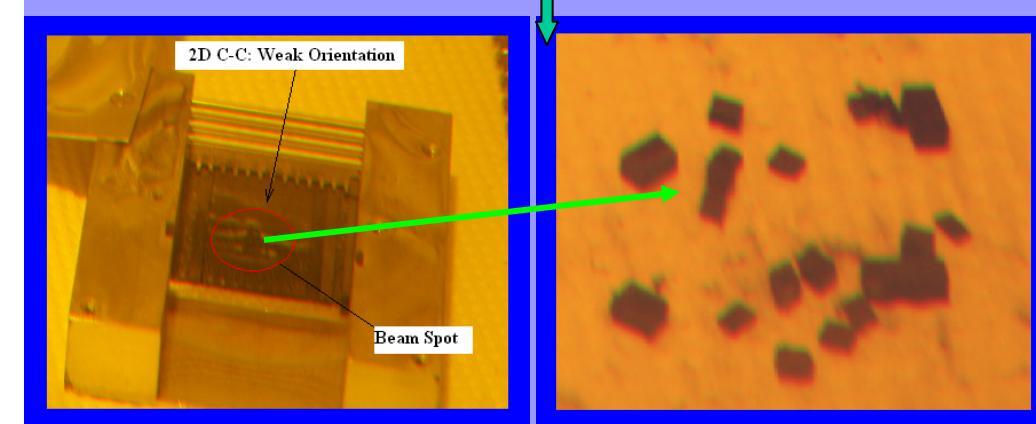
#### "weak" orientation

BAD NEWS: Serious structural degradation is observed as a result of high fluences Damage more pronounced along the "weak" orientation

# Bad News First: Shown is structural integrity loss (more pronounced in "weak" orientation)

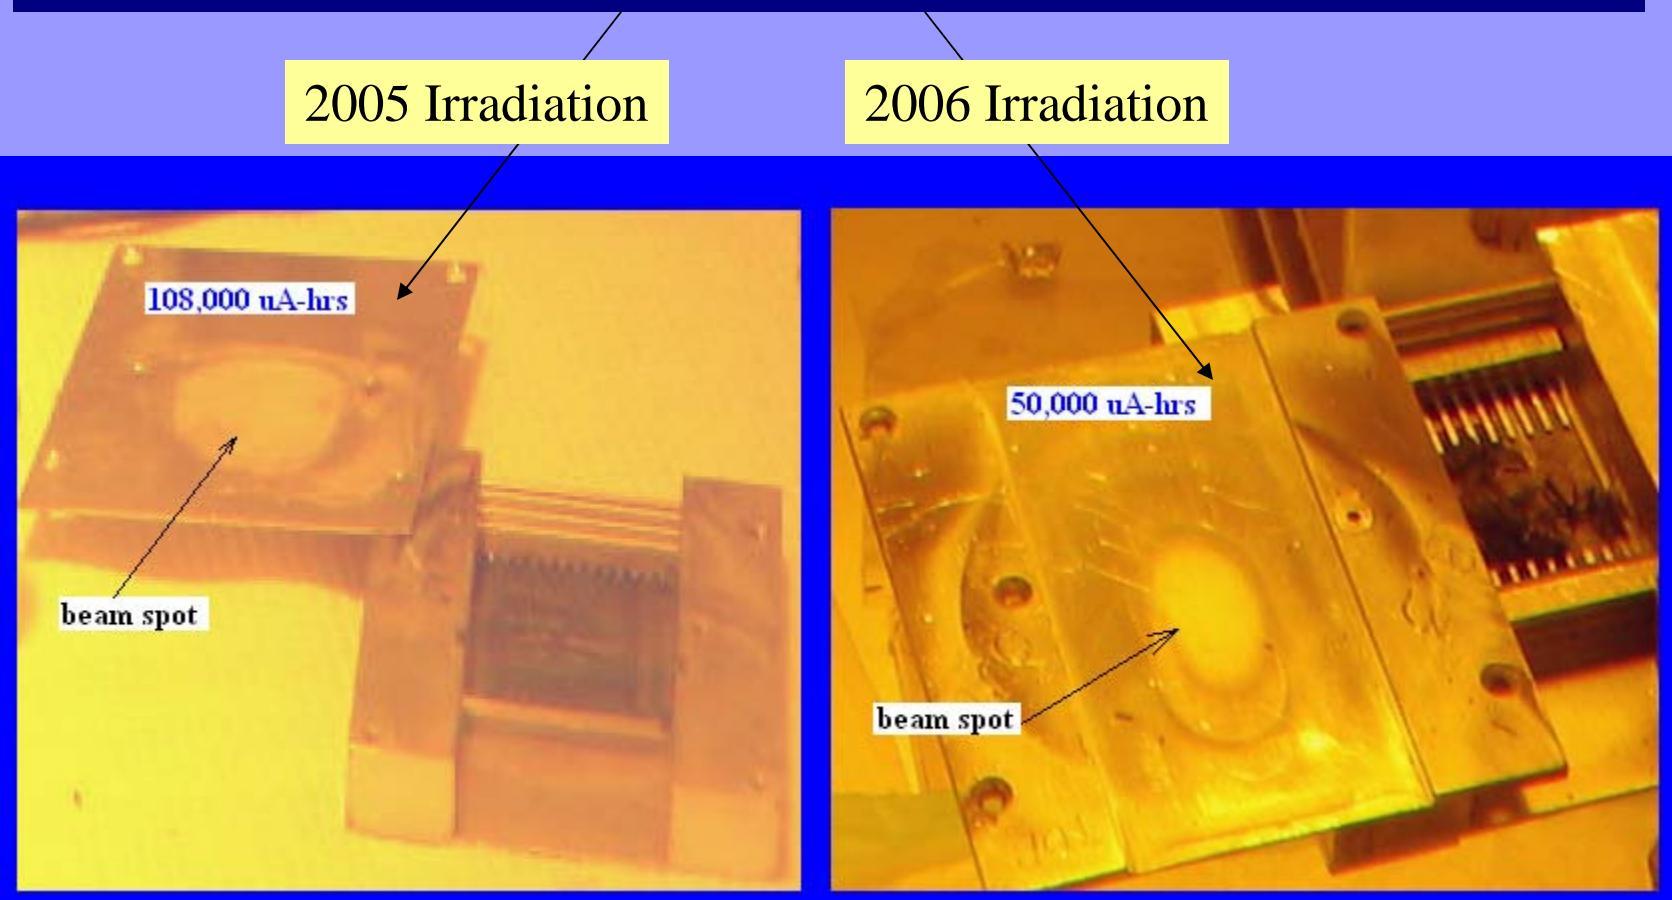
### Irradiating beam footprint

The integrated current is ~ half of the current achieved during the first exposure of the 2-D carbon composite and yet the damage is as serious. Beam spot measurements at the beginning of the latest round of irradiation and post-irradiation examination of the beam window point towards a tighter beam spot. This will imply that, effectively, the affected material was exposed to similar dose levels. This will soon be verified by detailed examination of beam-registering nickel foils placed within the irradiated assembly

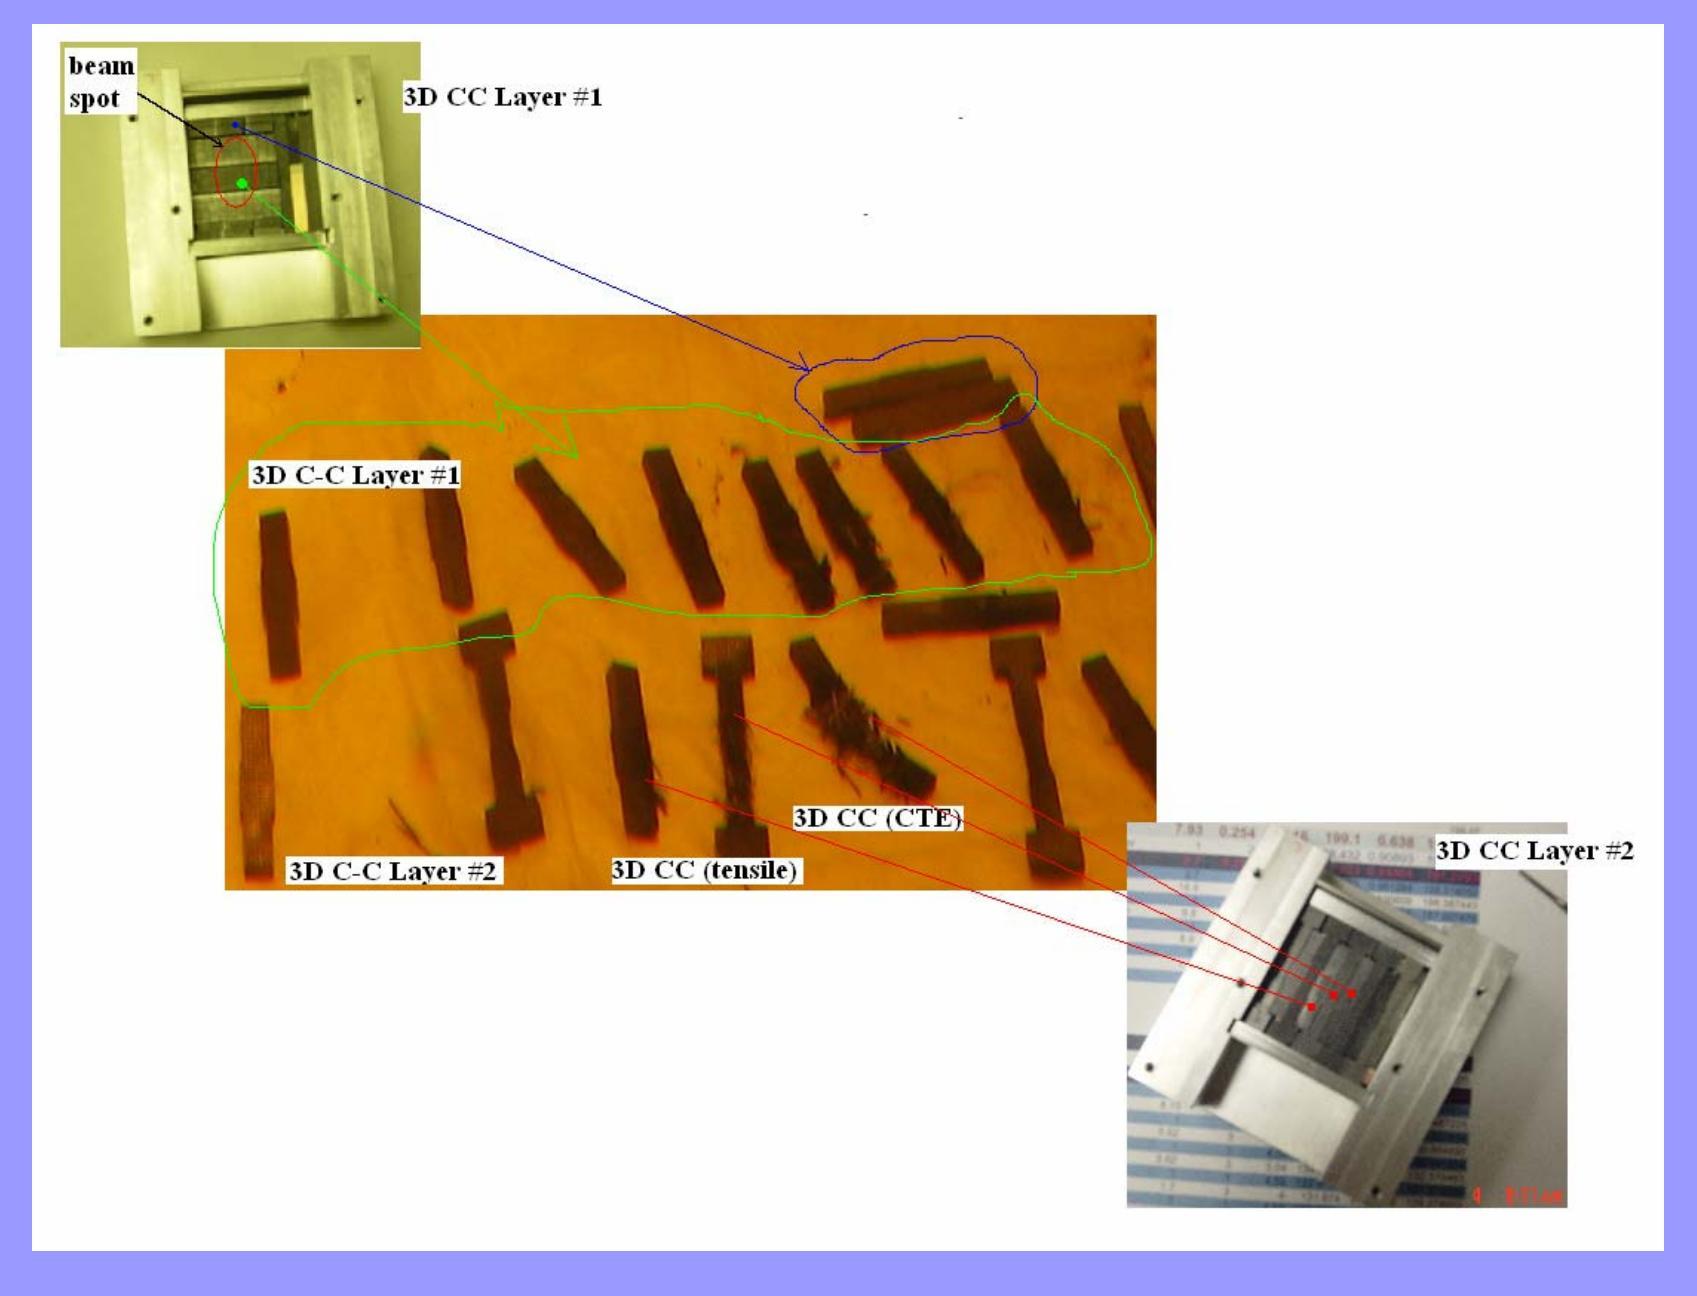
Damage to both C-C type is observed !

# Damage seen in the two layers of 3-D carbon composite. Observe the complete disintegration of irradiated specimens situated within the 1-sigma of the beam

- Further experimental scrutiny of 2D or 3D carbon composites for irradiation damage effects is not recommended. These composites clearly CANNOT tolerate the high fluences required by highpower beam targets. These results should prompt a change of course in the search for materials for the multi-MW beam targets.

- FOCUS needs to be shifted toward new graphite grades such as IG-430 that are isotropic in their structure (rather than planes that can move relative to each other)

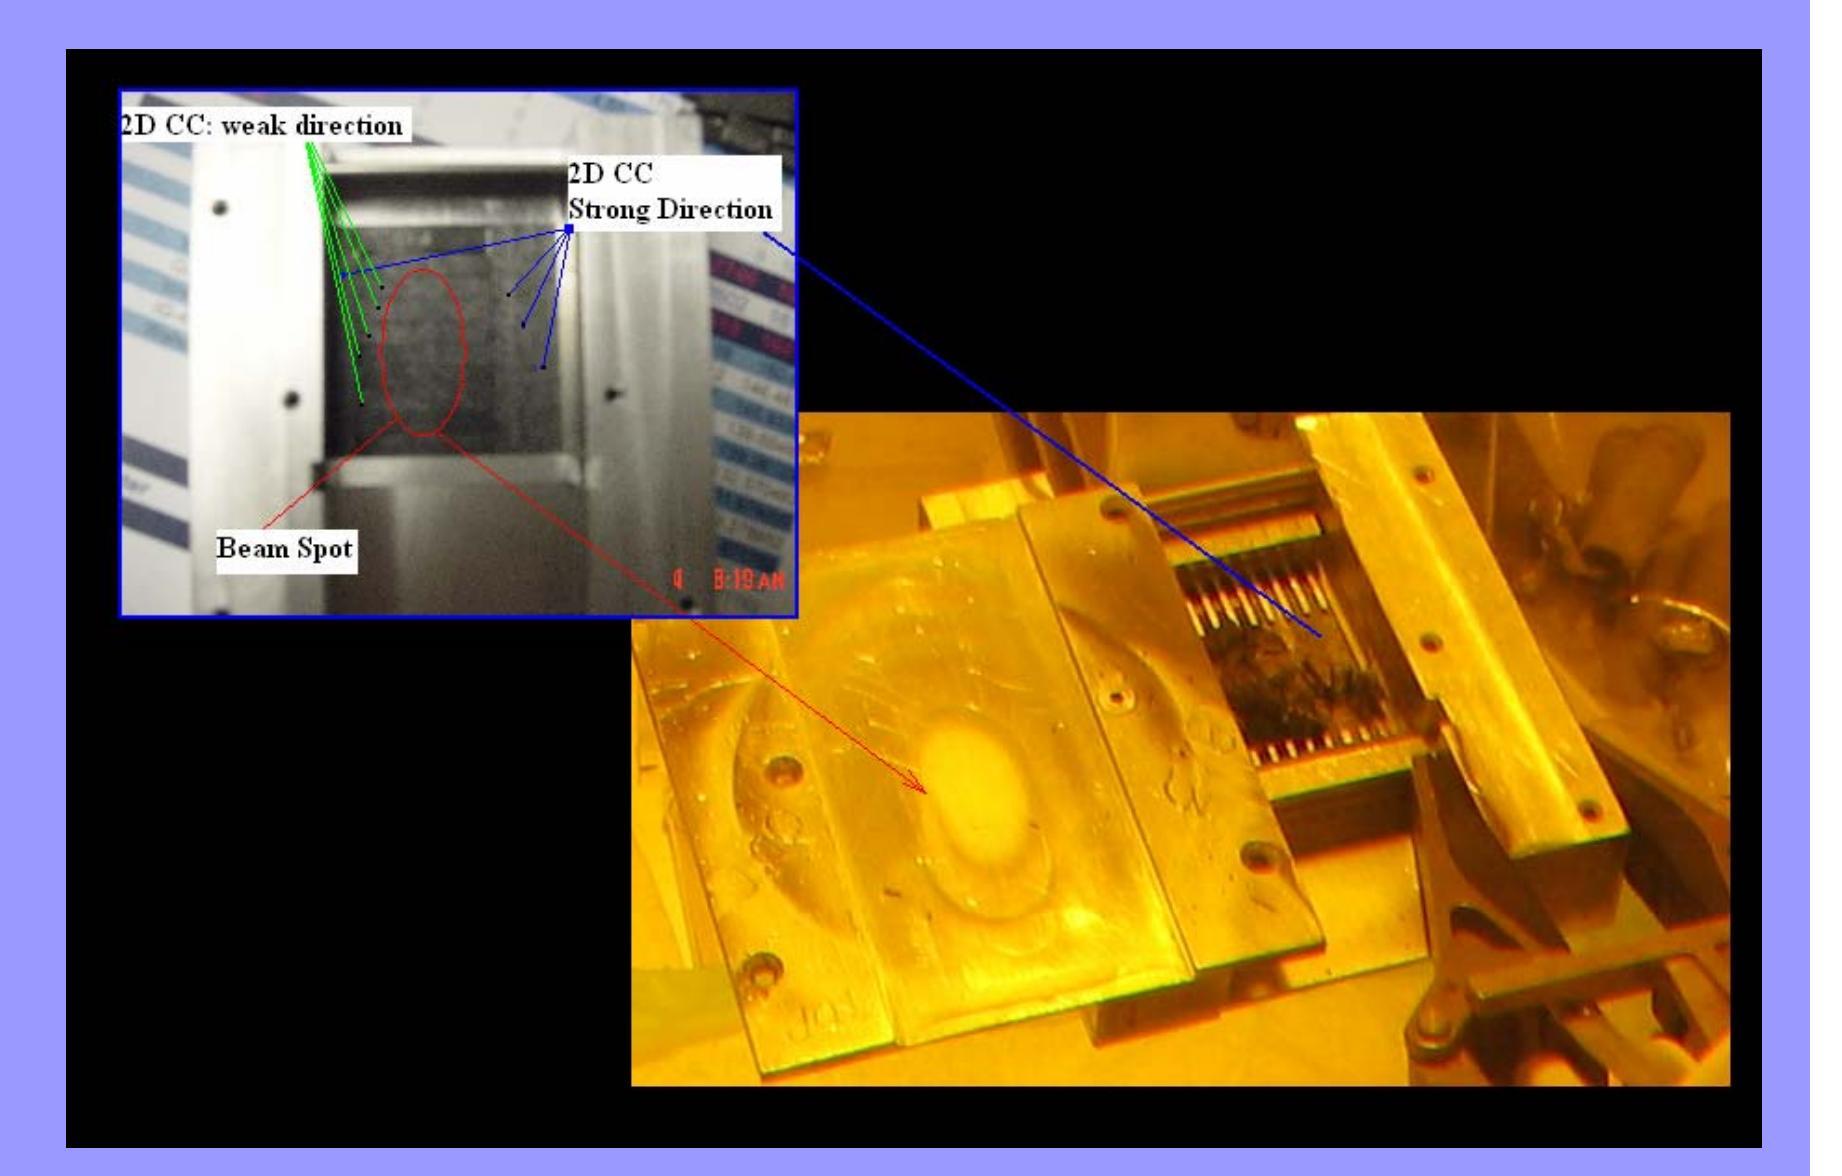
Damage seen in the layer of 2-D carbon composite. Severe disintegration of "weakly-oriented" irradiated specimens situated within the 1-sigma of the beam is observed
