Characterisation of HFS Detectors

Sofía Otero Ugobono^{1,2}

Hyper Fast Silicon Detectors

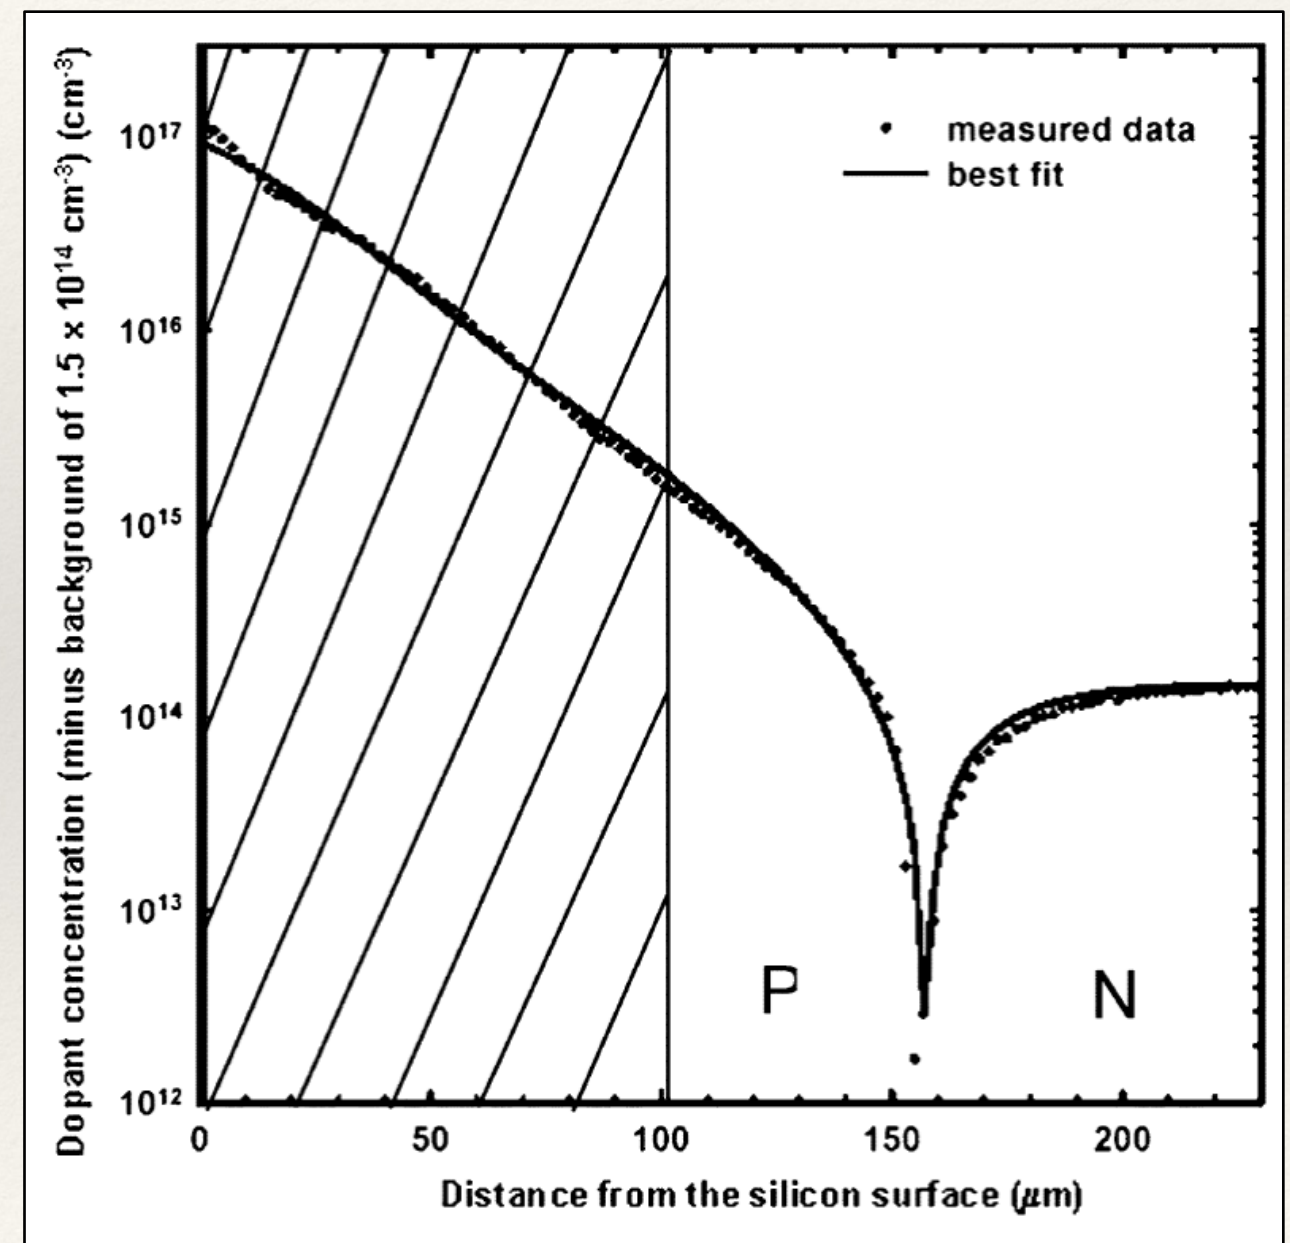
- ❖ Manufactured by RMD (Radiation Monitoring Devices Inc.)
- ❖ **Based on Deep Diffused APD**
 - ❖ n-type NTD-doped silicon from Topsil
 - ❖ Grooving wafer
 - ❖ Deep diffusion of p-type dopants
 - ❖ Gallium used as dopant
 - ❖ Etching of surface layer

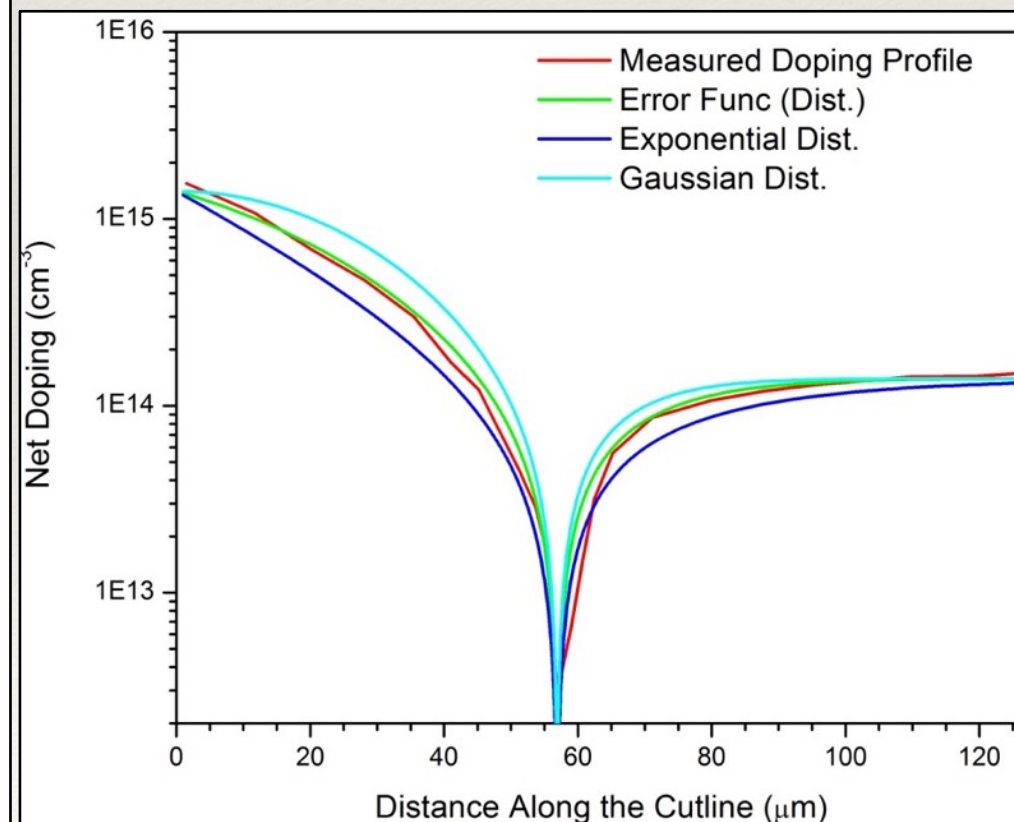
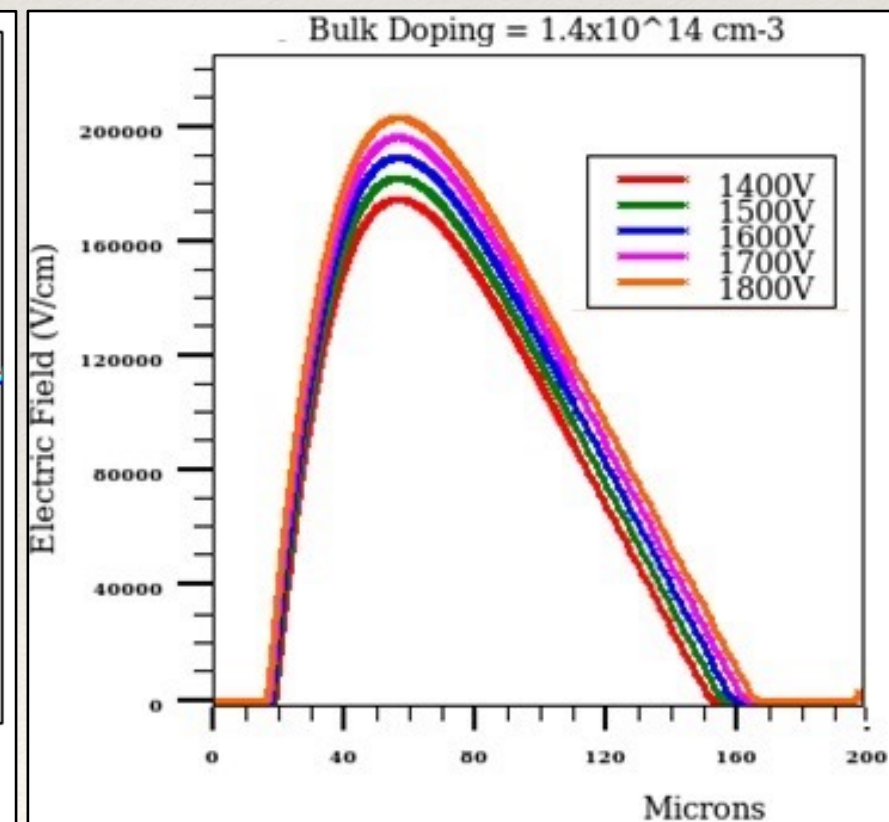
❖ TCAD Simulations

- ❖ Doping profile based on measured data (literature) used to simulate the E-field.

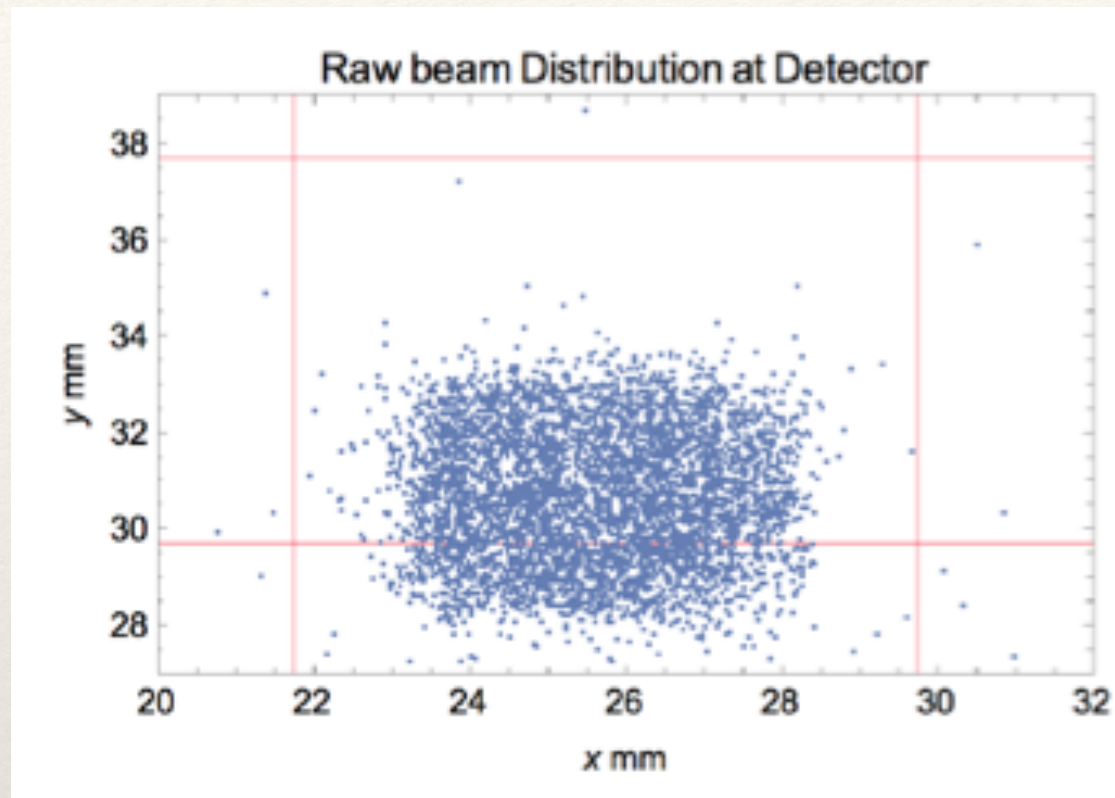
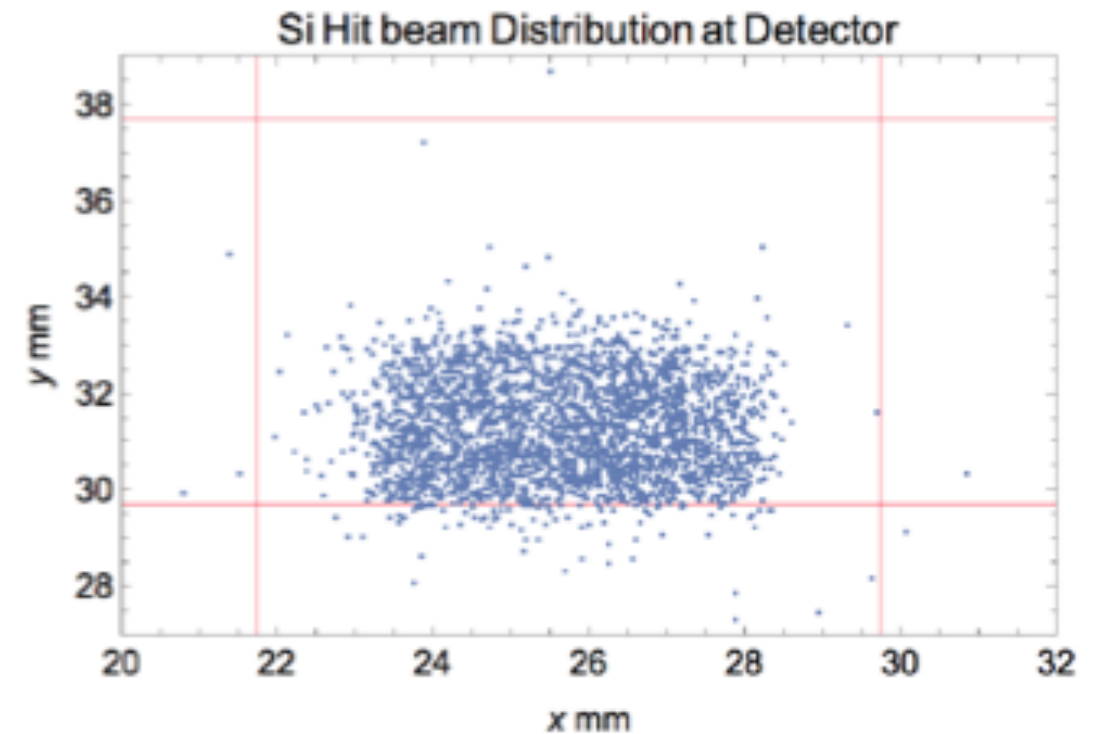
Detailed y edge view

- ❖ Test beam results obtained on a HFS detector of different dimensions (8x8 mm) to that characterised in this presentation.
- ❖ Homogeneous particle detection.

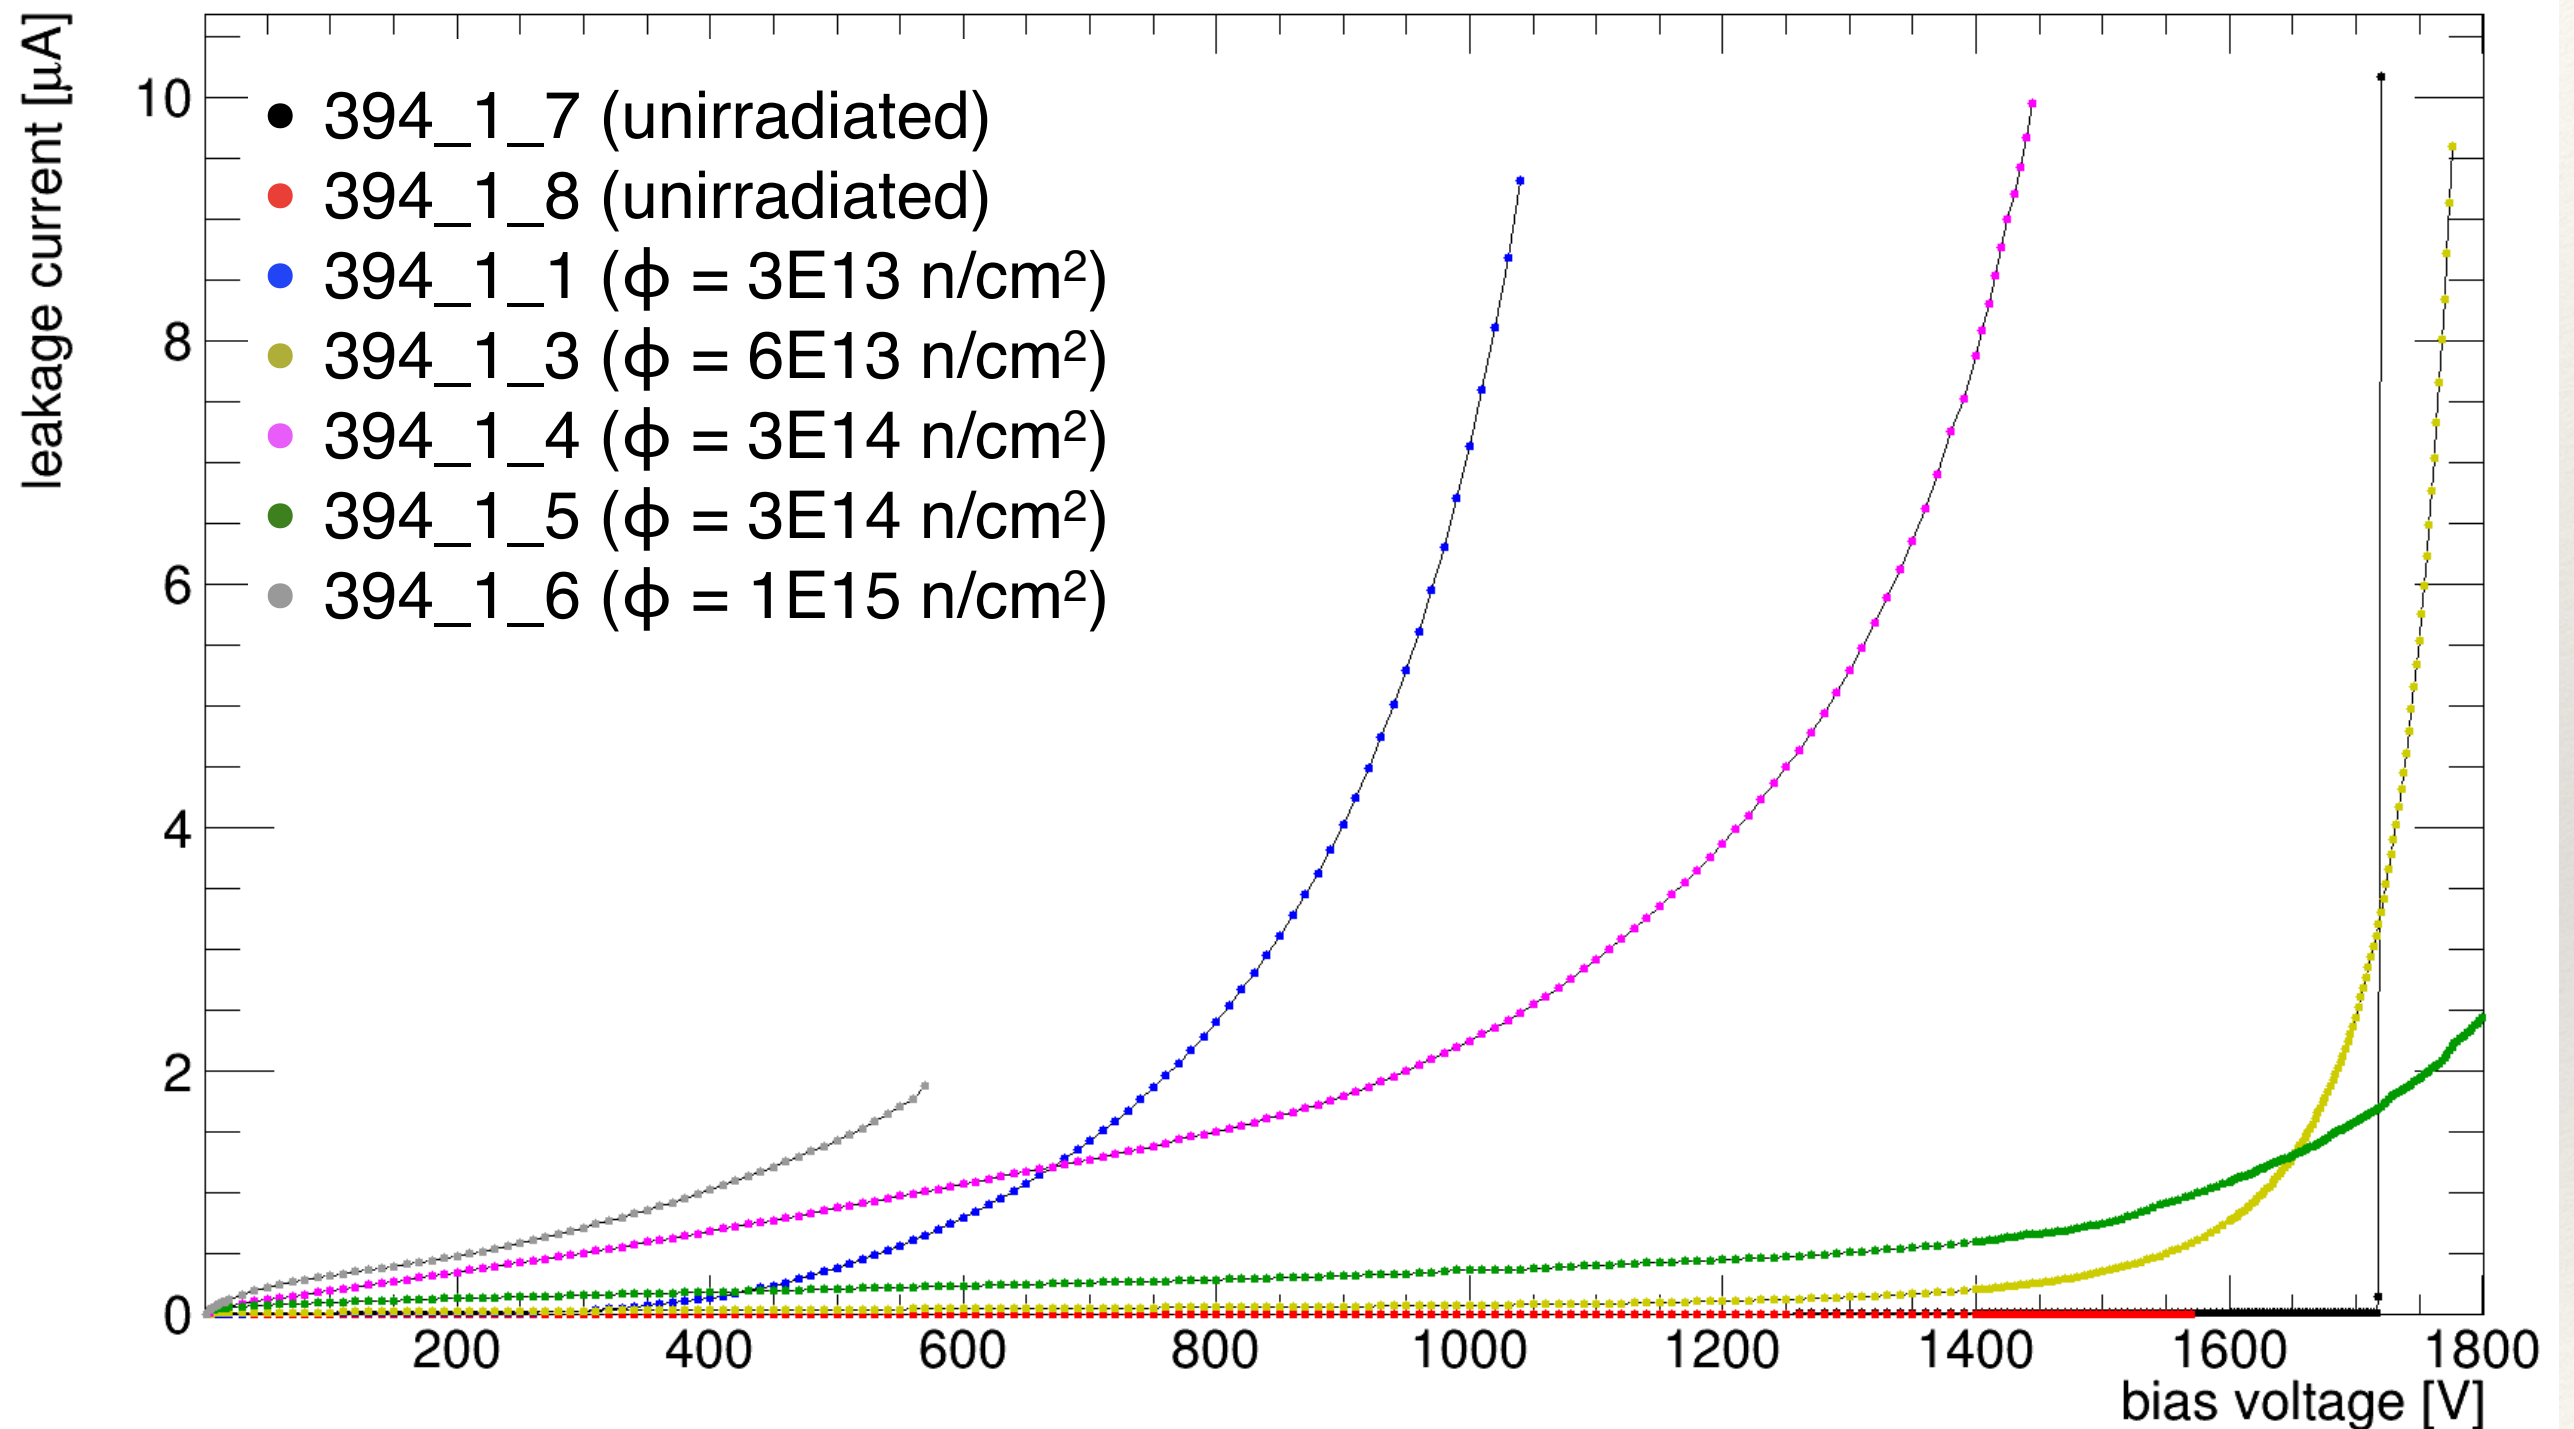
IV Curves @ -20°C

- ❖ Sample 394_1_3 suffered a change in breakdown voltage with respect to when TCT measurements were performed.
 - ❖ Possible explanation: damage to the cathode and/or anode connections.
- ❖ Samples 394_1_4 and 395_1_5 (both irradiated to $3\text{E}14 \text{ n/cm}^2$) behave differently.
- ❖ Also, the two unirradiated samples behave differently.
 - ❖ Possible explanation given by RMD: the sensors could be from different wafers which also means there could be differences in:
 - Doping profile
 - Depth of the PN junction
 - Thickness of the sensor

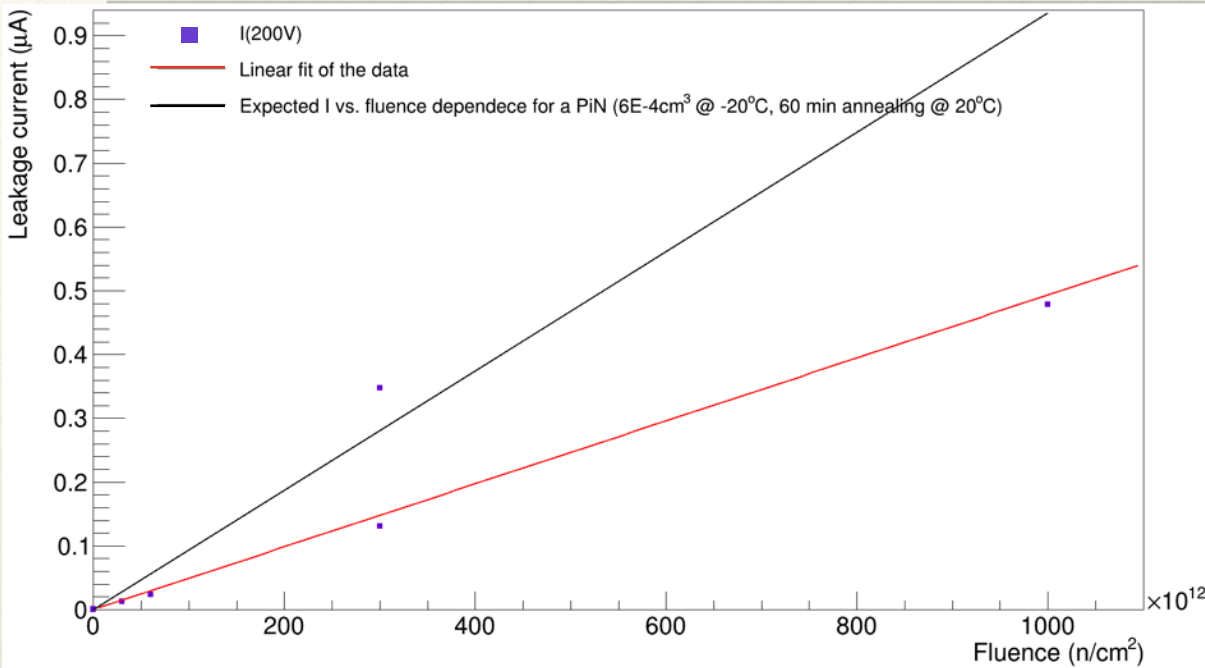
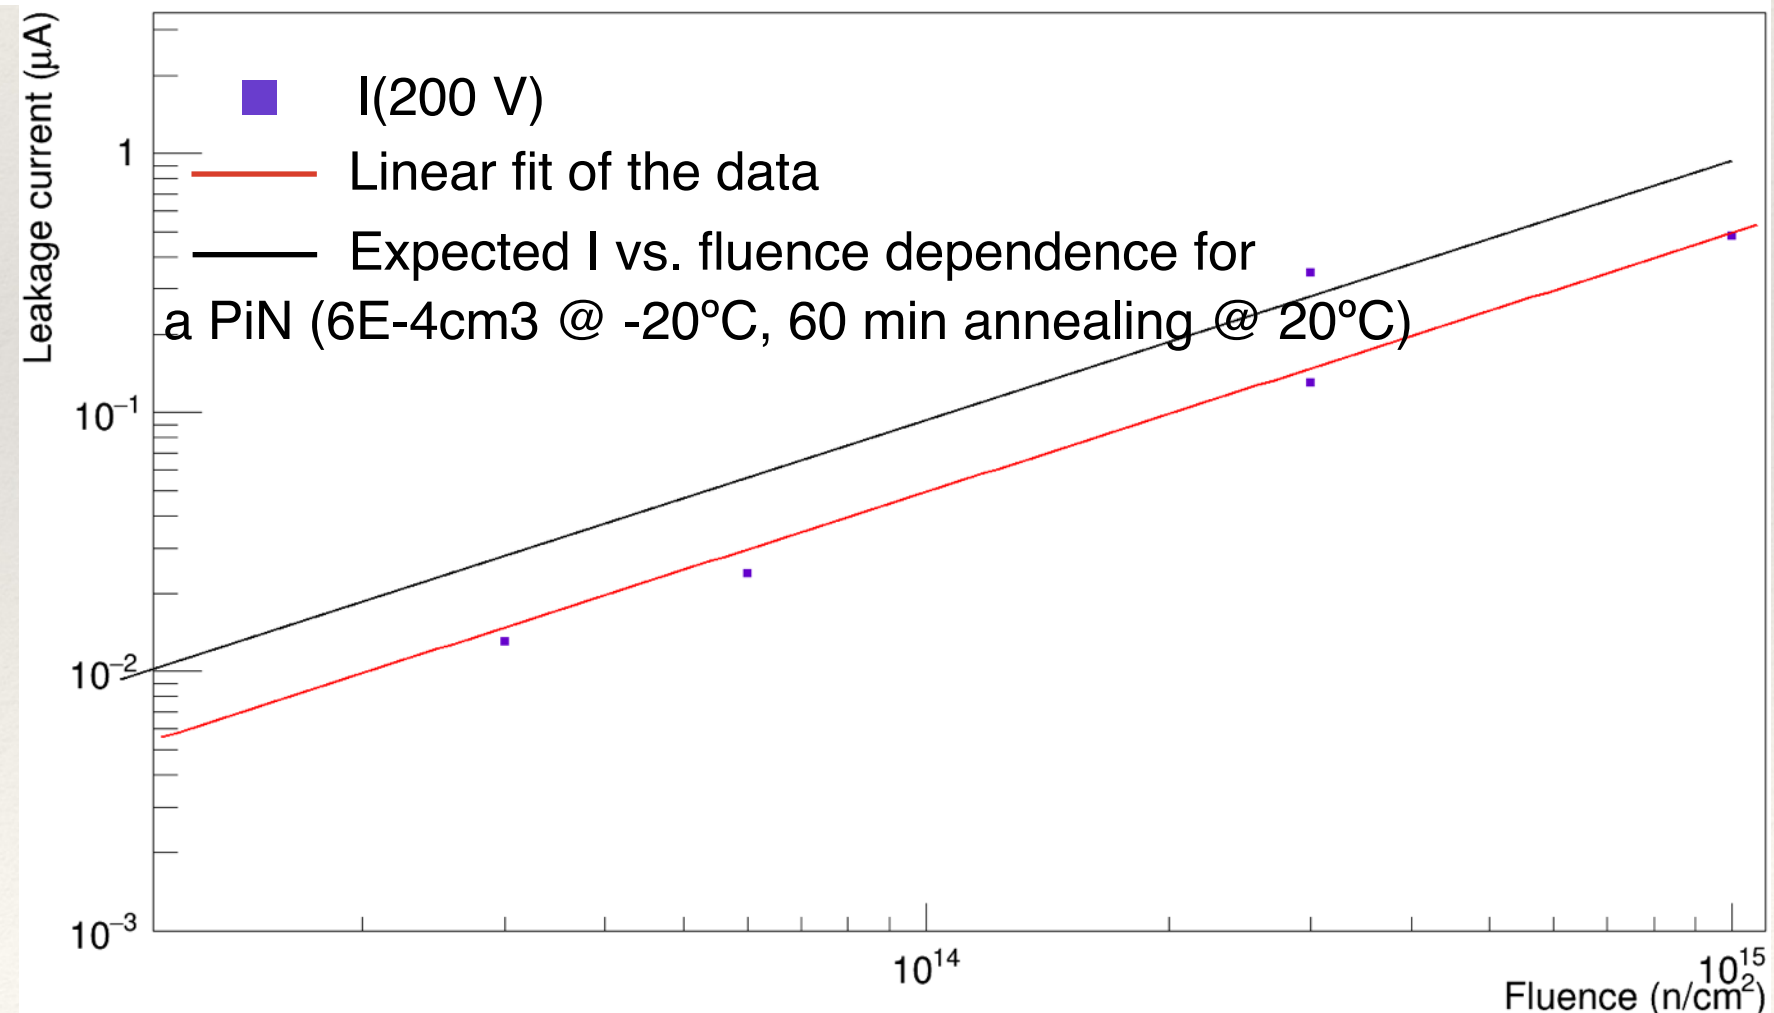
I(200 V) vs. Fluence @ -20°C

Damage coefficient:

- ❖ From fitting HFS data:
 $\alpha_{\text{fit}} \approx 8.22\text{E-}19 \text{ A/cm}$
- ❖ For a PiN with equal volume and annealing:
 $\alpha_{\text{PiN}} \approx 15.6\text{E-}19 \text{ A/cm}$

Active volume changes are not being considered.

Dimensions assumed:

Active area: 2x2 mm

Thickness: 120 μm

Estimated annealing:

60 min @ 20°C

- ❖ This has yet to be understood.
- ❖ TCT voltage scans show a decrease in charge collection with fluence.
- ❖ From the IV measurements @ 200 V (gain=1) it was possible to estimate α ($8.22E-19 \text{ A/cm}$), which resulted of the expected order of magnitude.

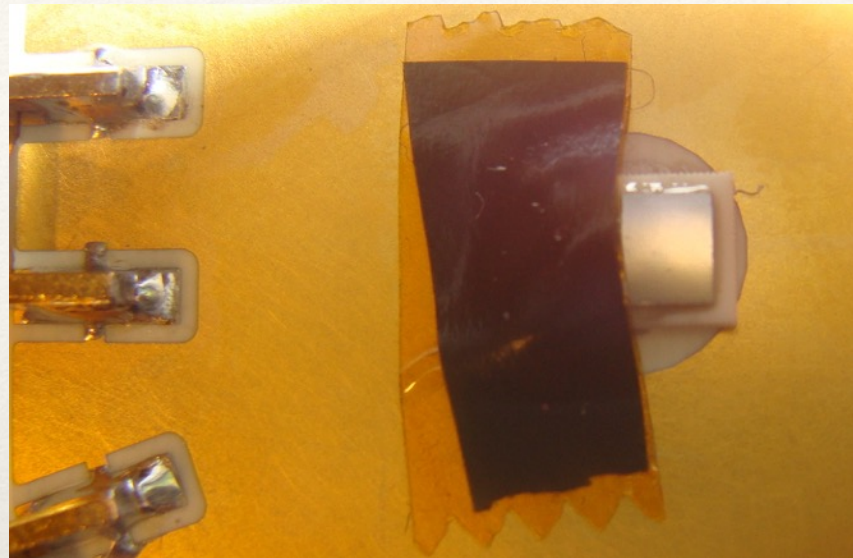
Charge collection outside the active area

- ❖ We covered one of the sides of the sensor so that a portion of the glue would be concealed.
- ❖ A TCT scan was done and the corresponding odd charge collection area disappeared.
- ❖ We concluded that the abnormal charge collection areas served are due to the reflection the laser on the glue.
