NUMI Targets: MINOS experience and NOVA/LBNE designs

Jim Hlyen
FNAL

NUMI Targets 4th HPTW

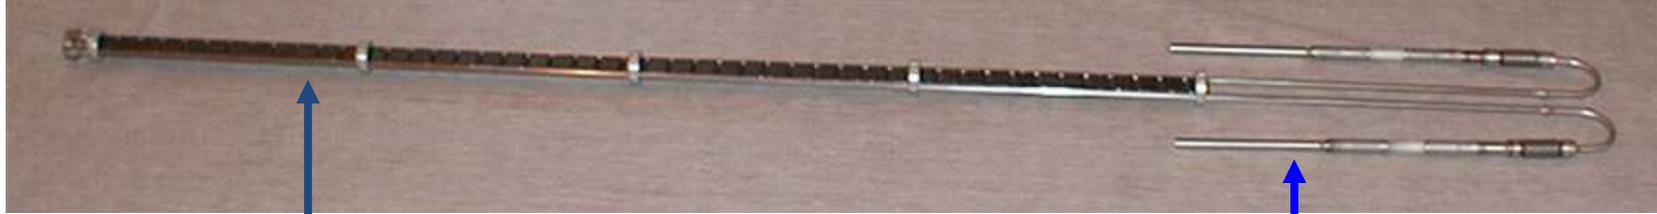
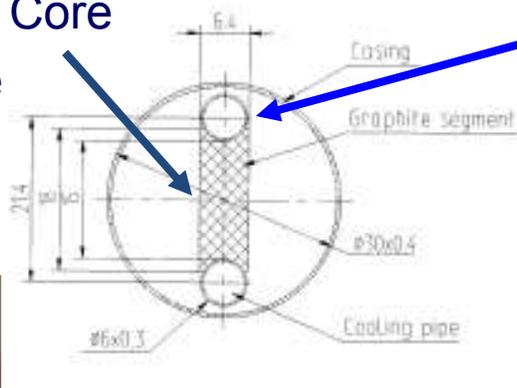
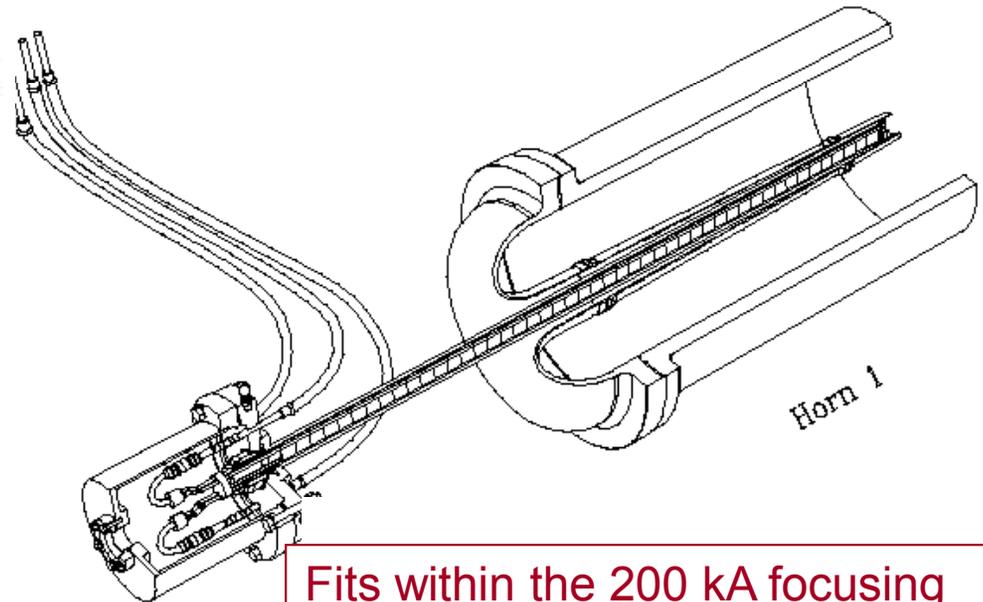
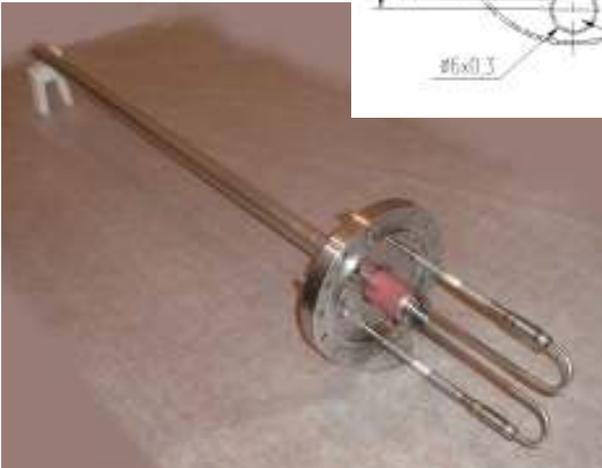
NUMI MINOS target

Designed with and constructed by IHEP Protvino Beams Group

2 int. length long; narrow so pions get out sides without re-interacting

Graphite Fin Core
6.4 mm wide

1 mm RMS
beam spot

Water cooling tube

Fits within the 200 kA focusing horn without touching.

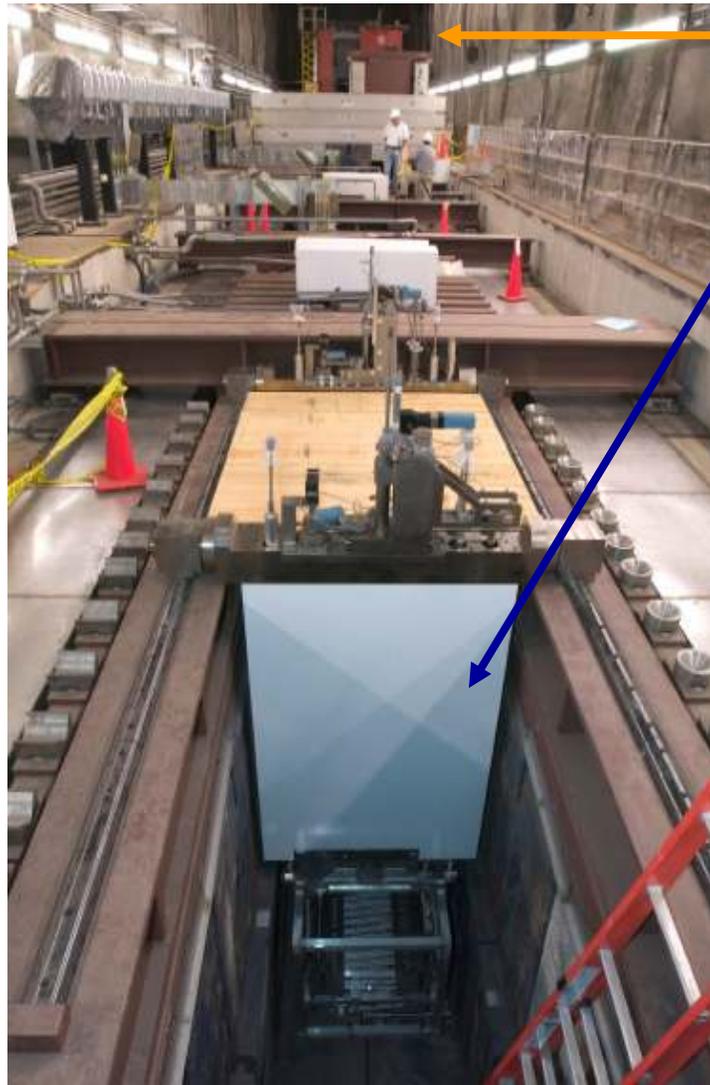
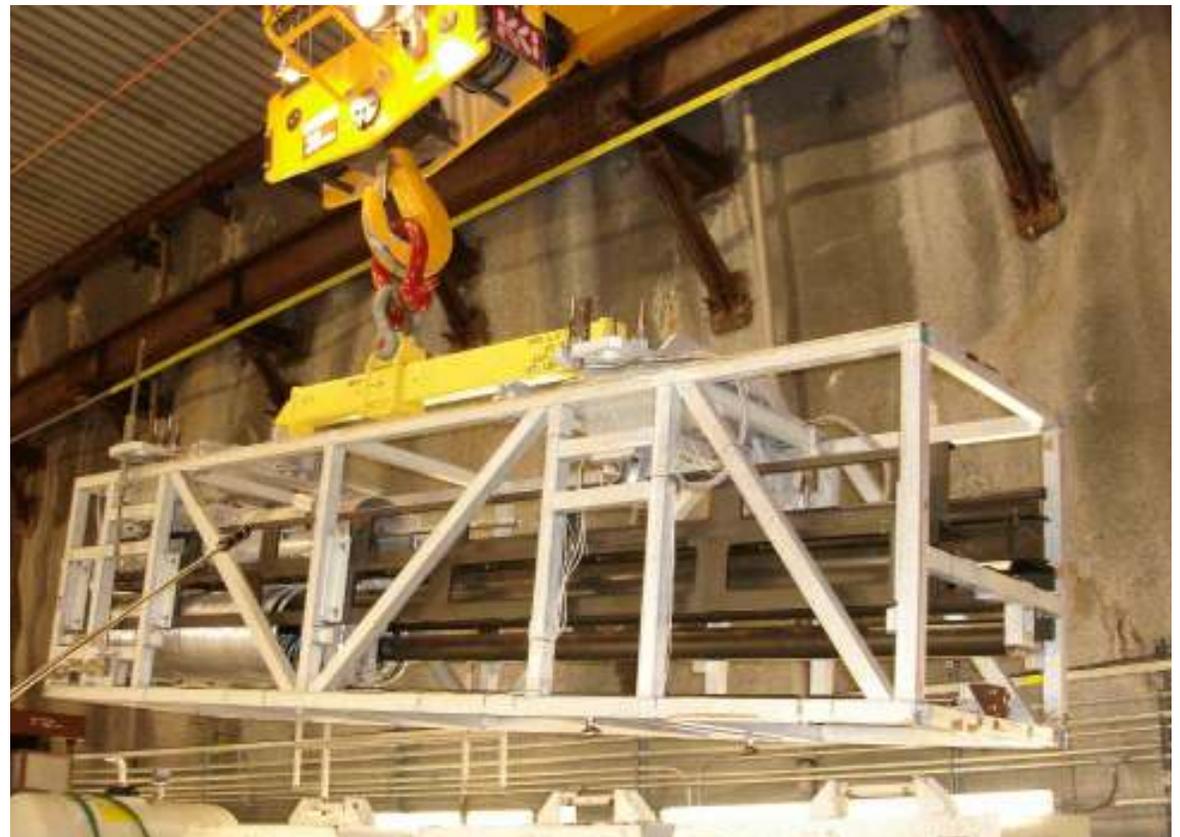
MINOS Target carrier

Work cell

Target module in beam-line

1st target being removed

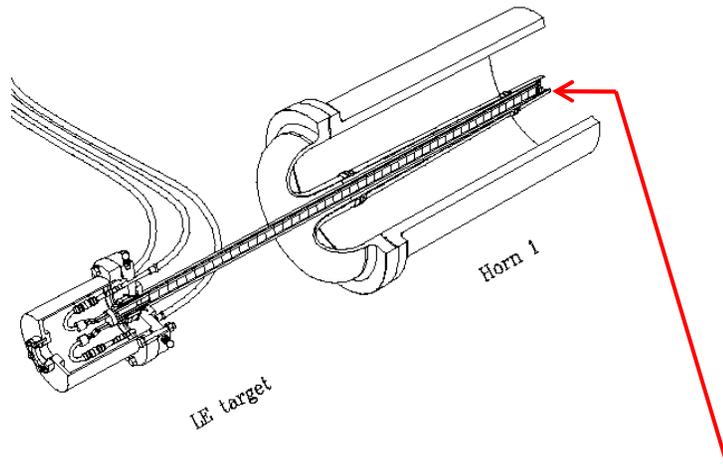
Target life-time history

Design goal	12 months
1 st target	16 months
2 nd target	33 months
3 rd target	10 months
4 th target	< 1 month
5 th target	4 months

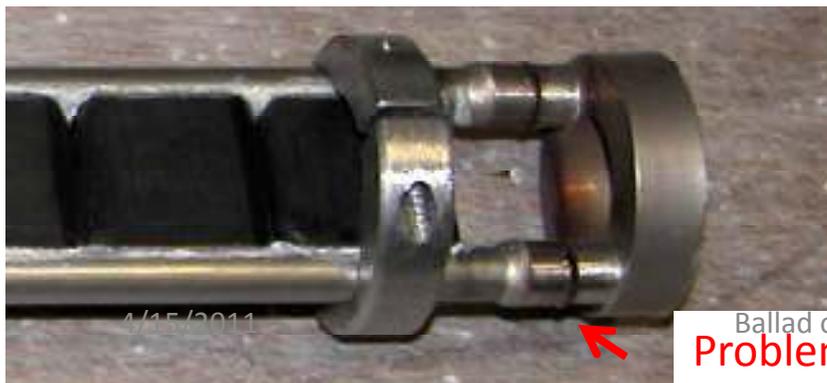
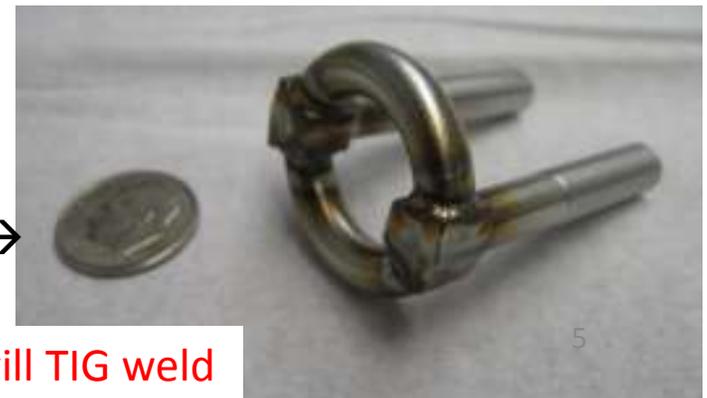
After two targets quickly failed with water line leaks (downstream water turnaround):

- Did autopsy on highly radio-activated target 5 to confirm location of leak
- Then modified target 6 (more robust weld and geometry) before putting it in beam

← Old design

New design →

Ballad of NUMI Targets - Jim Hylan
 Problematic laser weld – will TIG weld

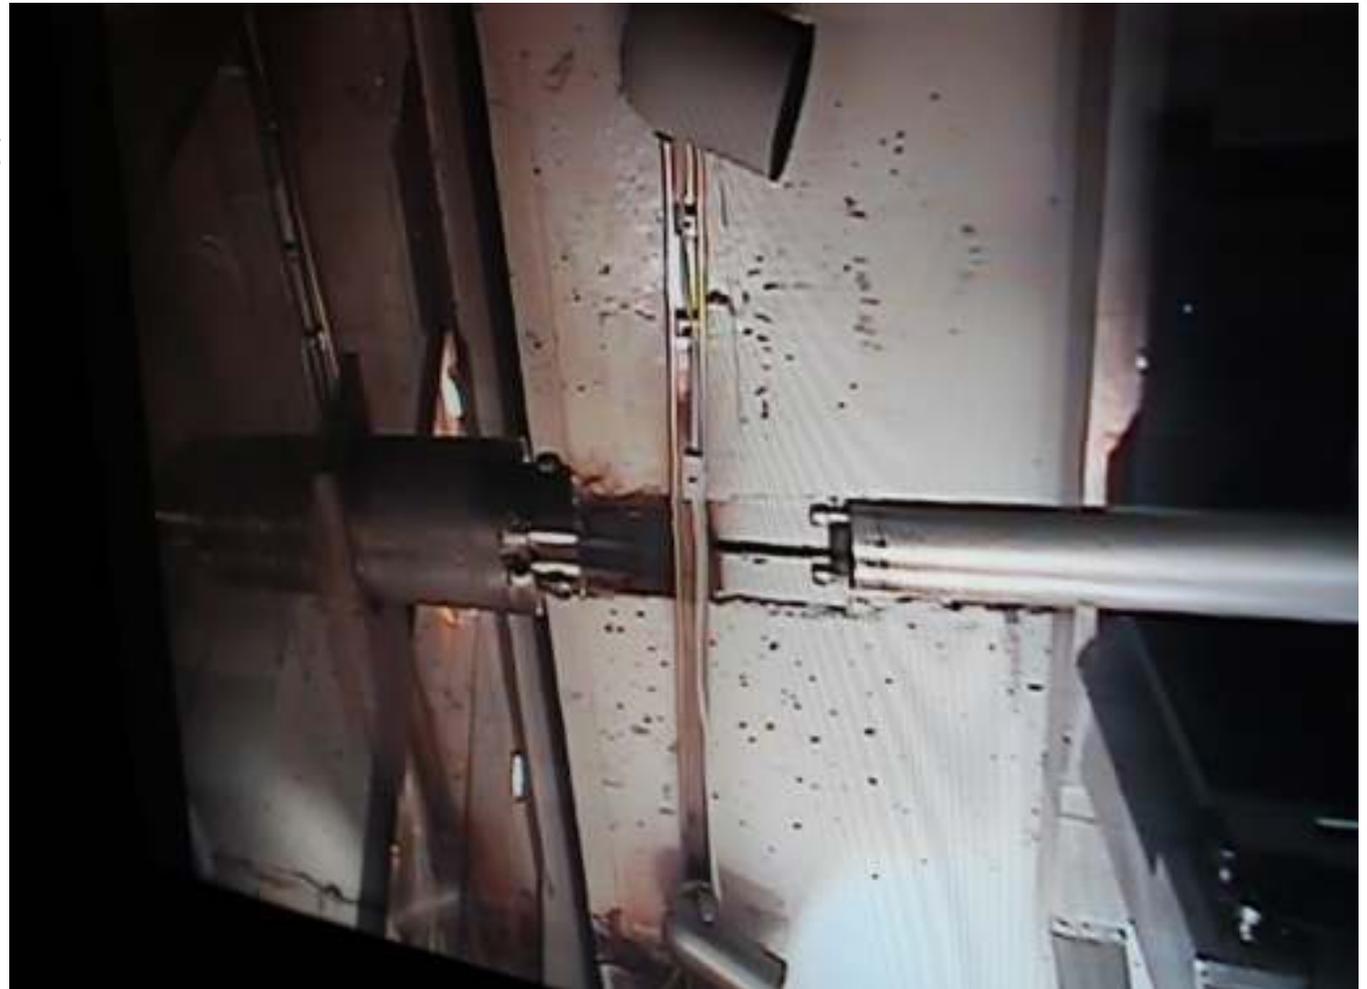
NT-05 Autopsy

When aluminum tube
was cut off, water
turnaround was missing

It was not cut by our tool

Note that the transition
tubes are still on
the water pipe

came apart at the laser
weld transition

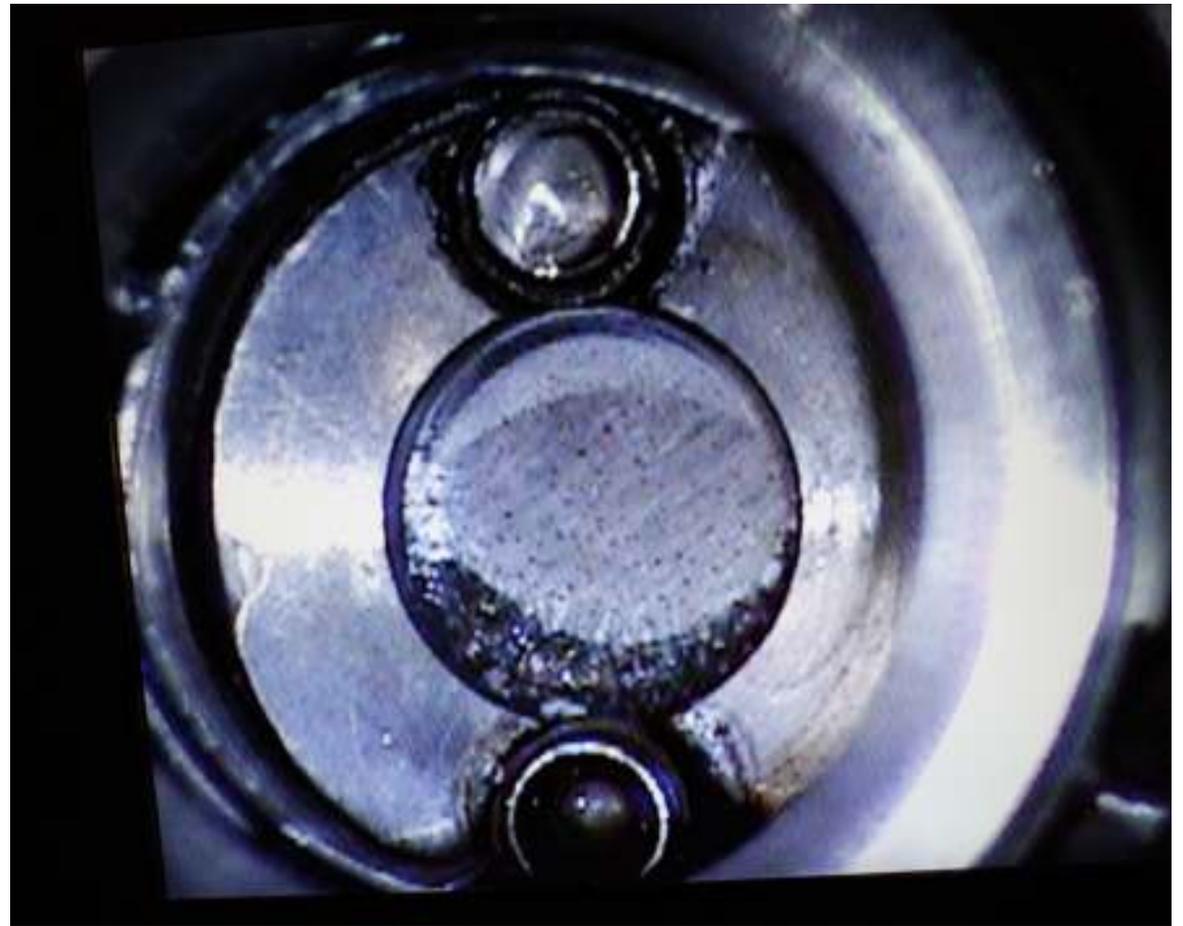
NT-05 Autopsy

Water turnaround came off
in the cutting tool with
the aluminum tube

Do not see cracks or corrosion

Just failure of laser weld

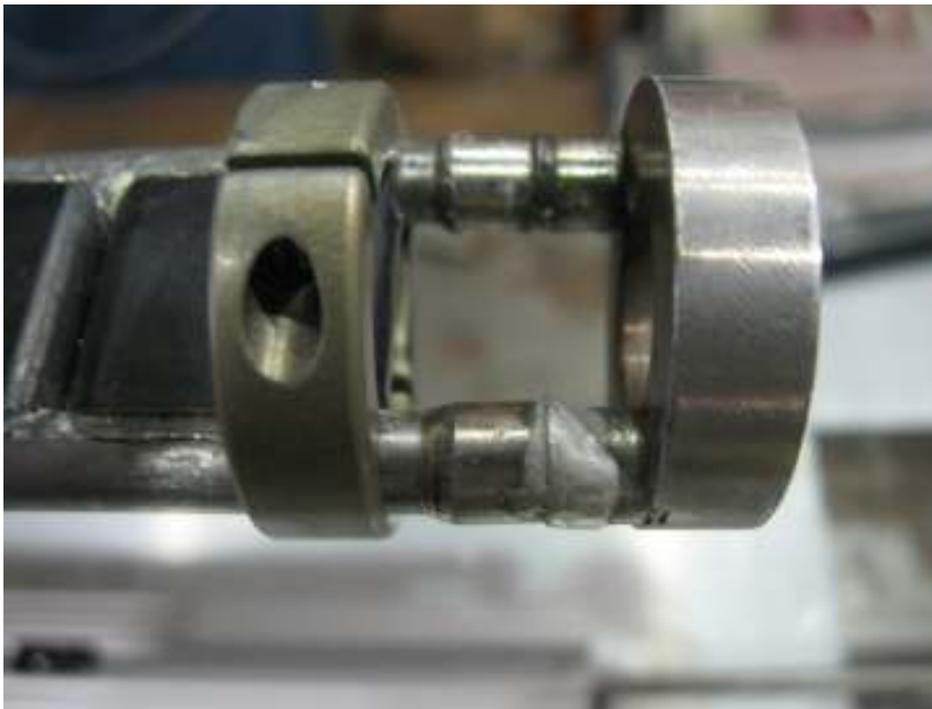
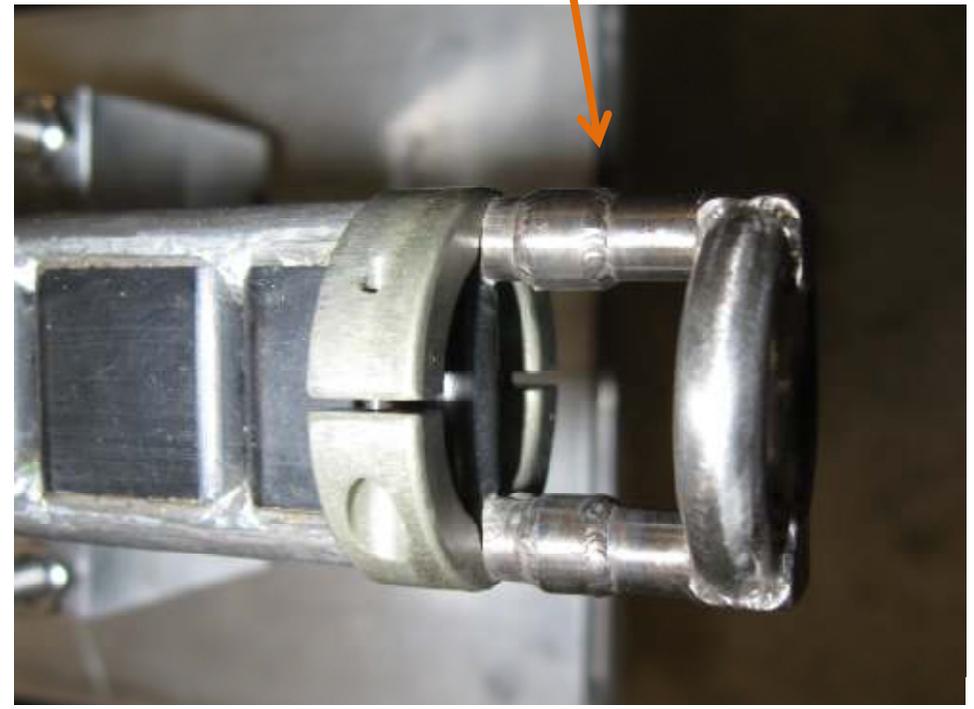
NT-06 reworked

new weld

- Ream old weld of water-feed-through at base (not shown)
- Wire EDM off old water-turn around (minimal vibration)
- Clean up and make room for new connection tube (made special tool)
- Micro-tig-weld new tip on
- Re-weld water feed-through
- Pressure leak test

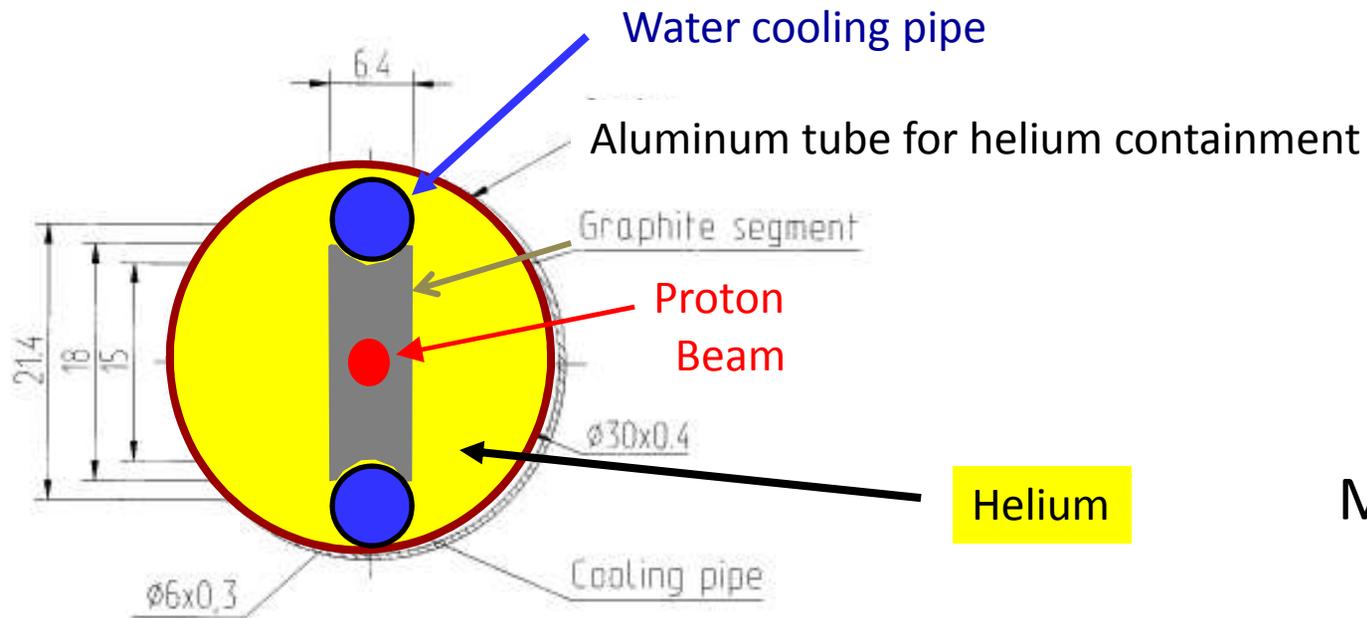
NUMI LE Target

MINOS LE target

All units mm

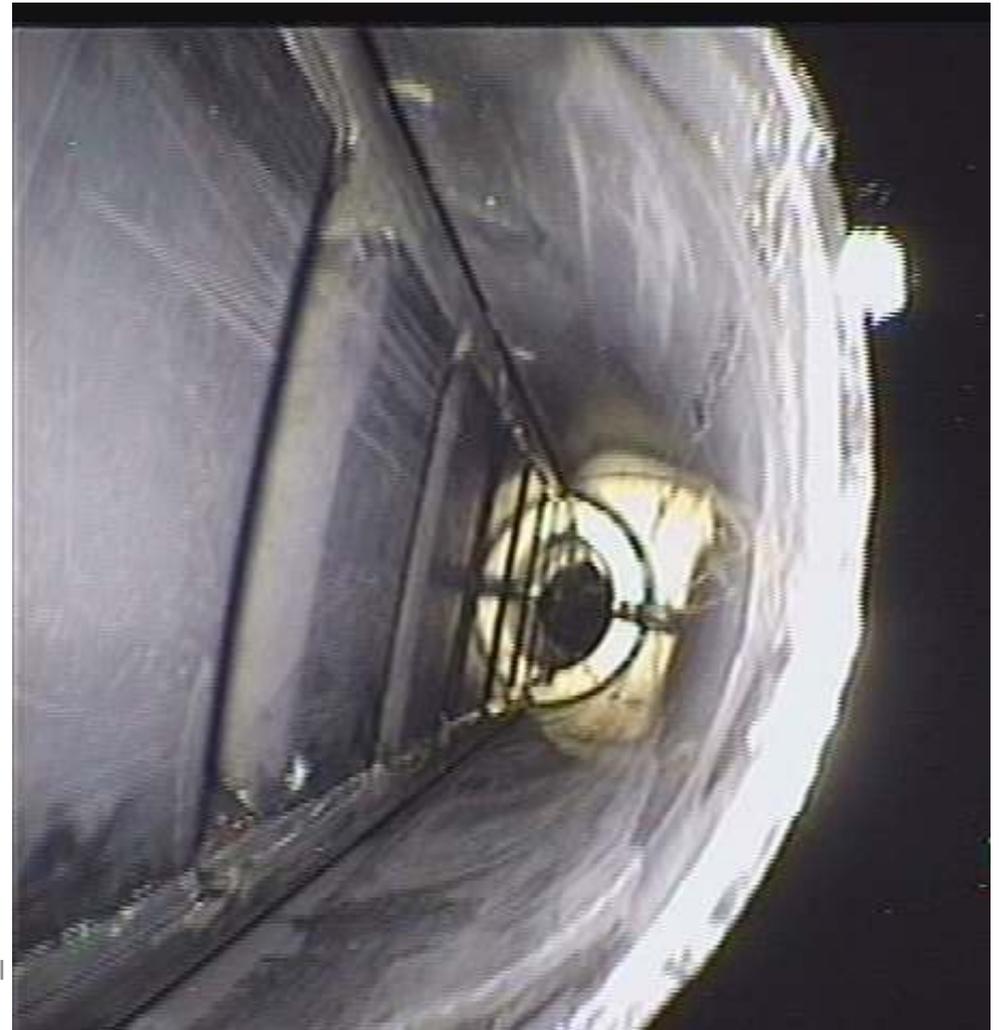
NT-05 Autopsy March 2011 *downstream end*

This part of graphite looks perfect
after 1.25×10^{20} POT in 1 mm RMS spot

No corrosion of aluminum

Solder joint to graphite looks fine

Steel cooling pipes look fine

Downstream spacer ring had walked
several inches upstream

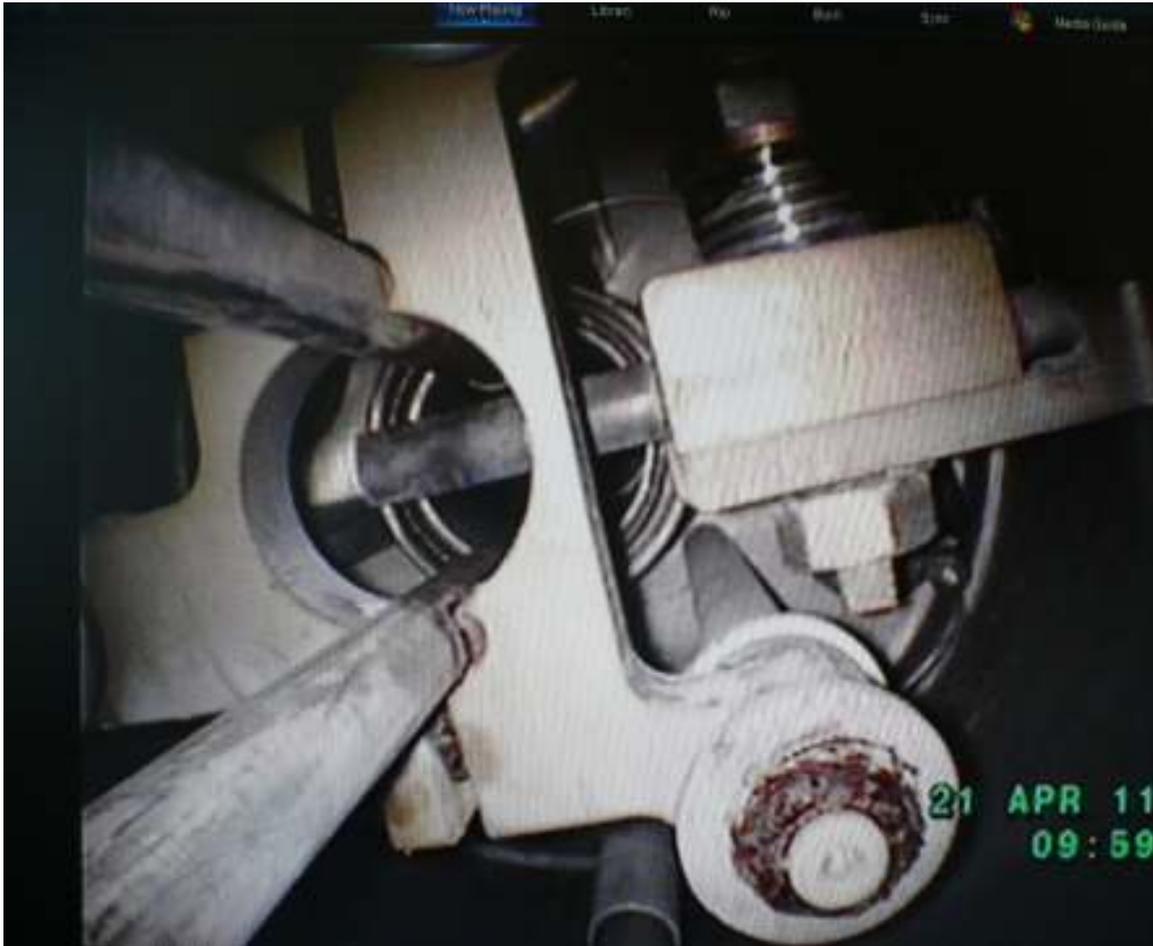
NT01 inspection April 2011 *upstream end*

Target interior flooded
early during operations
- leak location unknown

Dried out, then operated for 1 yr
Removed when drive stuck
- then 4 yr on shelf

Accumulated $1.6e20$ P.O.T.
120 GeV protons in
1 mm RMS spot on
6.4 mm wide graphite fin
Neutrino spectrum did not
visibly change during operation

Cannot see most of fin, but
upstream end of graphite
looks good.

Drive for insertion into horn has now being repaired, upstream beryllium window replaced, and are re-aligning target for use as spare.

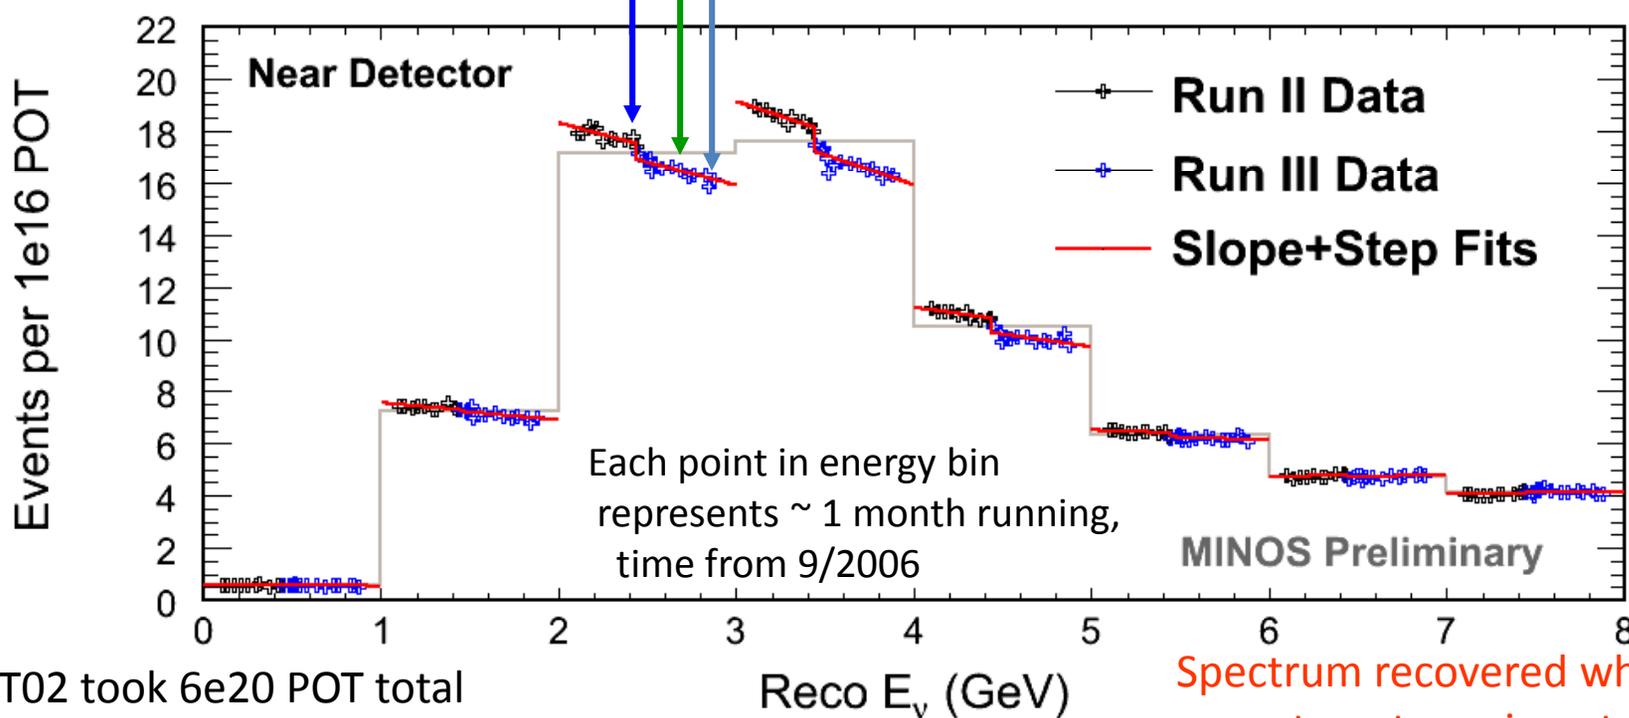
NuMI 2nd target depletion (ZXF-5Q amorphous graphite) *NT-02 replaced when spectrum shift became too large.*

Gradual decrease in neutrino rate attributed to target radiation damage

Decrease as expected when decay pipe changed from vacuum to helium fill

No change when horn 1 was replaced

No change when horn 2 was replaced

NT02 took 6e20 POT total
in 1 mm RMS spot size

~ 0.7 DPA

Spectrum recovered when
new target was inserted

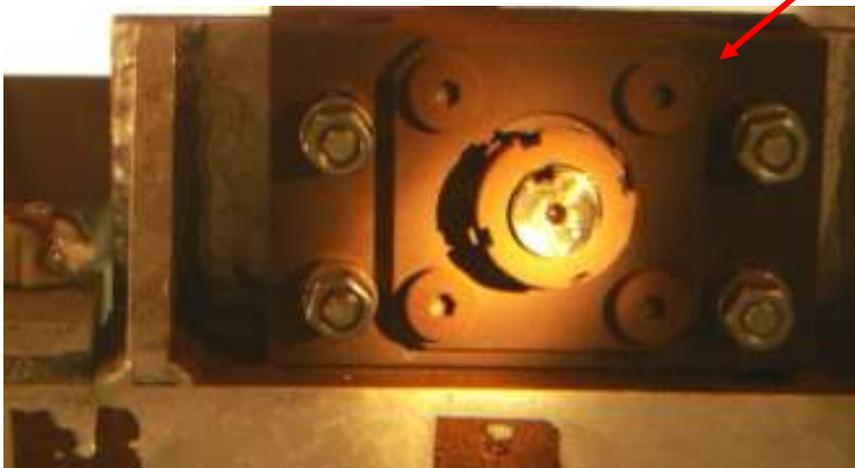
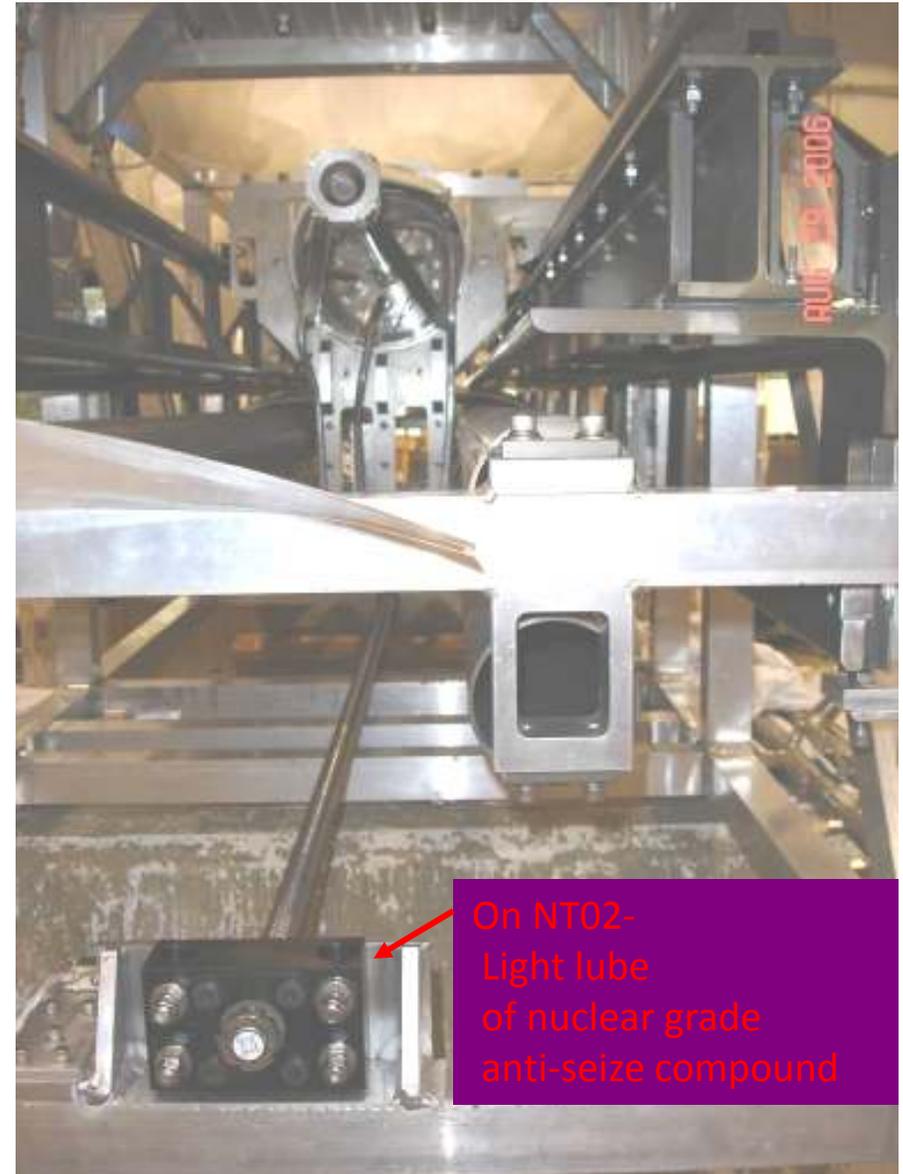
NT-01 Frozen drive shaft

target replaced because could not move it to LE position

After month-long test in High Energy position
drive shaft would not rotate to move target
into Low Energy position

Old jammed pillow-block

Changed to spare target + carrier (NT02)
(drive also became sticky after beam)

NT03 onward, changed to graphite bushing
NT-03 drive moved smoothly at the end
of it's year lifetime.

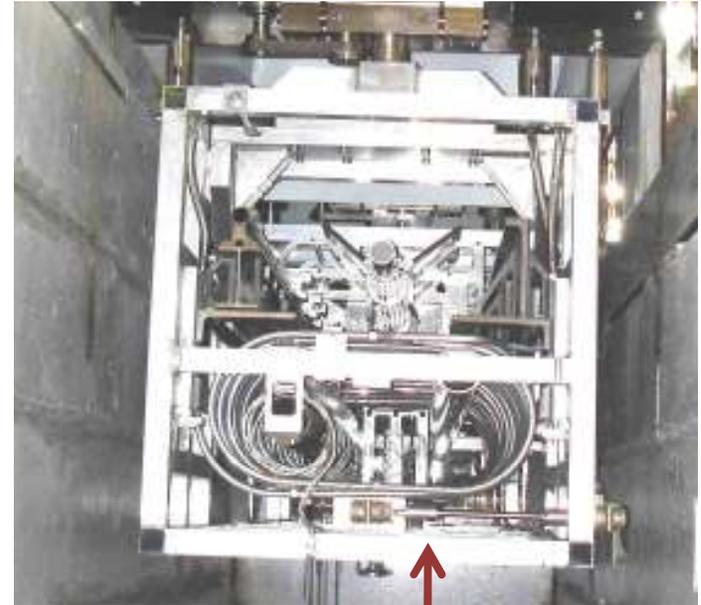
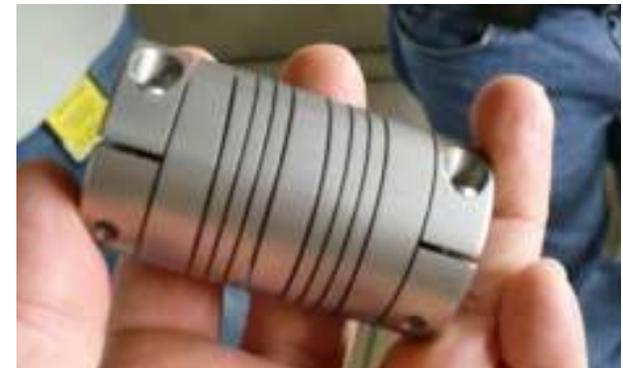
Target remote drive coupler failure (repaired)

Air + radiation = nitric acid

Nitric acid atmosphere

→ hydrogen embrittlement of high strength steel

→ steel cracks

High strength steel bolts in couplers on target
drive linkage failed, so could not move target
to different position.

Have changed to non-high-strength bolts.

No more failures of this type.

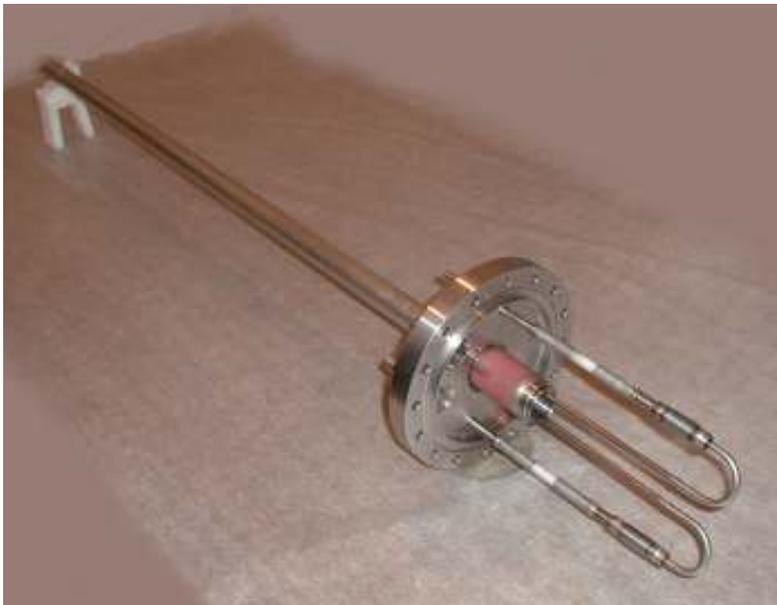
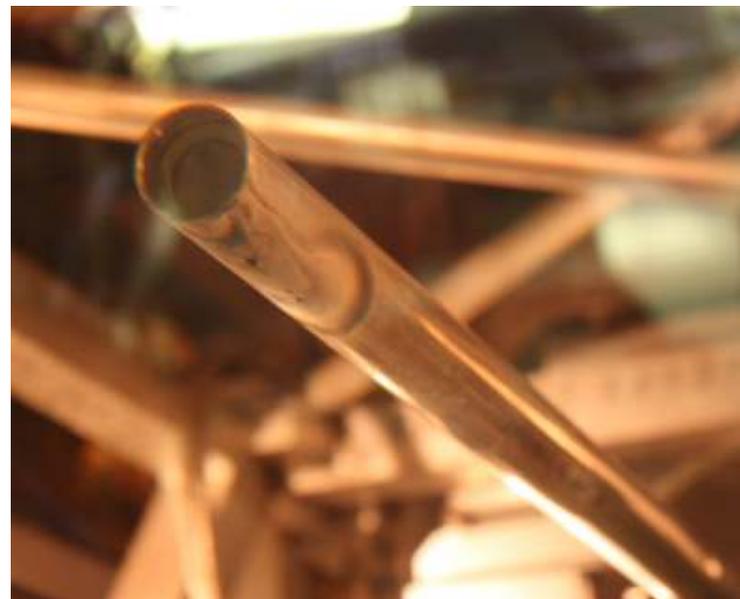
NT-03 failure

Helium leak developed, and target fin moved beam-left.

Exam showed leak at ceramic insulator at base of target – presumed cause is failure of braze joint or ceramic causing (X=4 mm, Y=8 mm) displacement of target tip

Exam also showed helium leak/damage at bottom of target tube

- presumed collateral damage from horn current with target resting on horn conductor (which limited the vertical displacement to 6 mm)

We re-adjusted target so parallel to beam again, and ran another two months.

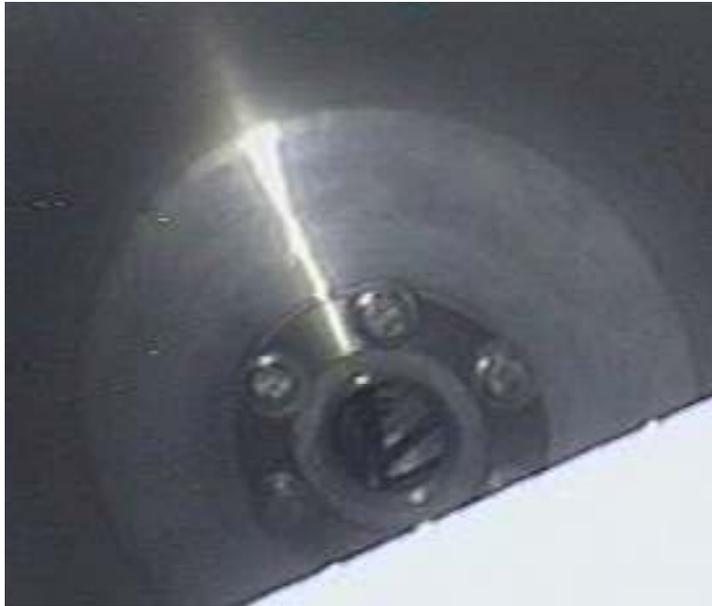
What upstream “window” looks like:

Water leaked into helium volume
Beam dissociated H₂O into Hydrogen and Oxygen
Small spark ignited Hydrogen
The burn punched out the upstream window
Also damage at downstream tip

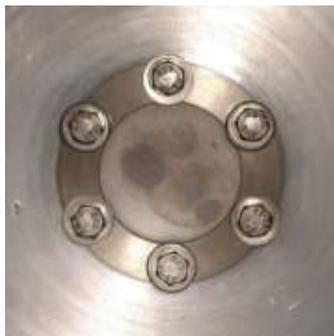
What it should look like

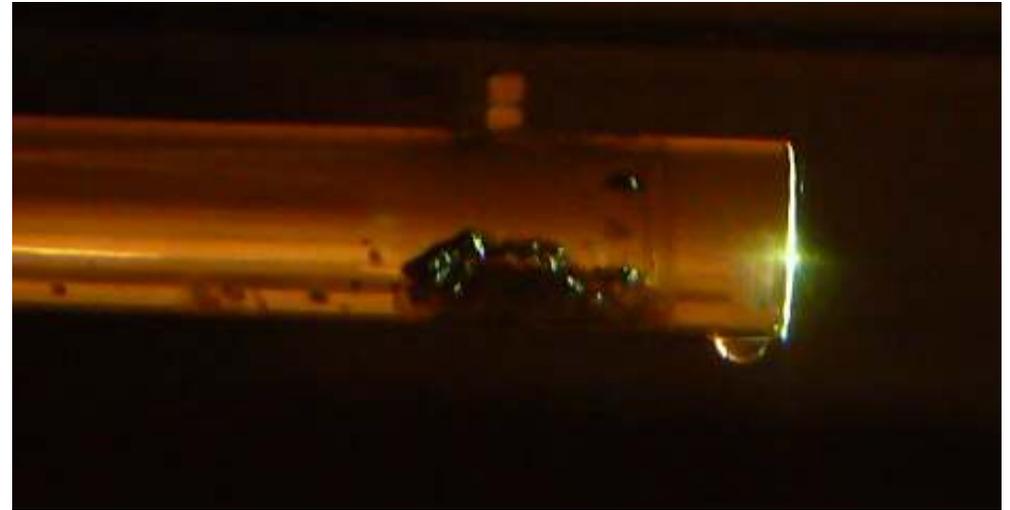
Target tip with drip

NT04 had Helium at lower pressure than water.
Now always run with Helium at higher pressure than water,
so helium goes to water system, not water into target

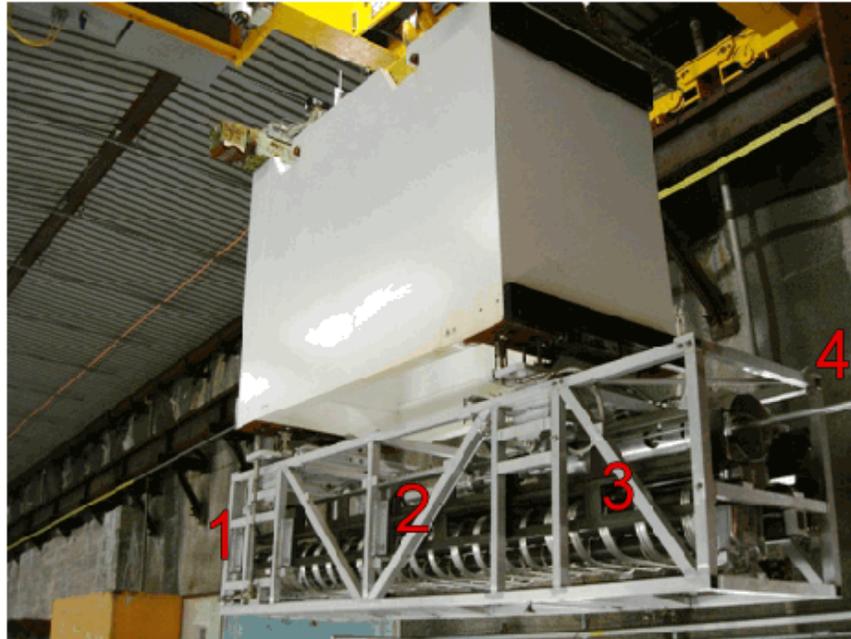
Target NT-02 residual radiation when removed

NUMI Target Beam Right

Point	Doserate @ 1 foot (mr/hour)	Doserate On Contact (mr/hour)
1	200	300
2	600	700
3	3000	3500
4	11300	45000

Target dose rate was
45 R/hr

0.45 seivert / hour

(has dropped ~4x
after 20 months)

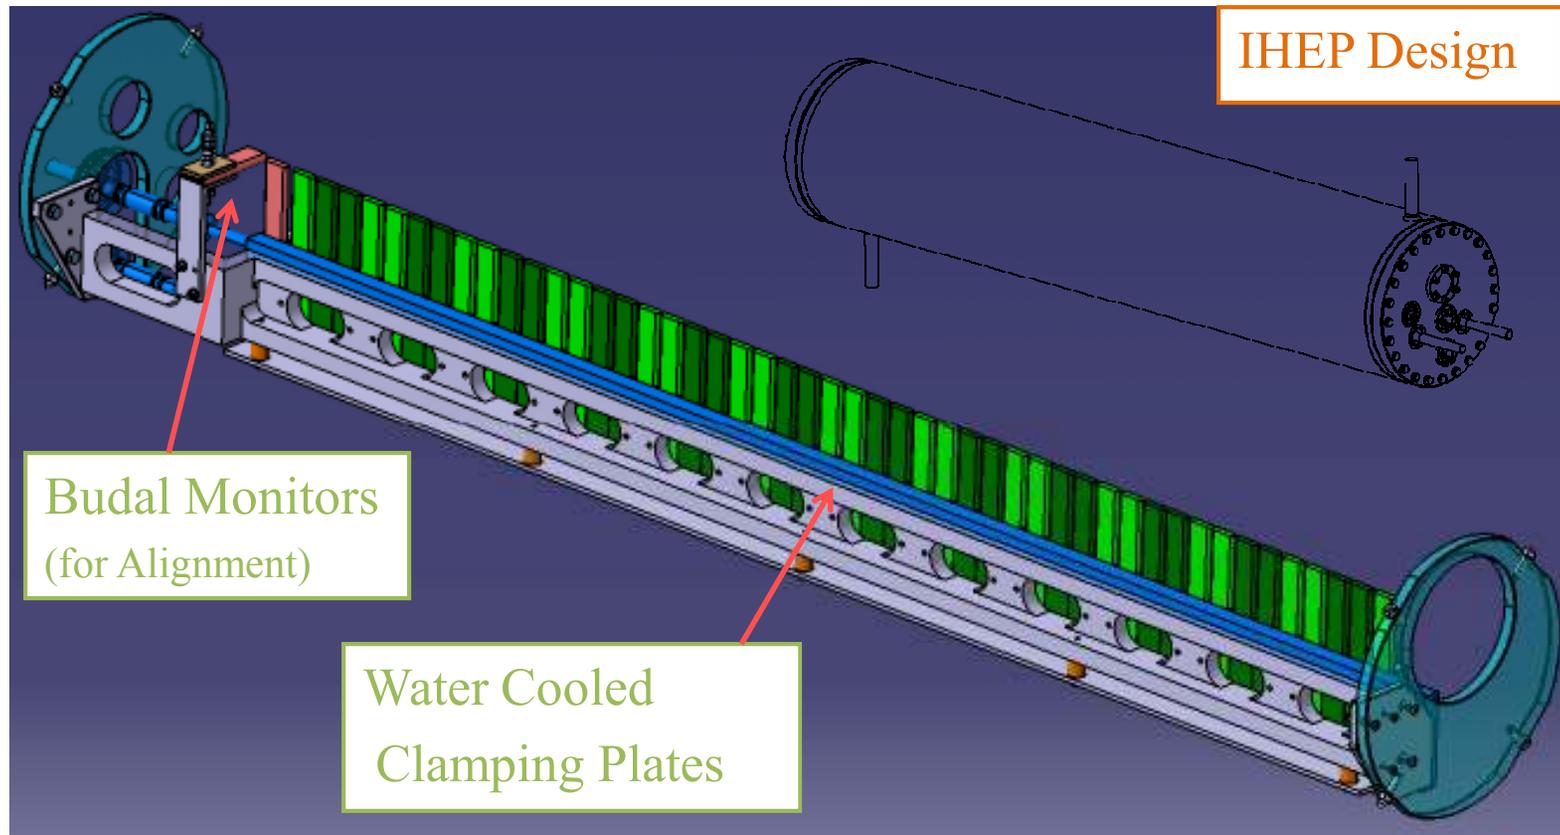
NOVA ME Target

Nominal max. beam power 700 kW

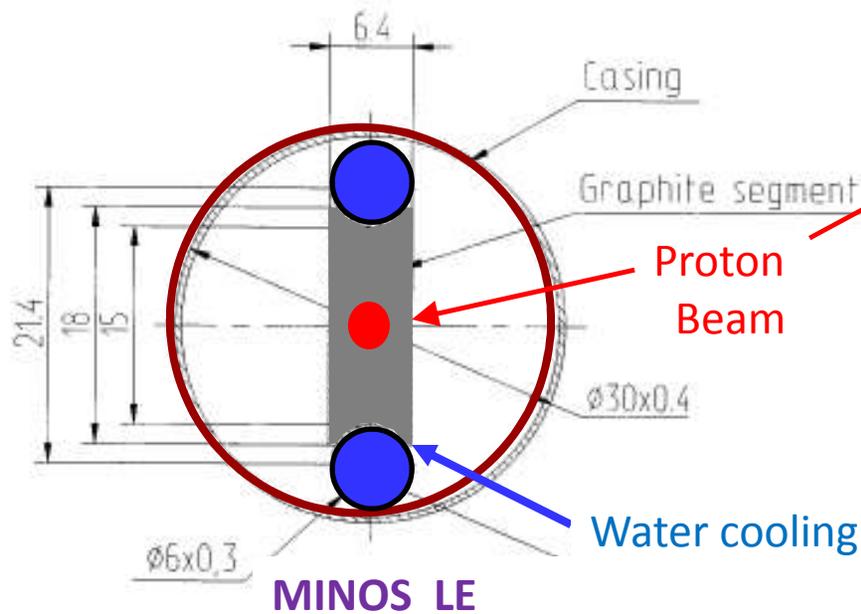
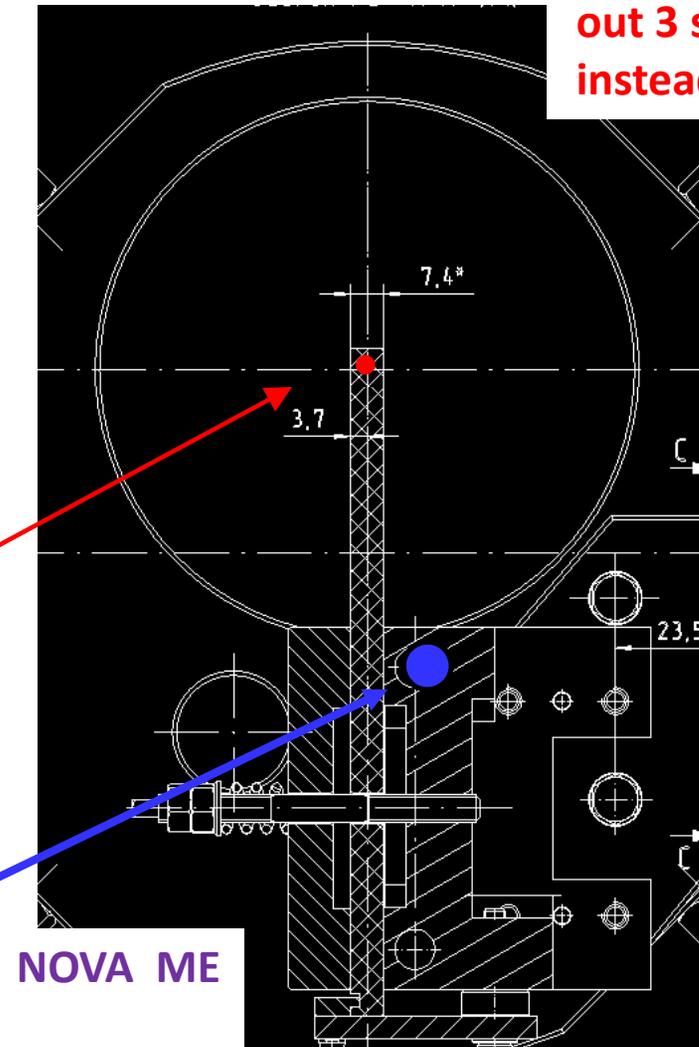
Target cross section comparison

water cooling 8 times as far away, 0.1 x the water hammer

MINOS beam spot size of 1.1 mm RMS is increasing to 1.3 mm for NOVA, increasing 6.4 mm target width to ~ 7.4 mm - reduces the neutrino flux ~ 1%, but eases alignment tolerance.

Pions come out 3 sides instead of 2

Spacing between fins
0.5 mm / 24 mm versus 0.2 mm / 20 mm

All units mm

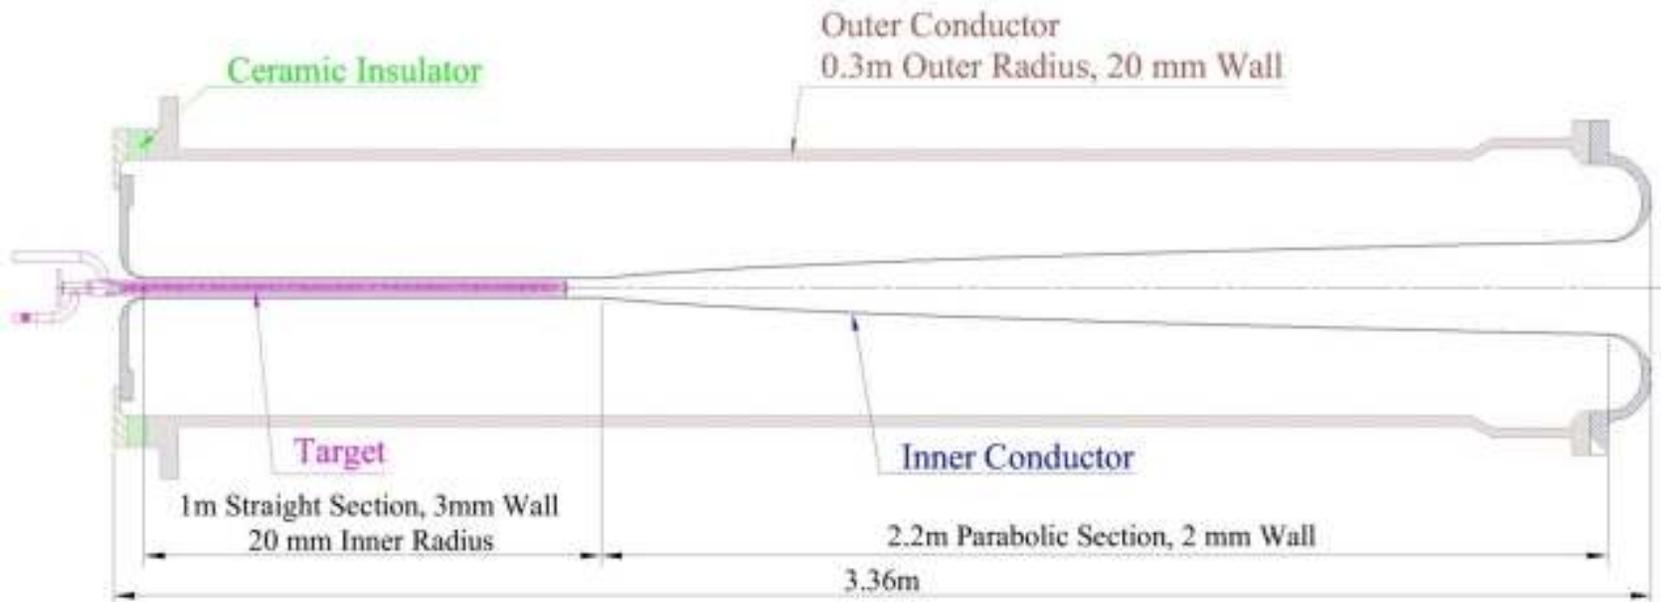
LBNE target more similar to NUMI LE

In horn neck without touching

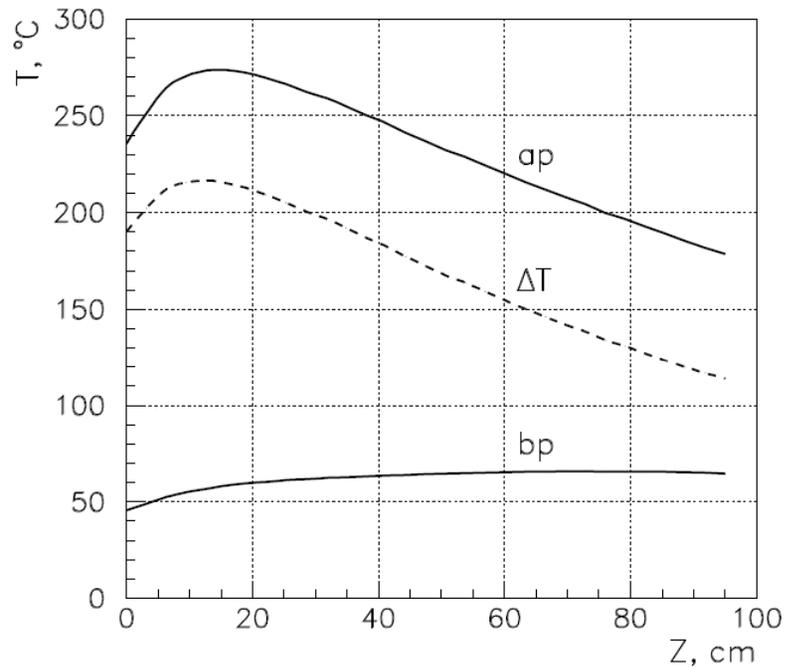
Temperature along center of target before and after beam pulse

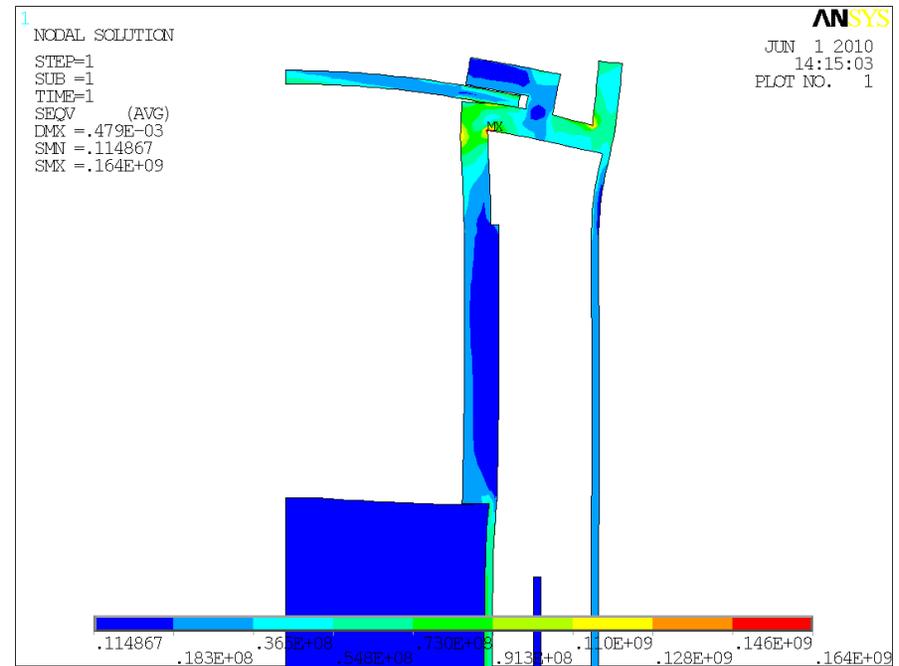
Stress (color) and deformation (x120) of downstream target tip just after beam
