First SNS Target Replacement Experience

October 2009

Workshop on Applications of High Intensity Proton Accelerators
October 19-21, 2009
Fermi National Accelerator Laboratory, Batavia, IL, USA

First SNS Target Replacement

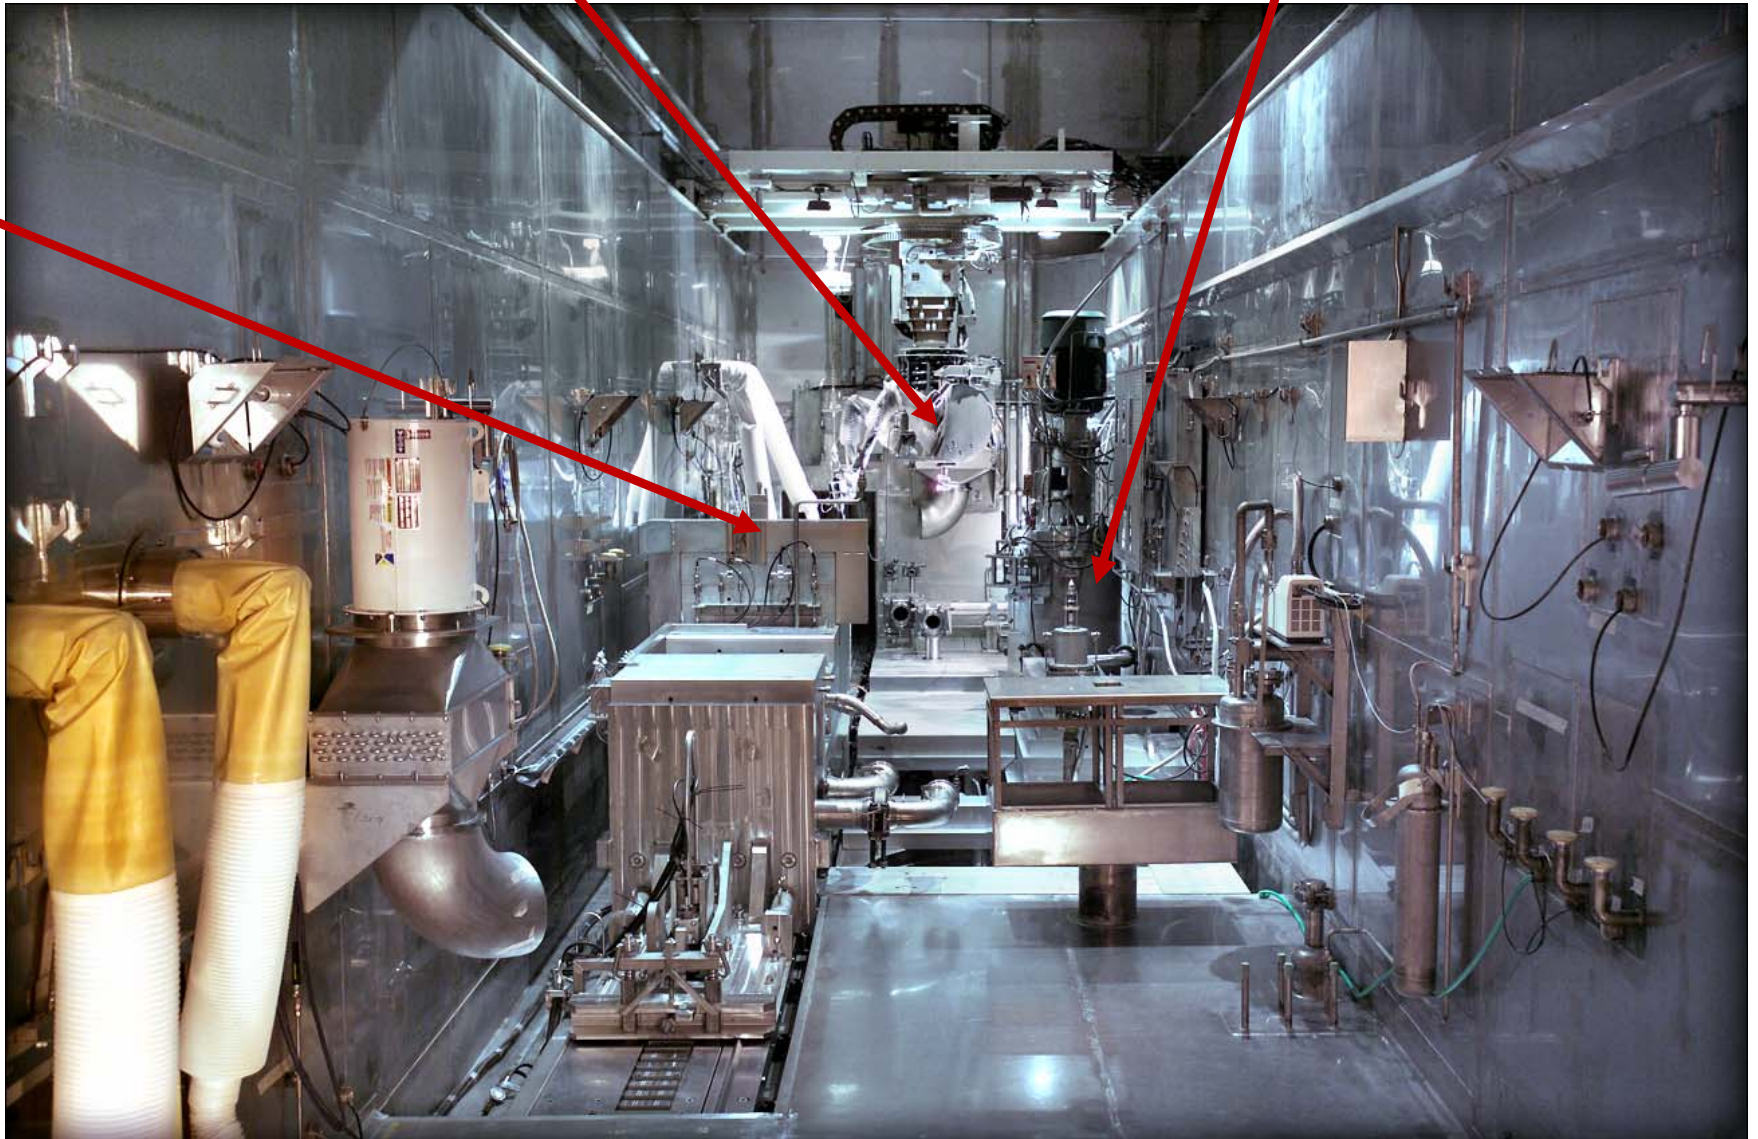
Target Service Bay

Servo-Manipulator

Mercury Pump

Target
Cart

Service Bay Size: 31.4 meters x 4.3 meters

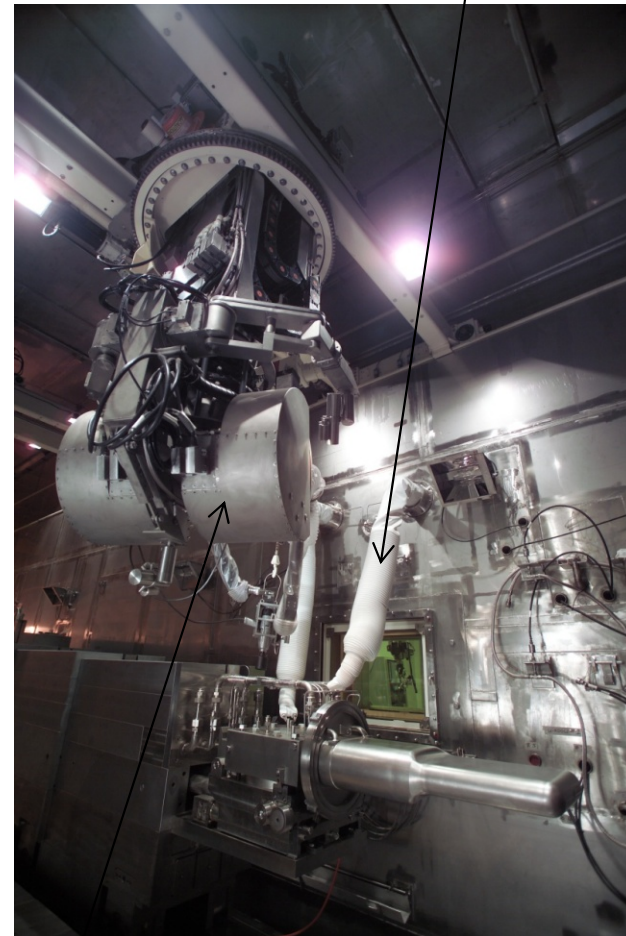
Master-Slave Manipulator

- Four window workstations each containing a pair of master-slave manipulators are built-into the target service bay. Only one workstation is dedicated to target change-out.
- The servo-manipulator is required to perform most operations including bolt torquing, tool transport, inspections and precision operations.

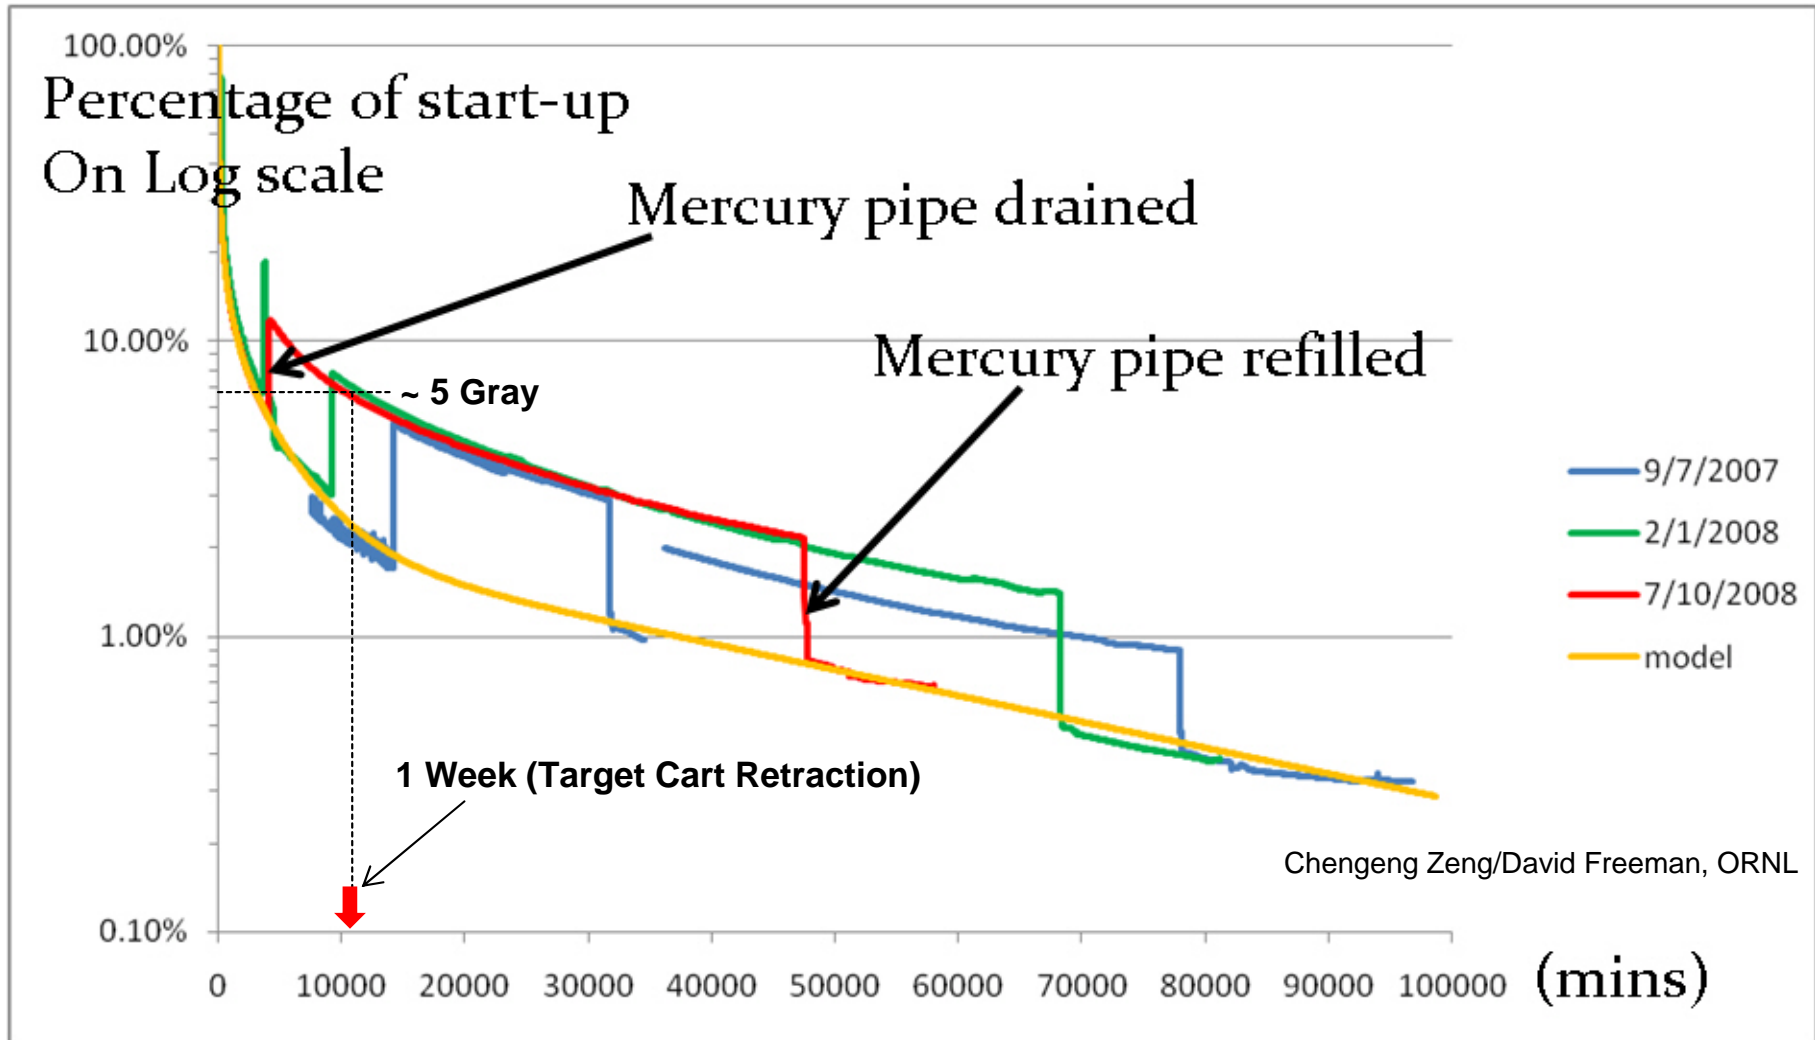
- **During Beam-On Operations**
 - Mercury process equipment contact radiation level is ~400 gray/hr
 - Steel shielding (.2 - .3 m) inside cell reduces area background to ~ 2 gray/hr
- **During Maintenance Operations**
 - With mercury drained from process lines, residual contamination results in contact radiation levels of 3-5 gray/hr
- **Target Radiation Levels (following 400 kW operation)**
 - ~14 gray/hr at 1.1 m six days after shutdown
 - Full power targets (2 MW operation) are expected to be ~ 70 gray/hr at 1.1 m

- Dose rates measured on Mercury Process Piping
SNS Radiation Measurements After Shutdown

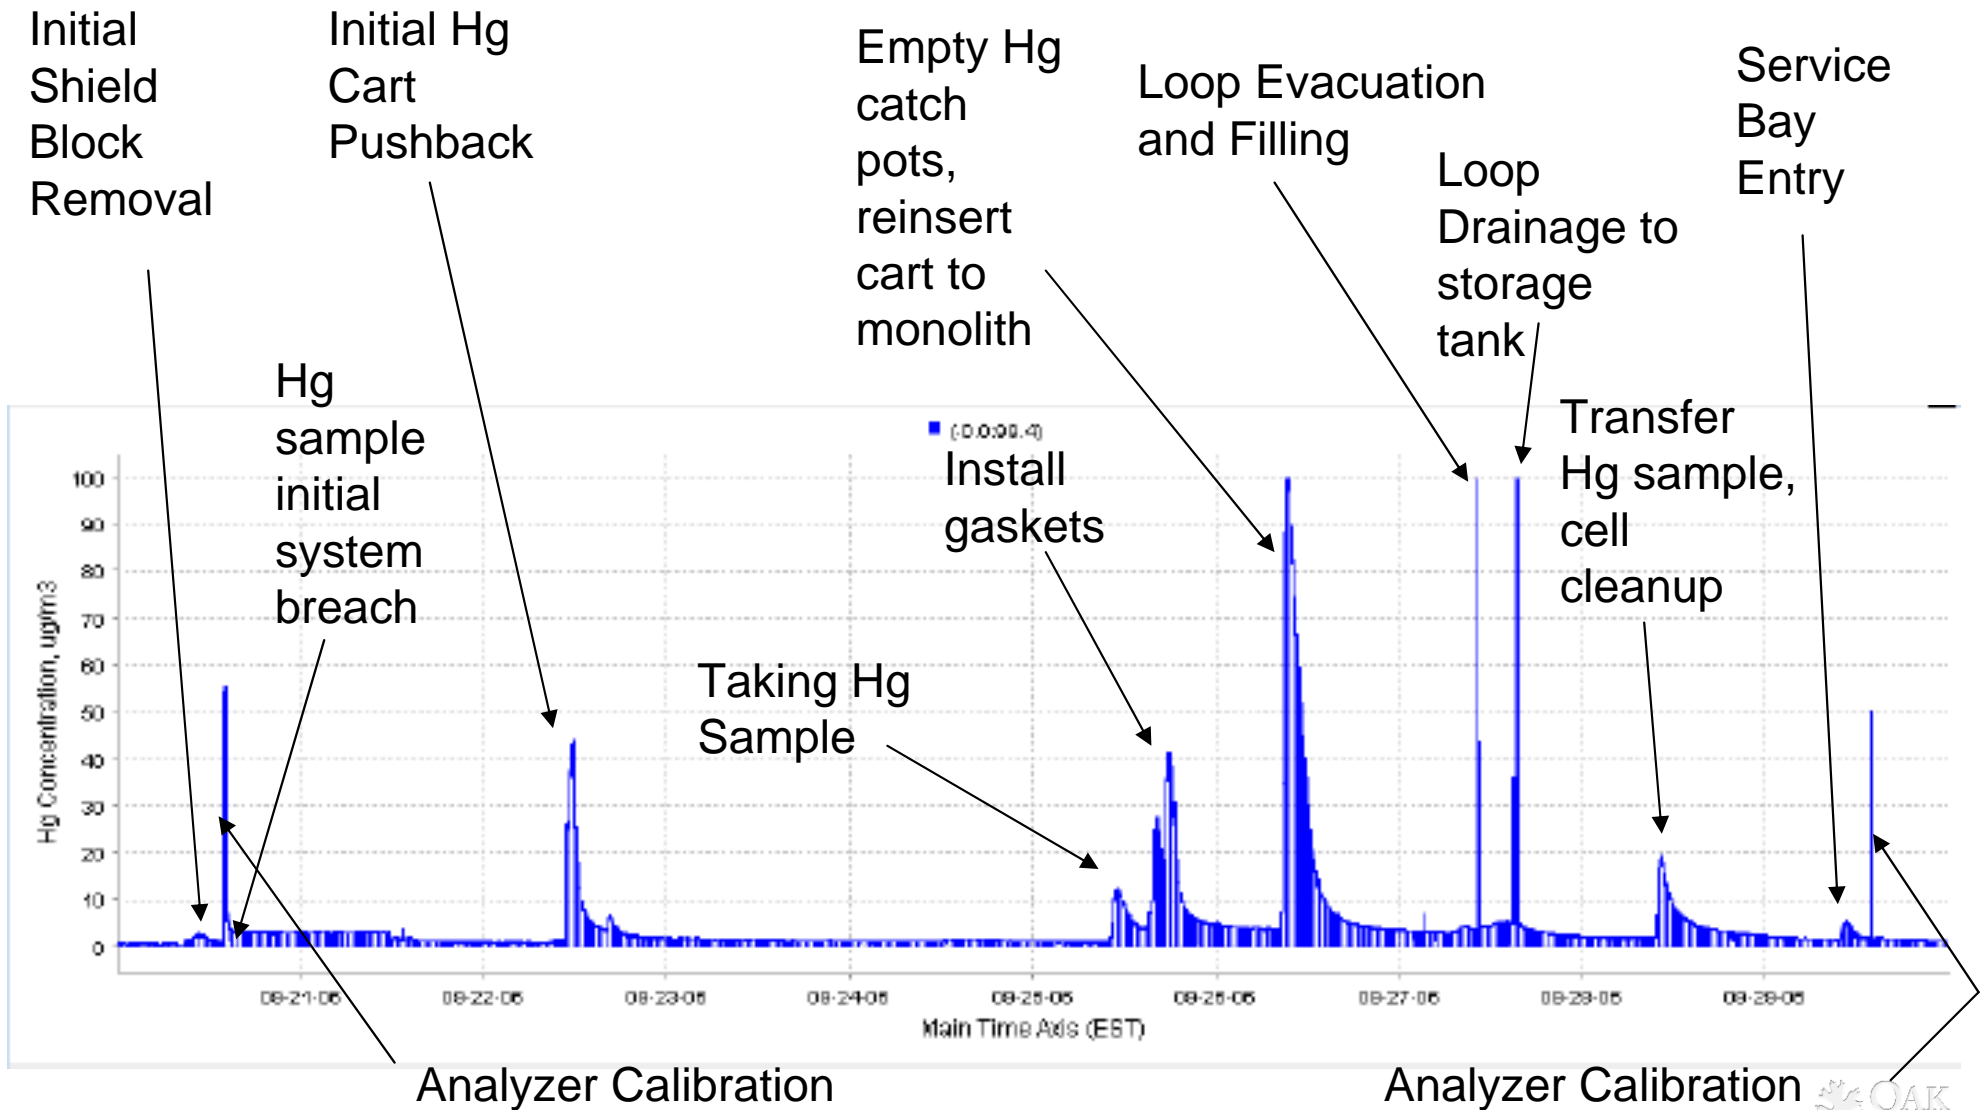
- Opening the mercury process lines results in an expected increase in mercury vapor in the Service Bay during replacement operations
- Once exposed to atmosphere, the mercury forms an oxide layer that mitigates vaporization until disturbed by vibration or movement
- The following charts depict the spikes seen in mercury vapor levels in the Service Bay (in micro-g/m³) during operations involving the mercury process system

September, 2006 Outage Hg Concentration

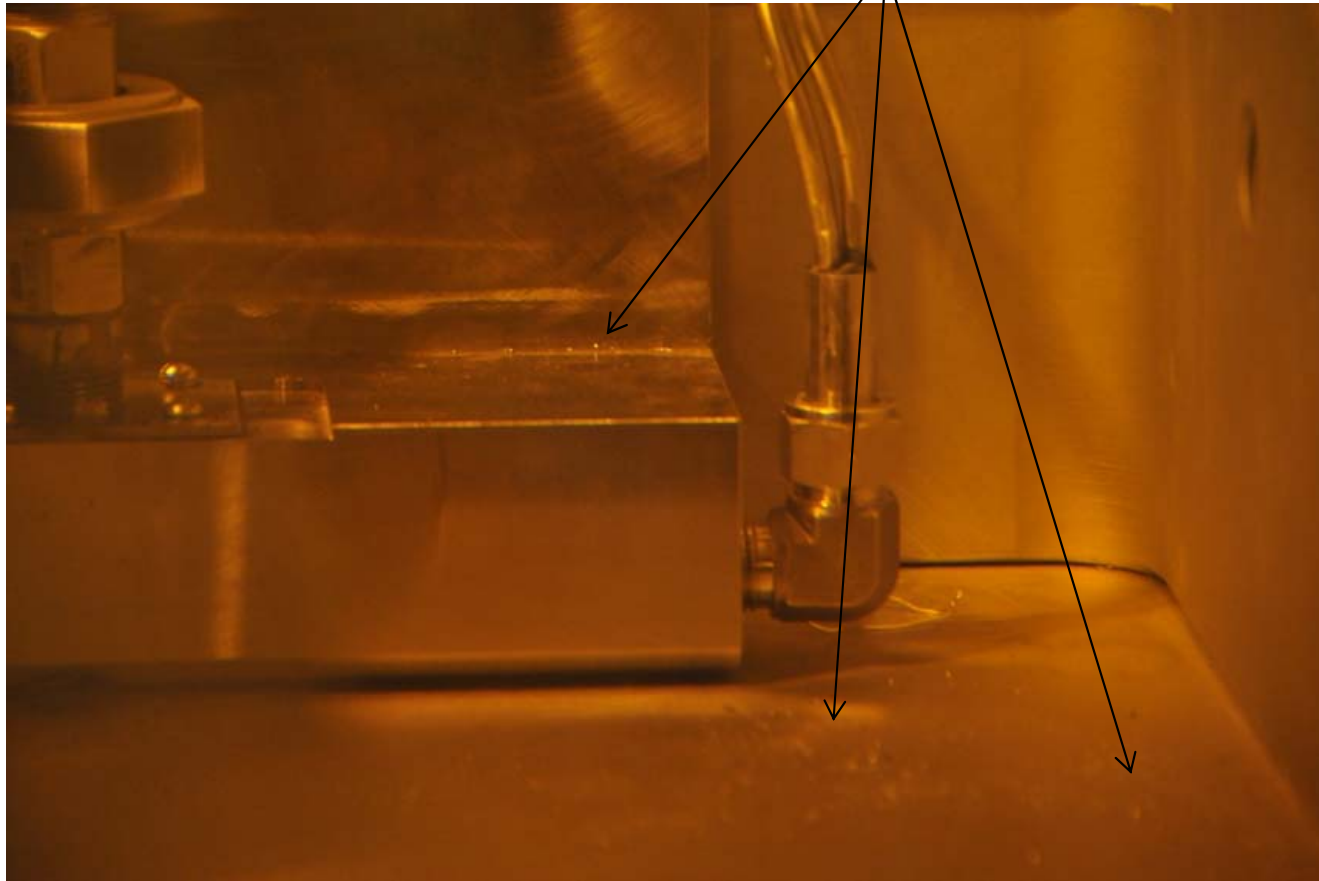
- The mercury vapor environment also leads to widespread condensation of mercury on surfaces within the Service Bay unrelated to the Target replacement operations

Mercury condensate on Target Cart surfaces

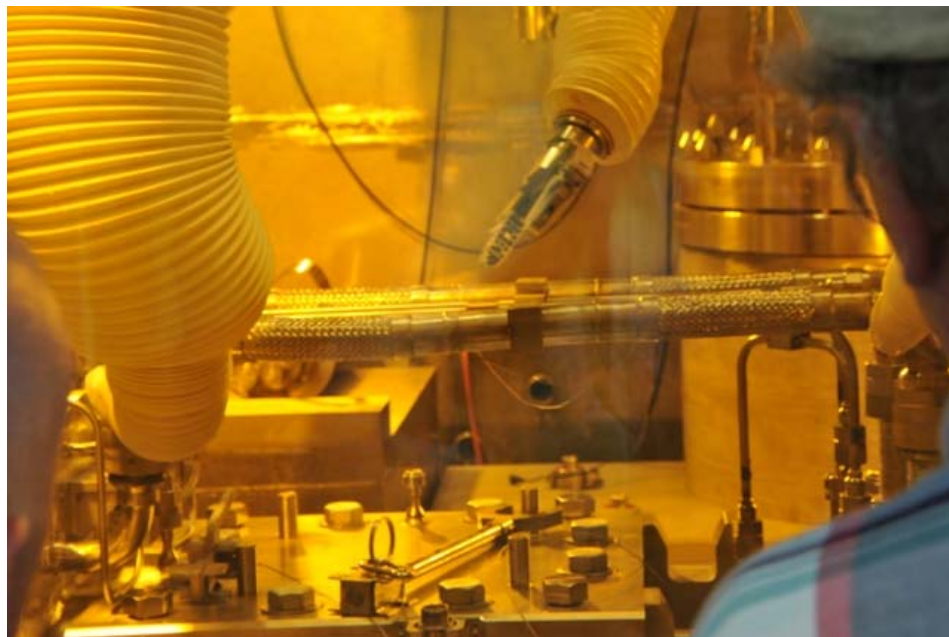
- Due to the lack of valving in the target process loop, change-out connections cannot be tested until the Target Cart is fully inserted. Additionally, access to many of the system connections are precluded due to full insertion of the Cart.
- Four target systems are potentially impacted:
 - Mercury loop
 - Coolant water loop
 - Target Seal Helium pressure
 - Target Seal Vacuum

**Coolant Loop Jumper Removal
using the servo-manipulator and
master-slave manipulators
simultaneously**

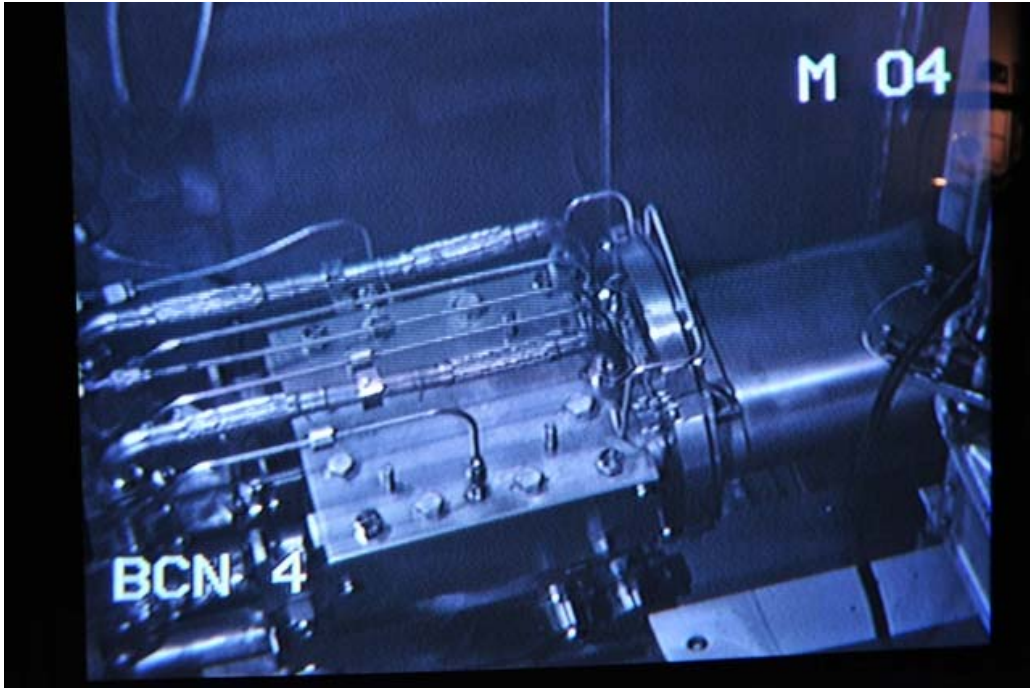
- Mercury loop integrity testing is accomplished using a vacuum leak test when the system is fully assembled (target cart fully inserted)
 - Initial vacuum testing indicated a substantial leak
- Leak detection activities were impacted as only three of the five mercury process loop connections are accessible with the Target inserted. Retraction of the Target to access the remaining two connections precluded testing due to the open process loop.
- Test fixtures and procedures were developed real-time to enable the leak to be identified. It was ultimately fixed by simply tightening a loose fitting.

Jumpers between Target and Target Cart

Target utility jumpers are tightly packed. This makes remote access to the fittings difficult.

- It took approximately 3 weeks to work through this problem. Many of the tools and procedures developed during that period will be used regularly in future replacements to avoid a repeat.
- Additional procedures will be developed to enable interim testing of the remaining three systems (water, helium and vacuum) to identify potential problems prior to insertion of the Target Cart.
 - These procedures add complexity, time and risk to the replacement process

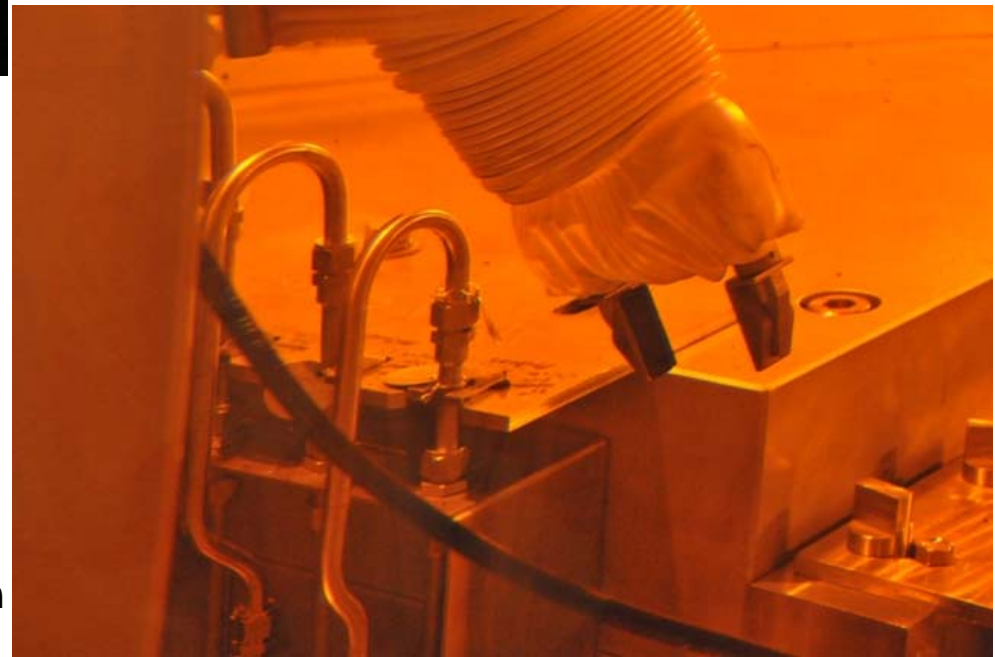
Re-connection of utilities between Target Cart and Facility

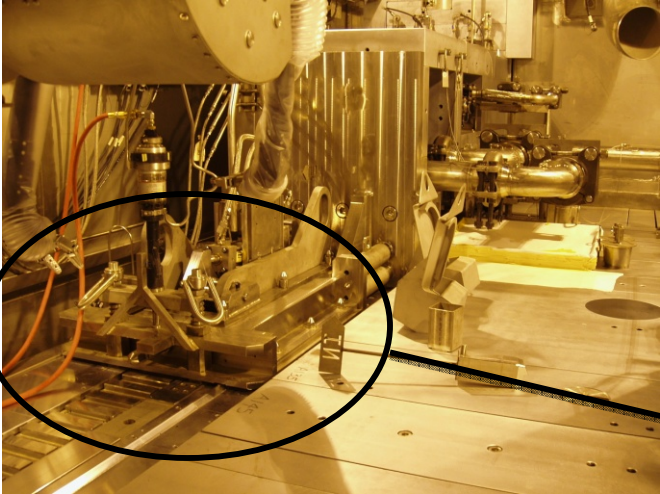
- The target cart is spring-loaded in the operating position to accommodate thermal expansion with an unnecessarily complex locking mechanism.
 - During Target Cart insertion, brake pins are inserted at the aft portion of the Cart and then heavily-preloaded springs act against the pins to maintain a preload on the Cart
 - Subsequent retraction of the pins requires removal of this preload
 - During remote operations it was very difficult for the operators to assess the point at which the preload had been removed prior to retracting the brake pins
 - The initial pin retraction attempt resulted in deformation of the portion of the structure that applies force to retract the brake pins

Locking Mechanism at Aft End Of Target Cart

Brake pin preload/insertion mechanism

Brake pins

- The mechanism remains functional but the damage has resulted in further difficulties in ensuring proper pin engagement
- This issue highlights the need to design remotely-operated hardware in such a way to ensure robustness and mitigate technician judgment

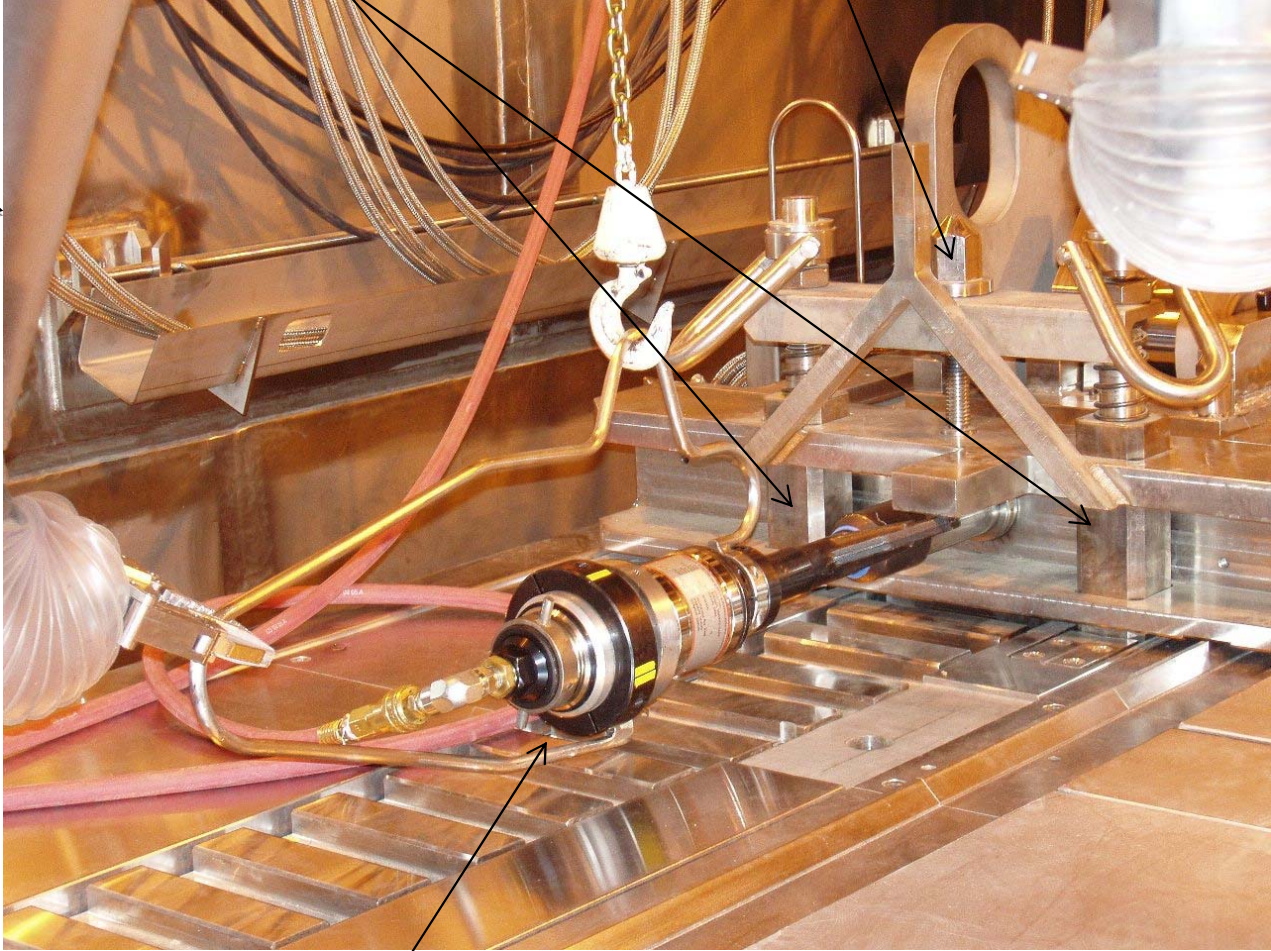
Using pneumatic wrench to preload springs

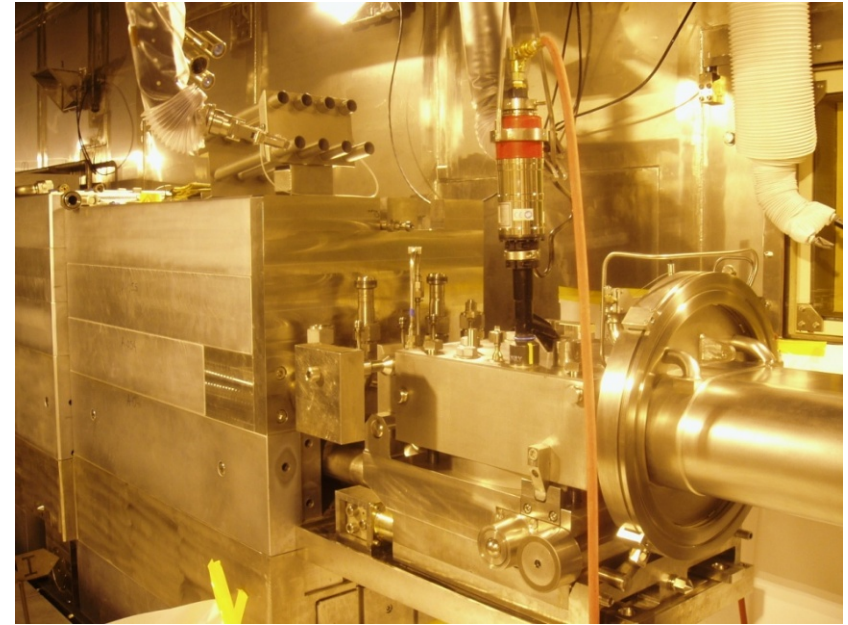
- Proper torquing is important for many target related connections; this proved to be more difficult than the cold mockup tests indicated.
- Pipe and tubing jumpers are generally tightened with manual wrenches. It was found that ensuring the correct torque application for threaded connections was difficult due to the design of the manual torque wrenches.
- The target tie-down bolts were torqued with sophisticated pneumatic motor driven tools with the capability of remote torque and speed adjustment. While functionally these have operated very well lubrication has proven to be more difficult than planned...

Torquing of Target Bolts

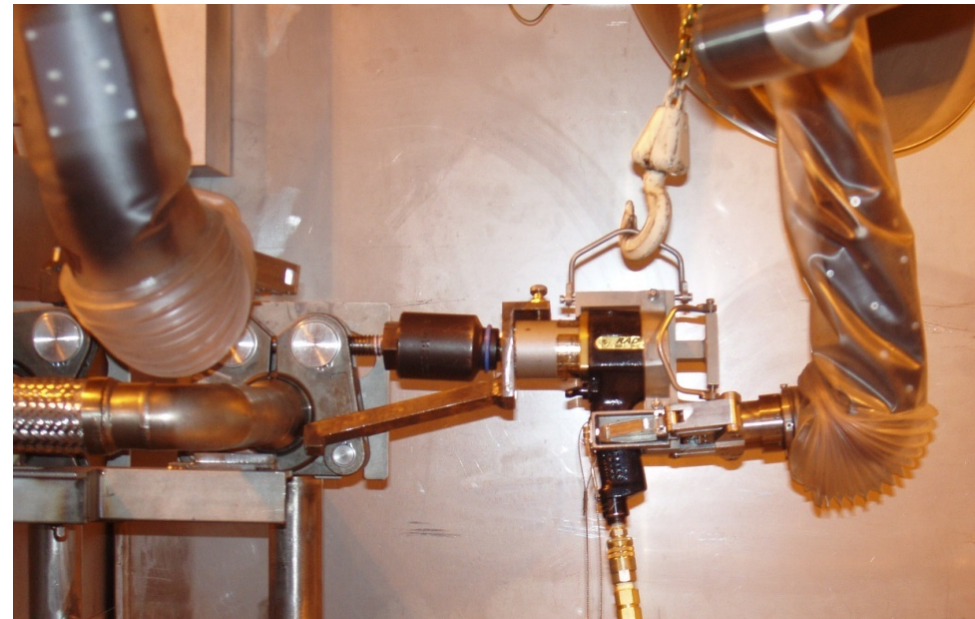
Torquing of Coolant Line Flange

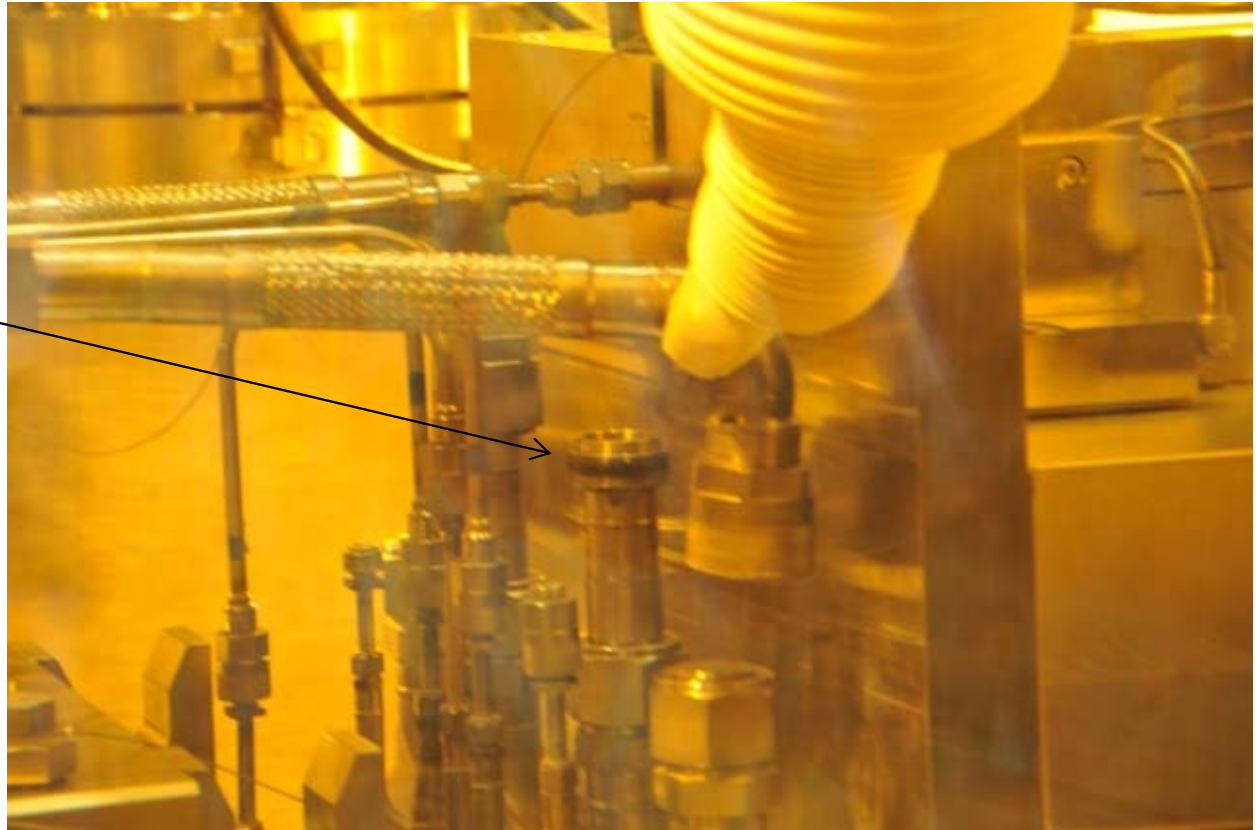
- Stainless steel fittings and fasteners are used extensively through out the process. While galling has not been a problem to date the extreme consequences make it an ever present threat during remote operations.
- One of the single-bolt Grayloc connectors galled during pre-ops testing. This lead to a policy of regularly using anti-seize on threads considered to be vulnerable.
- A means of remotely applying anti-seize on threads is currently being developed.

**Anti-seize visible
on threads**

Removal of Coolant Line Jumper
