MEGAPIE – unexpected behaviors and findings during operation and dismantling

*Michael Wohlmuther, Werner Wagner
on behalf of the MEGAPIE team @PSI and MEGAPIE project*

Paul Scherrer Institut, Switzerland

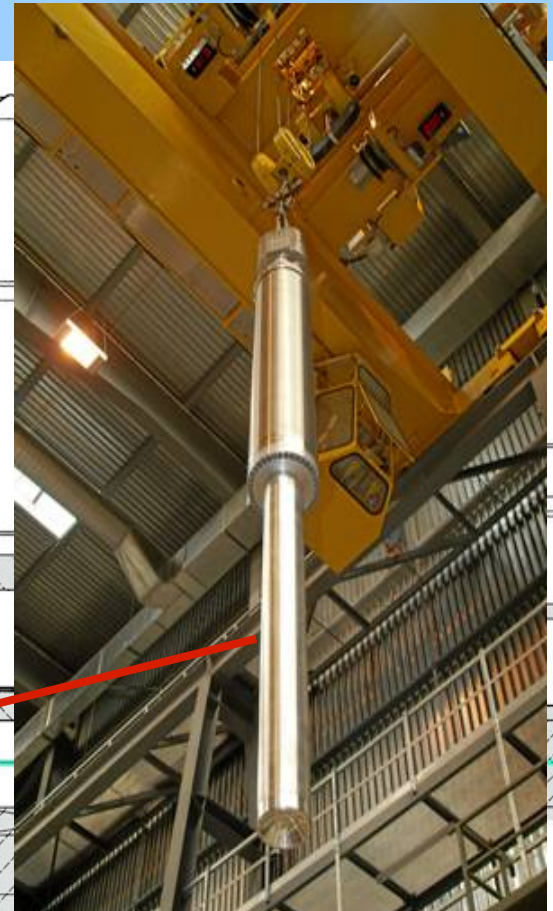
MEGAPIE target

**Proton beam on
SINQ:**
590 MeV / 51 MHz
p-Current: 1,5 mA
Power: 0.9 MW

**SINQ
Target
Station**

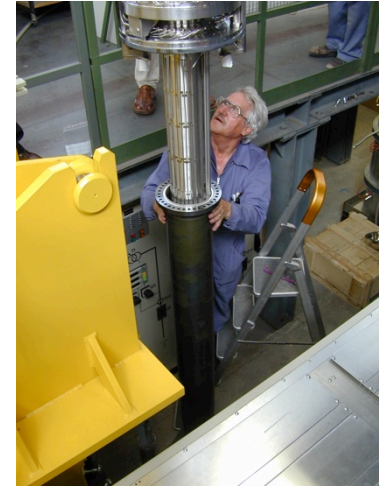
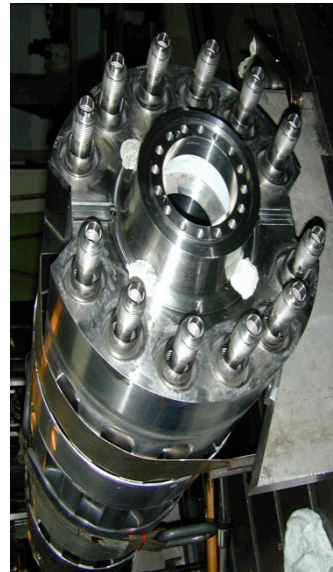
MEGAPIE target features

lower target assembly

target head

central flow guide tube

heat exchanger

safety shroud

beam window with leak detector

electro-magnetic pumps

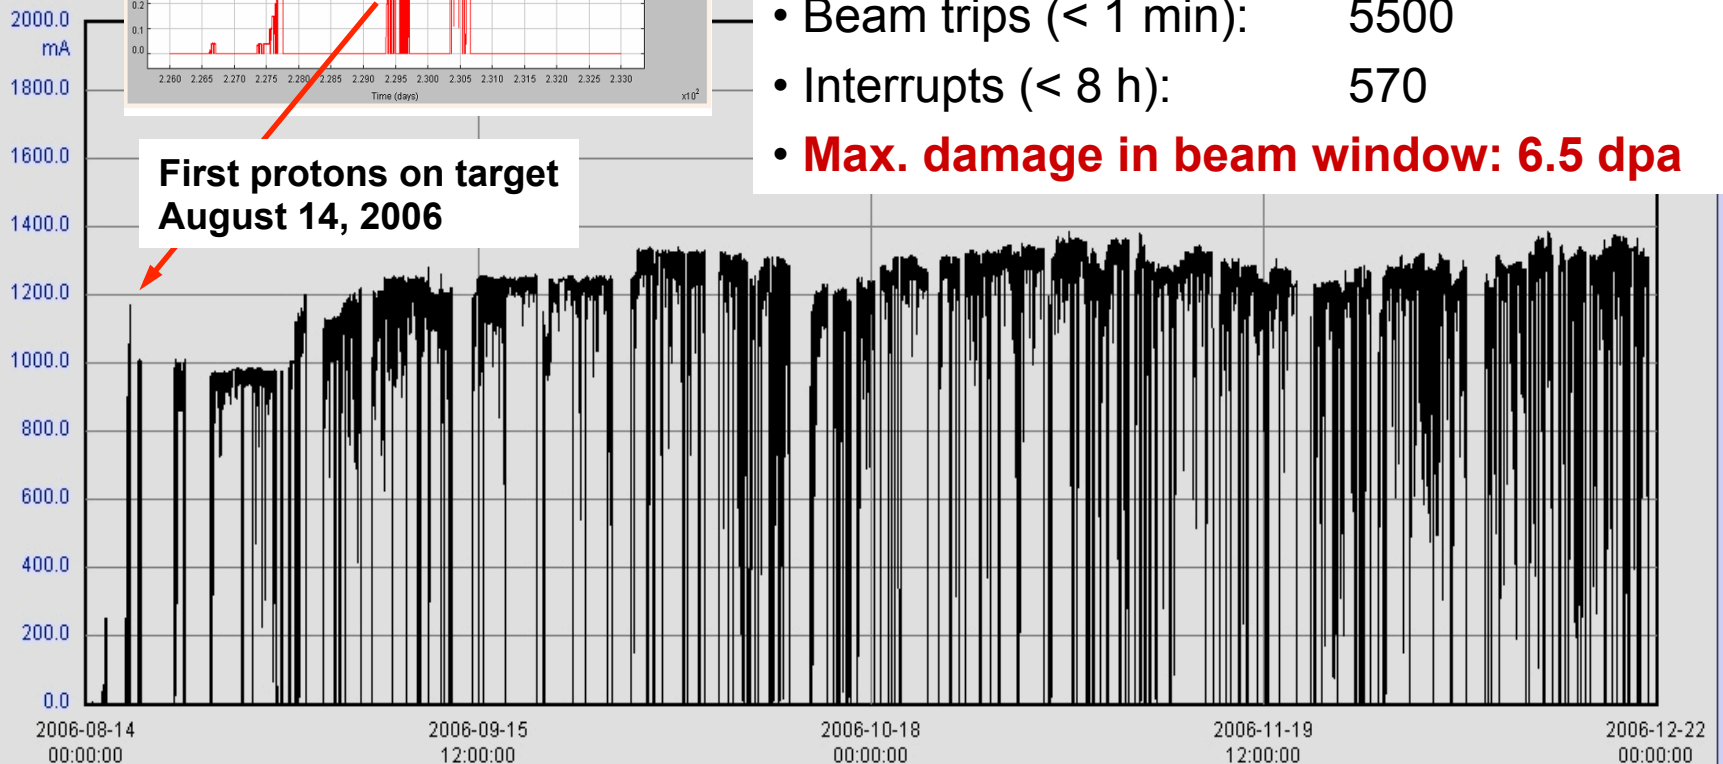
On beam: August 14 – December 21, 2006

- Accumulated charge: 2.8 Ah
- Peak Current: 1400 μ A
- Beam trips (< 1 min): 5500
- Interrupts (< 8 h): 570
- **Max. damage in beam window: 6.5 dpa**

❖ Operation „smoothly“:
System behaviour, e.g.
 temperatures and –transients
 as expected

❖ **EMPs** without indication for
 degradation

❖ Measured neutron **flux**
increase of roughly **~80 %** to
 Target 6 (operated before
 MEGAPIE)

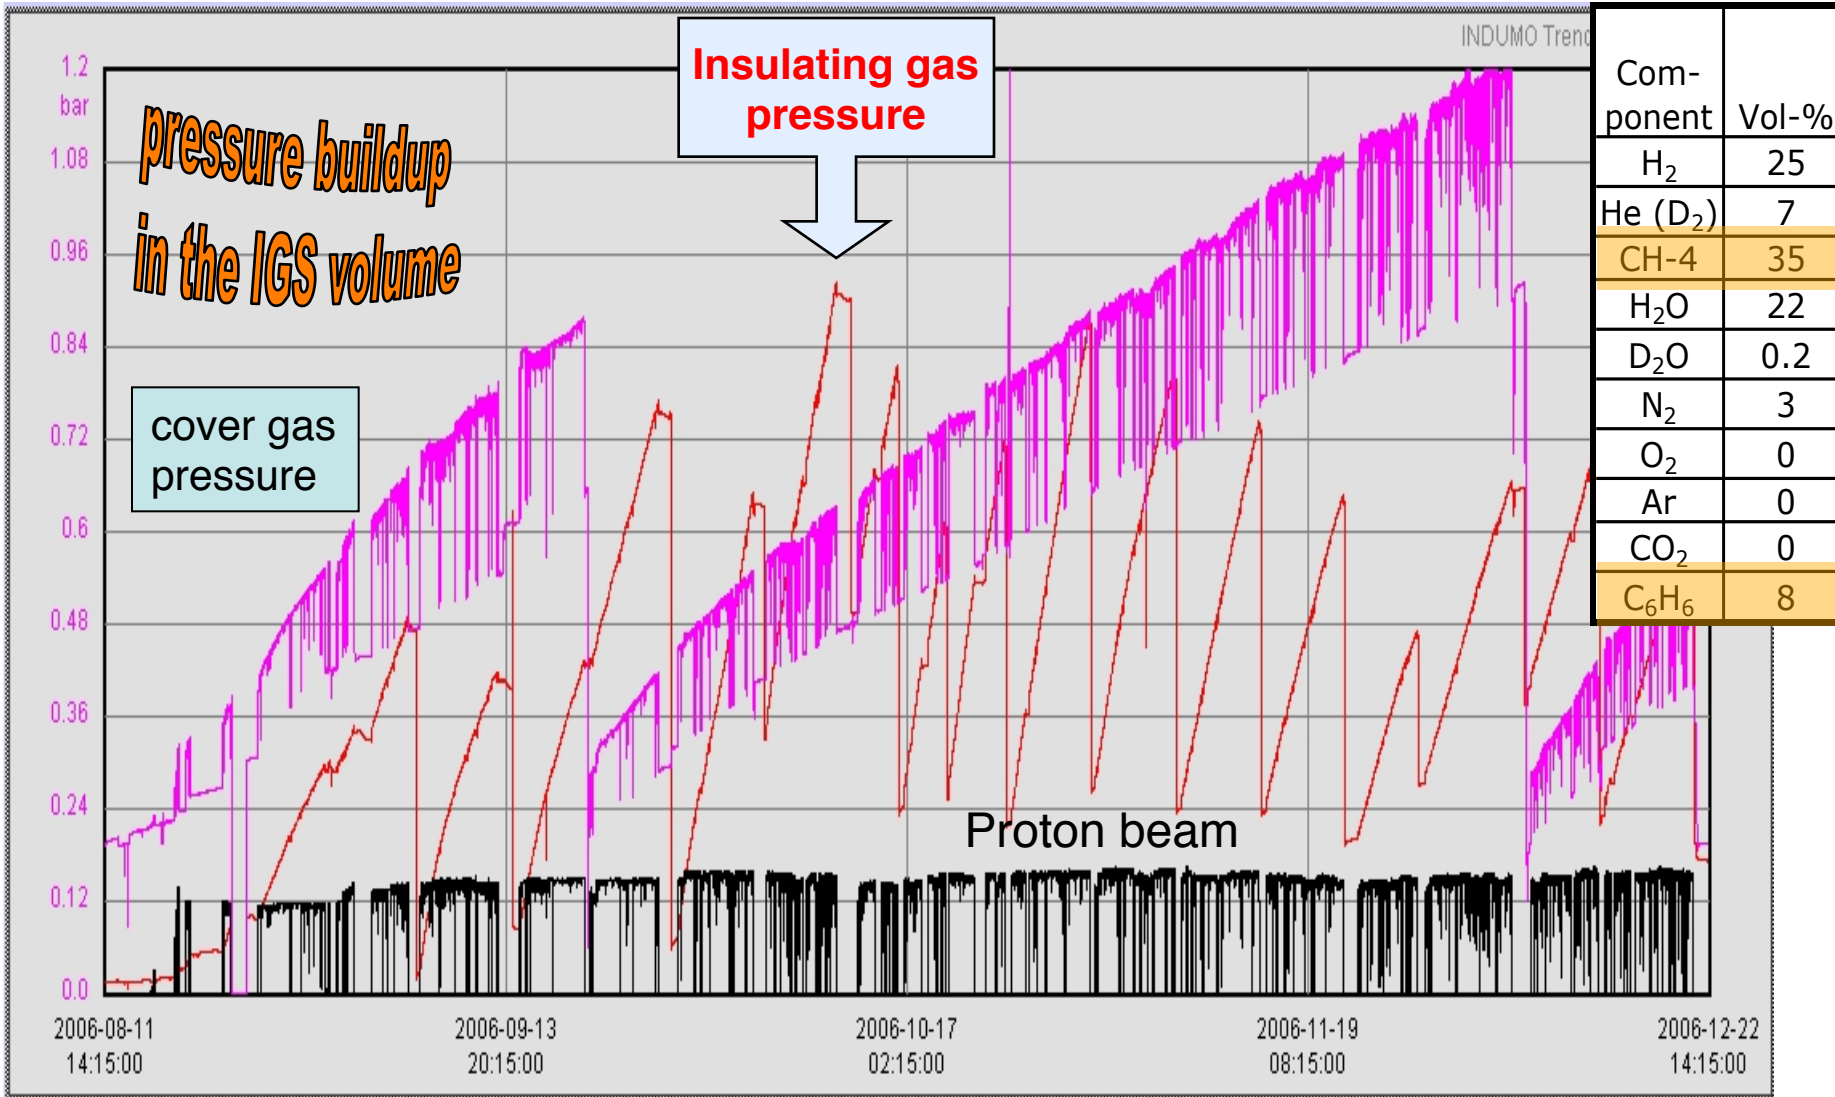
Cover gas & Insulating Gas Pressures during Irradiation

IGS: insulation gas volume

Problem:

continuous pressure increase by ~ 5 mbar/h

..slightly *contaminated* by (radioactive) covergas

- *decay period* and *gas sampling* required before venting

Remedial actions:

installation of 180 l *decay vessels* in cooling plant

regular (*weekly*) *venting* into the exhaust system

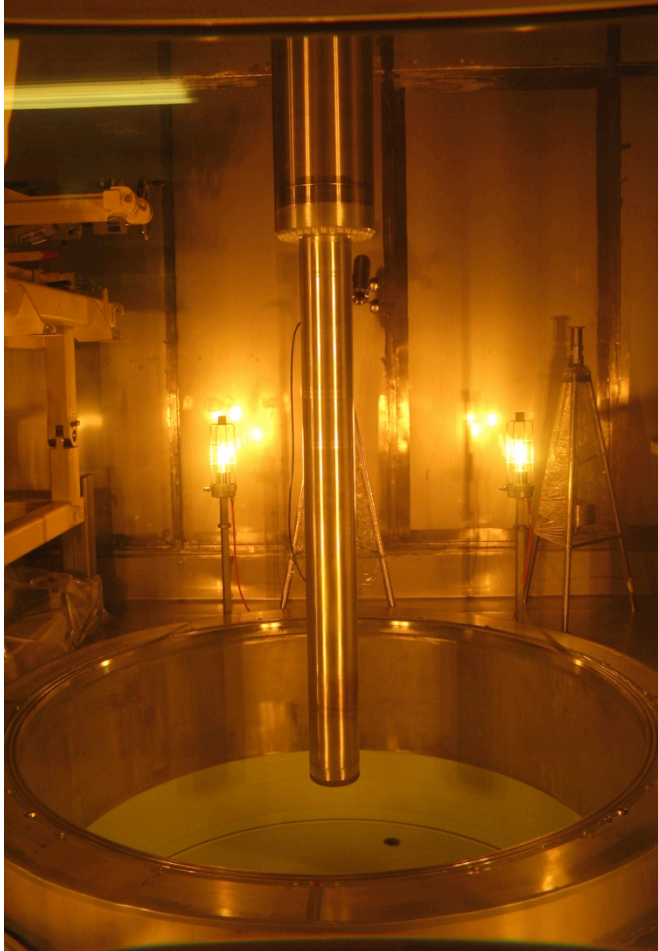
Lifting the target into the Hot Cell (HC)

- TC1 docked to HC from below
- The MEGAPIE target was lifted by the crane of the hot cell
- **First visual inspection** by rotating the target: No special findings; slight stain in high neutron flux region.
- **Next step:** The Lower Target Enclosure (Aluminum Safety shroud, LTE) was unscrewed.

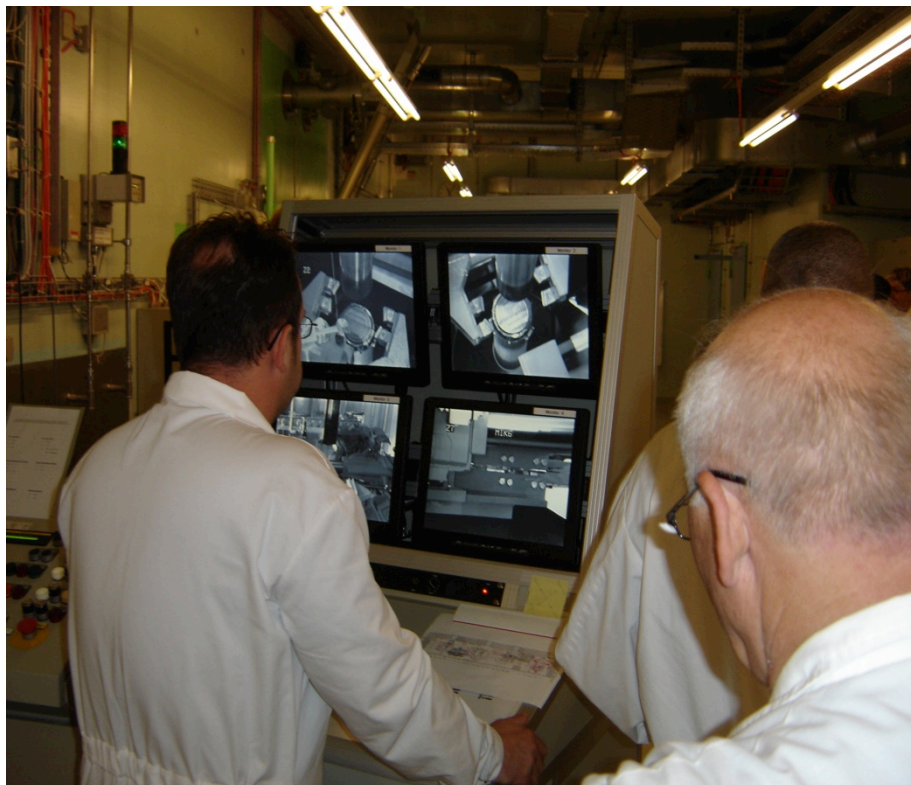
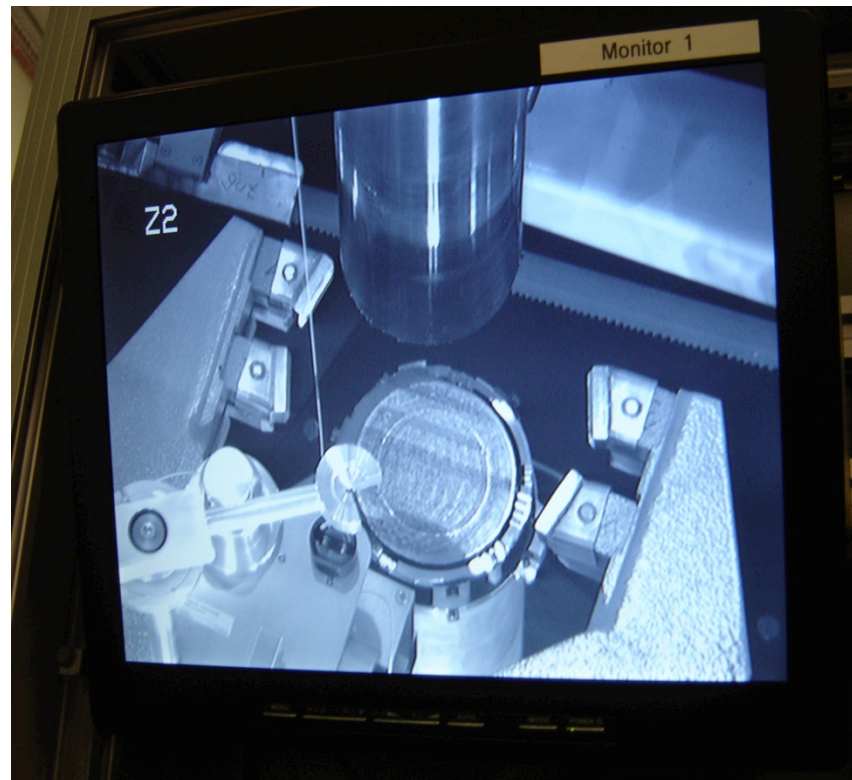
The first cut of the LLMC, July 15th 2009

The first cut removed the **Beam Entrance Window**

- **Each piece** cut from the target was held **in a special steel basket**, which could be moved with a special lifting devices.
- After each cut the piece was **cleaned using a vacuum cleaner** and subsequently lifted to an interim parking position using the power manipulator of ZWILAG hot cell.
- The cutting of the LLMC could be done with a **single saw blade**. No degradation was observed.

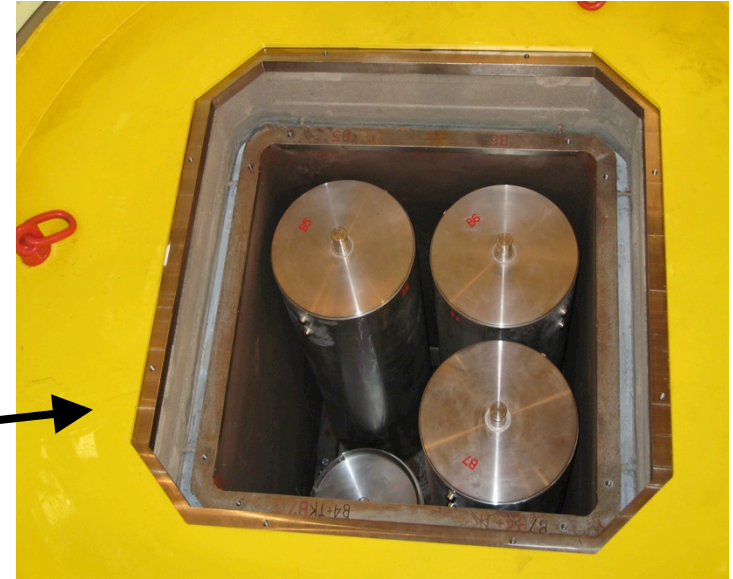
TC2

- All waste pieces were packed into the so-called “primary containers”, made from steel.
- The whole hot cell was cleaned with a vacuum cleaner. The collected flakes were as well put into one of the “primary containers”.
- The containers were closed and welded.
- ..and placed into a reinforced standard PSI waste container – TC2.
- This container has been prepared for disposal in a final repository by filling it with concrete.

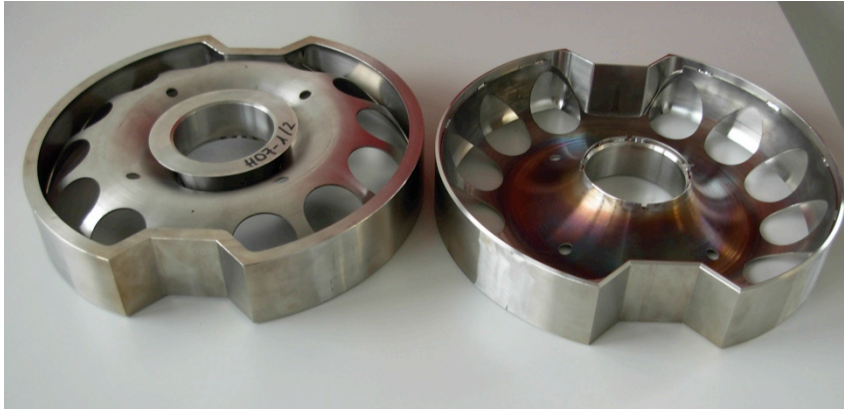
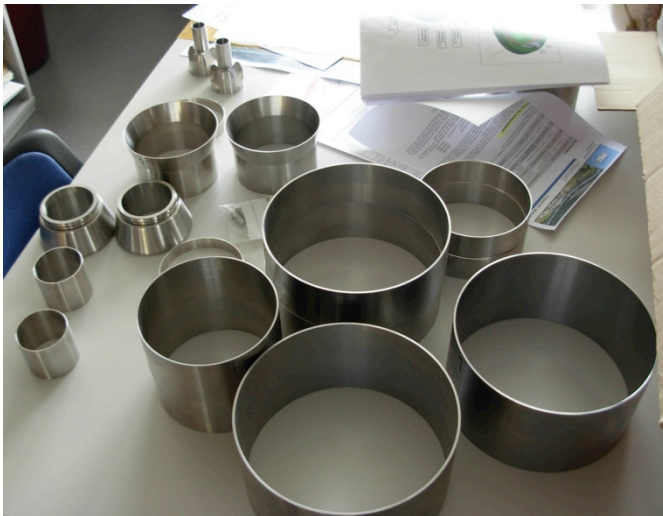
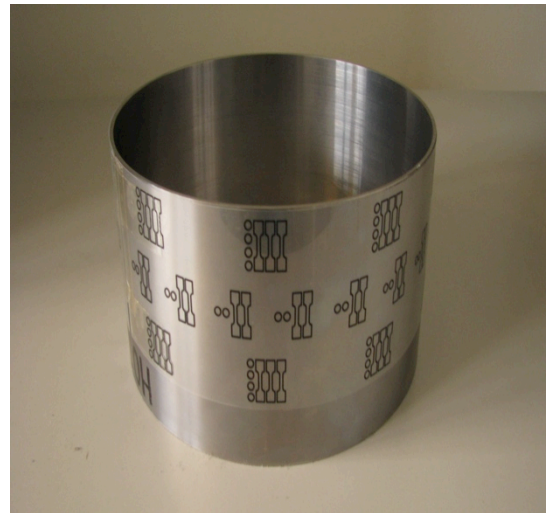
- 1:1 mock-ups of all sample types have been manufactured with original materials and dimensions.
- Groups of samples will first be 'raw-cut' using a diamond disk
- ..and 'fine-cut' by diamond blade saw for samples with LBE (Type 1)
- ..or wire-cut with an EDM machine for tensile and TEM samples (*not allowing LBE contamination*)

Type 1

Type 2

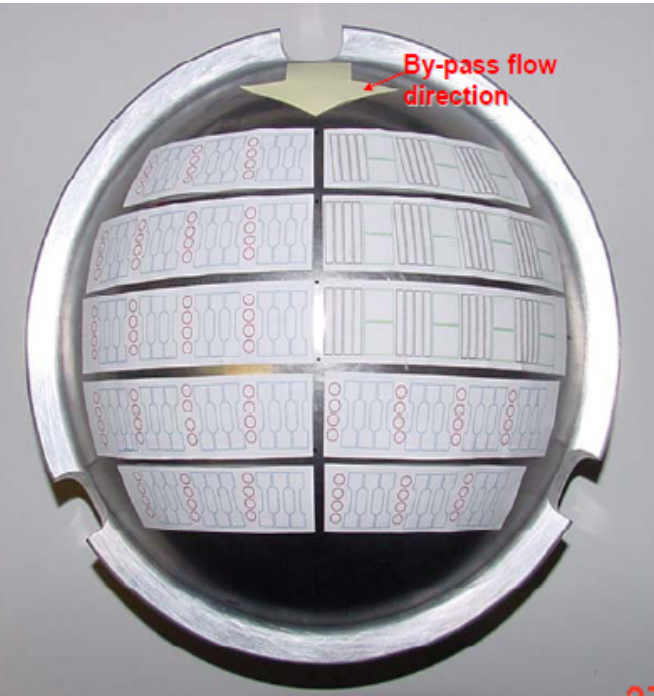
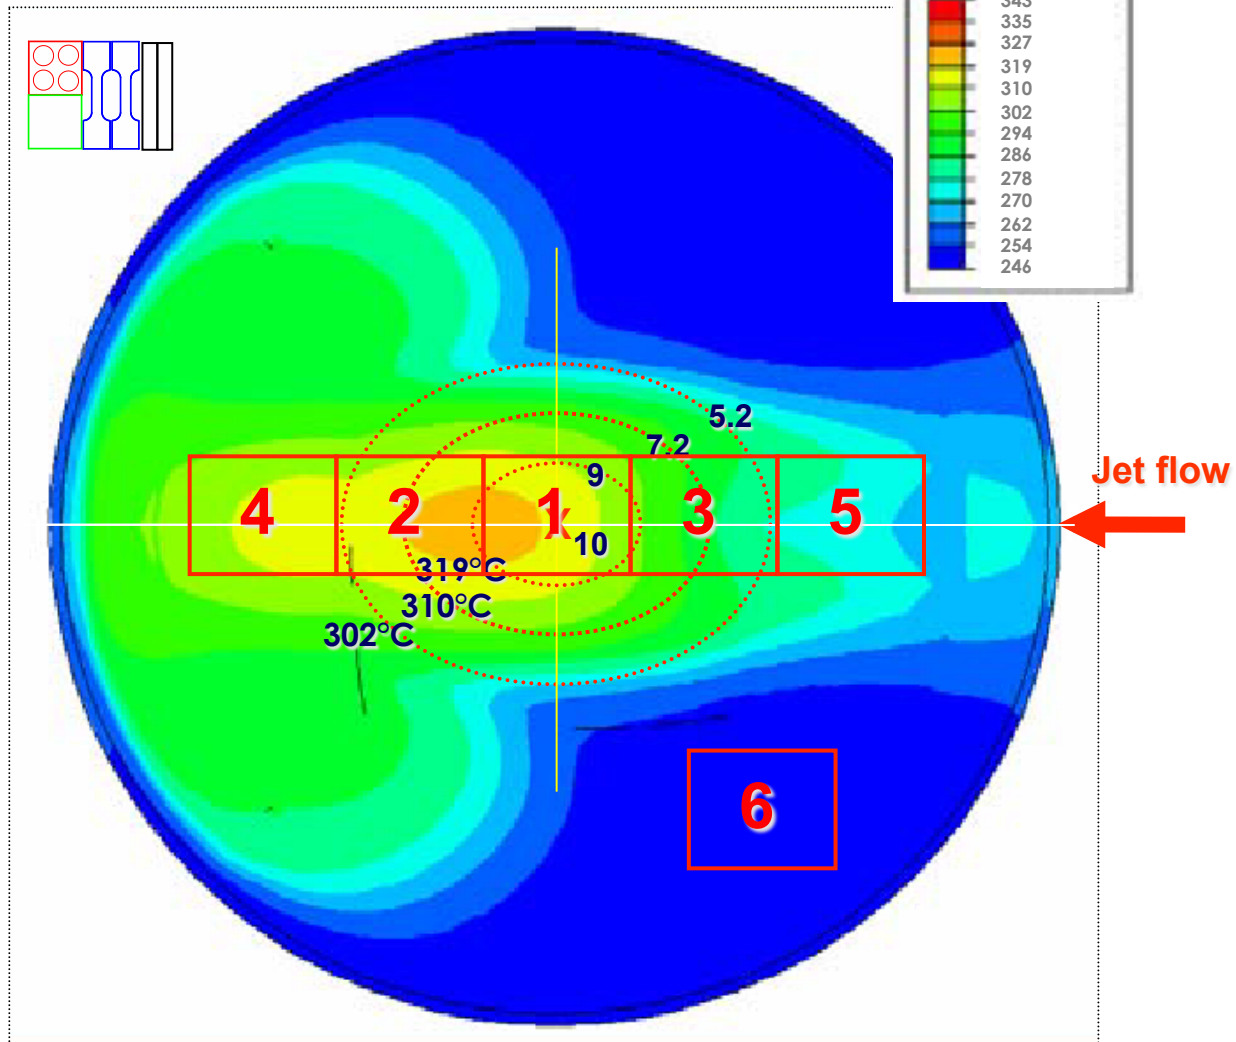
Cutting plan for the beam entrance window (Yong Dai)

$I_0 = 1.4\text{mA}$ Inner surface

6 conditions (or more):

- 1: highest dpa & T
- 2: high T, medium dpa
- 3: medium dpa & T
- 4: low dpa, medium T
- 5: low dpa & T, high flow
- 6: low dpa, T & flow
