Hg System Assembly and Testing Status

MERIT VRVS Meeting

Oct 25, 2006

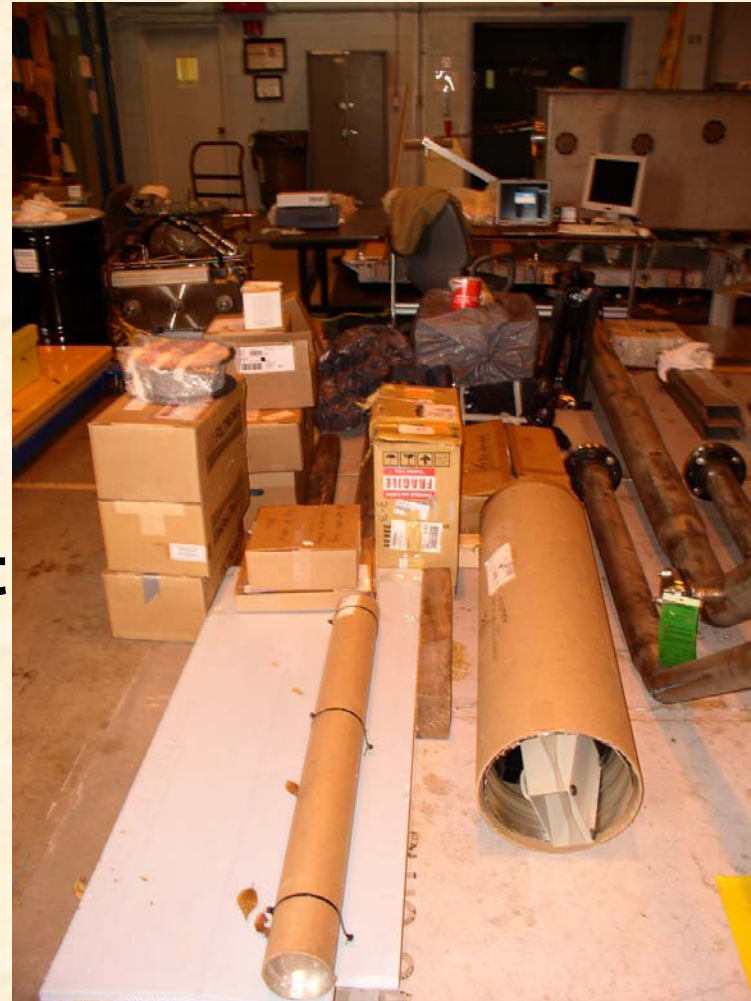
Equipment Arrived Oct 23

- **No damage noted during unpacking process**
- **Many small boxes, especially for optical diagnostics equipment**
 - **More efficient packing scheme needed for MIT/CERN transport**

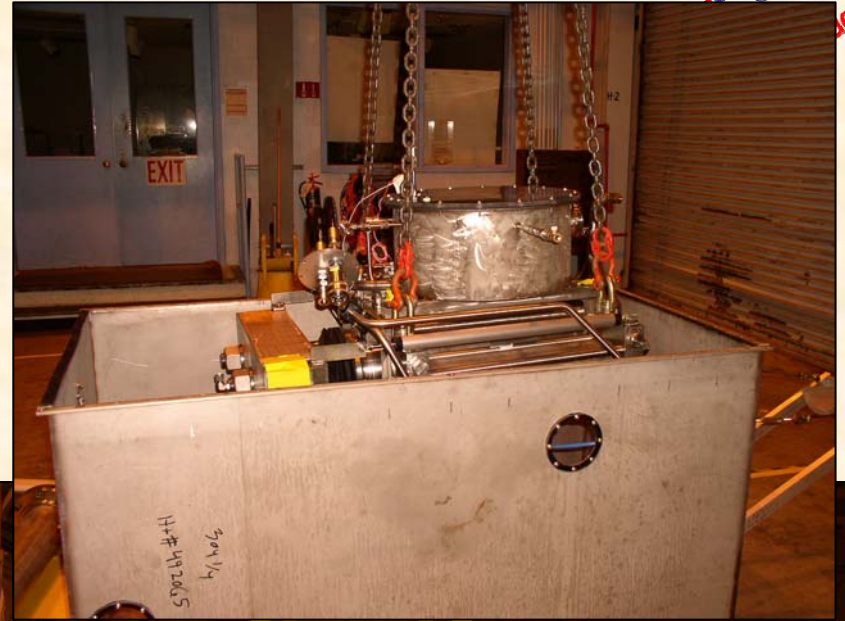
Preparations for Assembly

- **Welding must be performed on secondary and cart components**
- **Needed center of gravity to correctly place fork truck channels**
- **Actual CG was about 5" from estimate**
 - **Necessitates minor modifications to cart and baseplate**

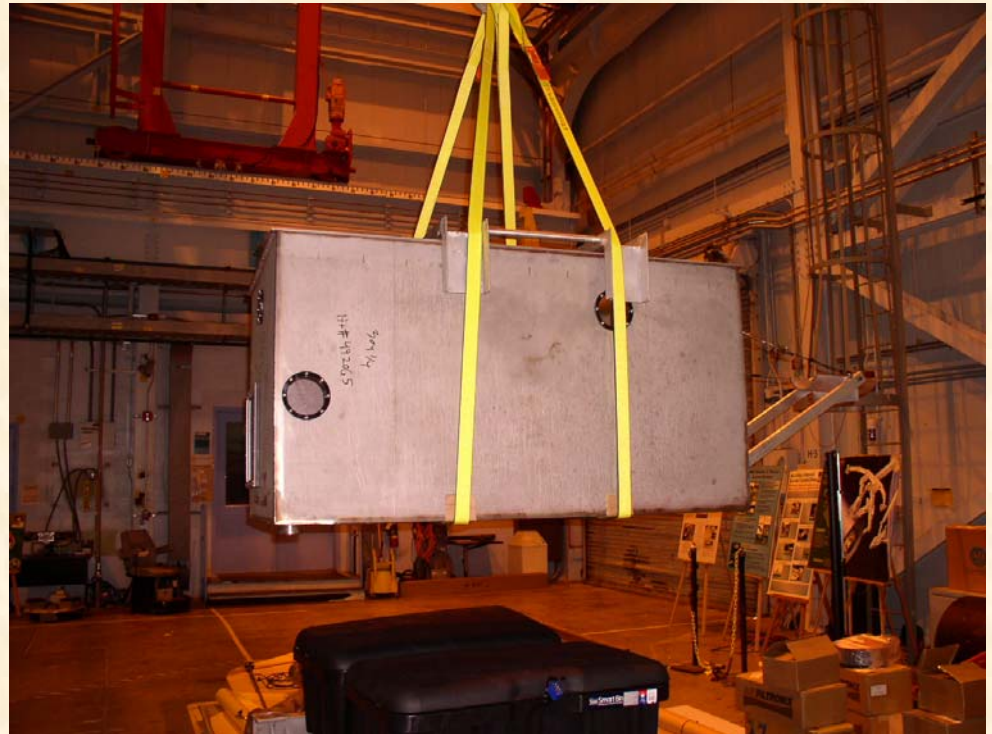
Actual Component Weights

- **Baseplate – 800 lbs**
- **Empty secondary box – 1000 lbs**
- **Syringe & sump assembly (empty sump, full drive cylinders) – 2000 lbs**
- **Secondary box, syringe assy, target snout – 3000 lbs**
