# BESIII RPC Aging Study

Changguo Lu  
Princeton University  
Princeton, NJ, USA

# (1) Aging test on one new RPC prototype

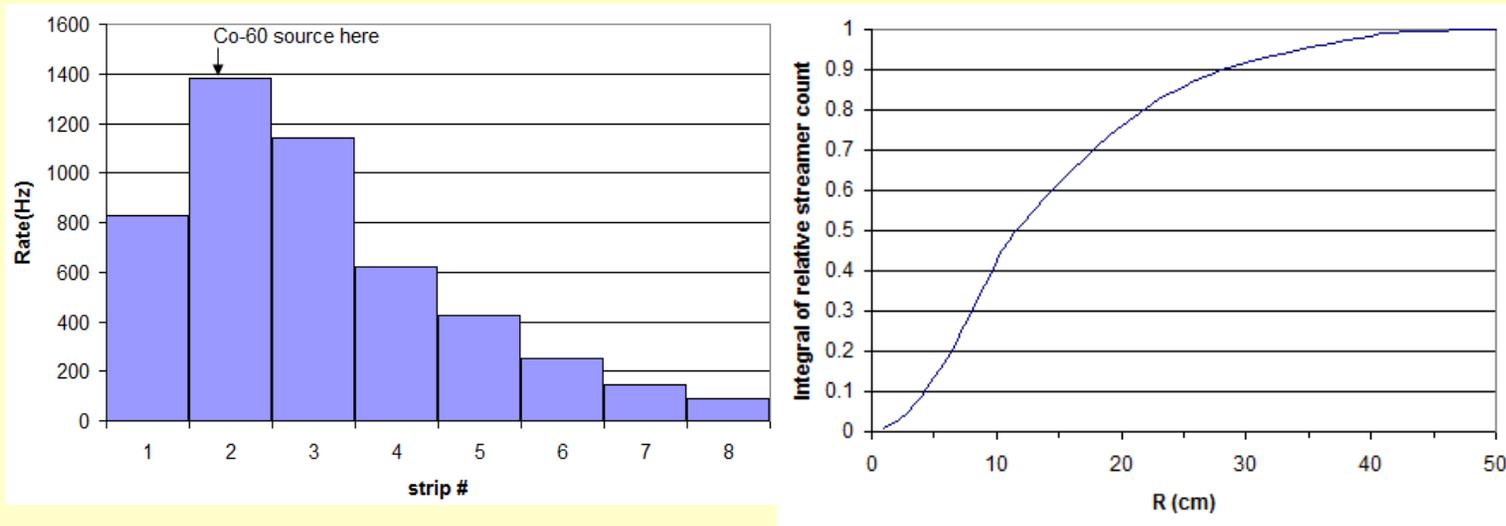
The measured streamer-rate distribution among 8 strips (6cm wide each) was surprisingly broad, did not resemble the gamma-ray distribution.

Due to the limitation of the streamer-mode RPC rate capability, this distribution does not reflect the  $\gamma$  ray intensity distribution. We use the measured rate distribution among the strips to simulate the streamer distribution in the RPC, then use this distribution to estimate the aging dose for the RPC. It indicates 40% of total dose is concentrated in a 10cm radius circle.

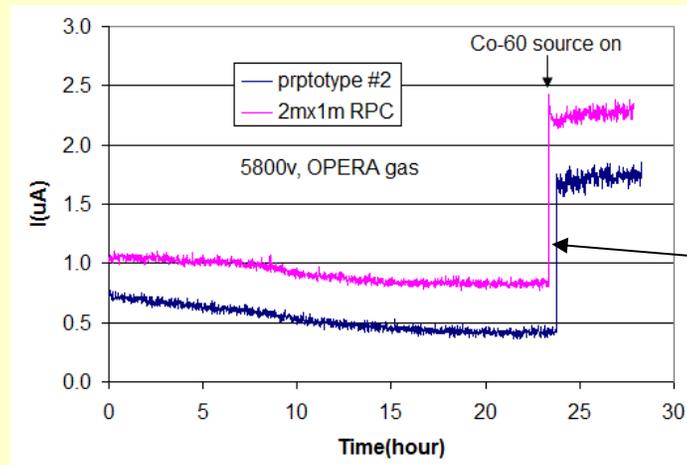
This jump is due to the source,  $1.3\mu\text{A} \times 40\% = 0.5\mu\text{A}$  concentrated on 10cm radius circle area.

The chamber currents, before aging, showed a jump of about  $dI \sim 1.3 \mu\text{A}$  when the Co-60 source was applied at hour 24.

$\sim 40\%$  of the streamers were concentrated in a circular region of radius  $R = 10\text{cm}$ . The current dose/area can be calculated:

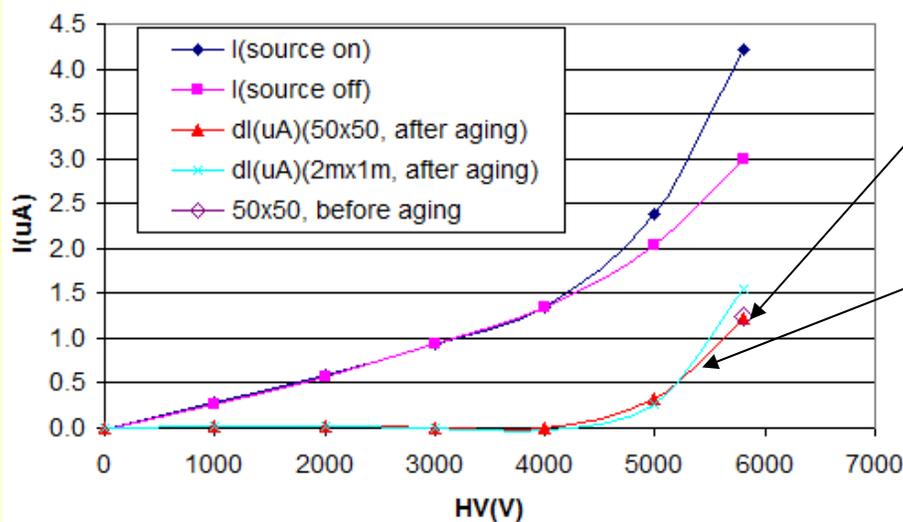
Aging chamber dark current at 5800V, w/ and w/o source.

There is no noticeable change after the first round aging test.

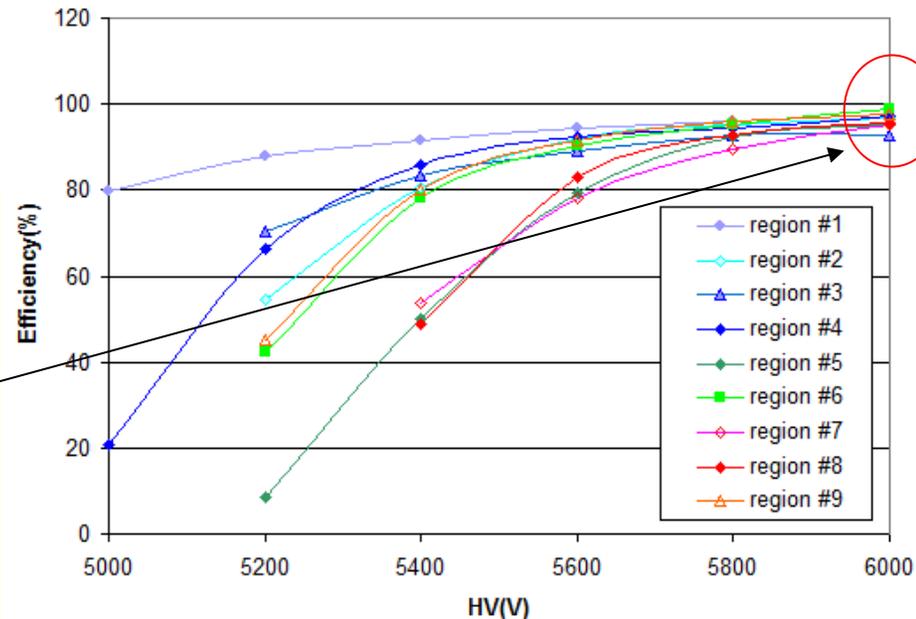
After 30 days aging, efficiency plateau curves of 9 regions.

Efficiency plateau starting points are quite different for different regions, but at 6000V all of them are above 90%.

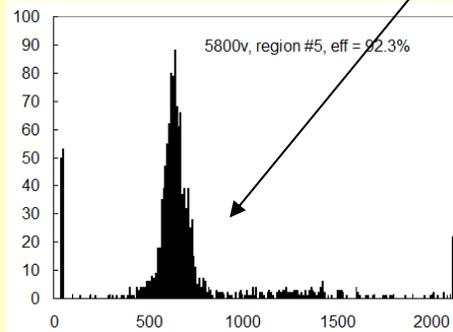
The other two spectra, triggered on the unradiated regions, show a narrow distribution, which is a typical streamer distribution.

We didn't record the peak spectrum before the aging, not sure if this is solely due to the aging, or may be just due to the bad region originally.

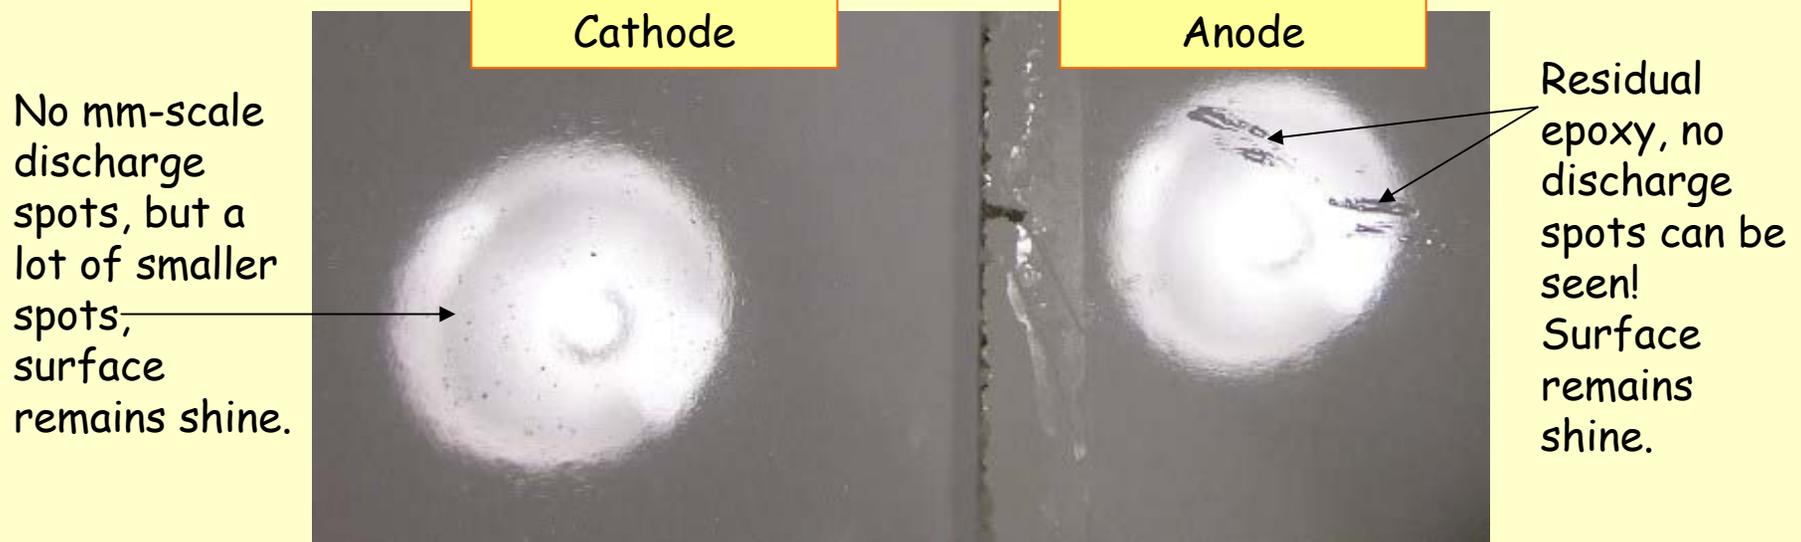
After 24 hours of training, we opened this chamber to search for the discharge spots on the anode electrode inner surface.

- (1) Any discharge spots on anode inner surface?
- (2) The luster looking on surface remains?

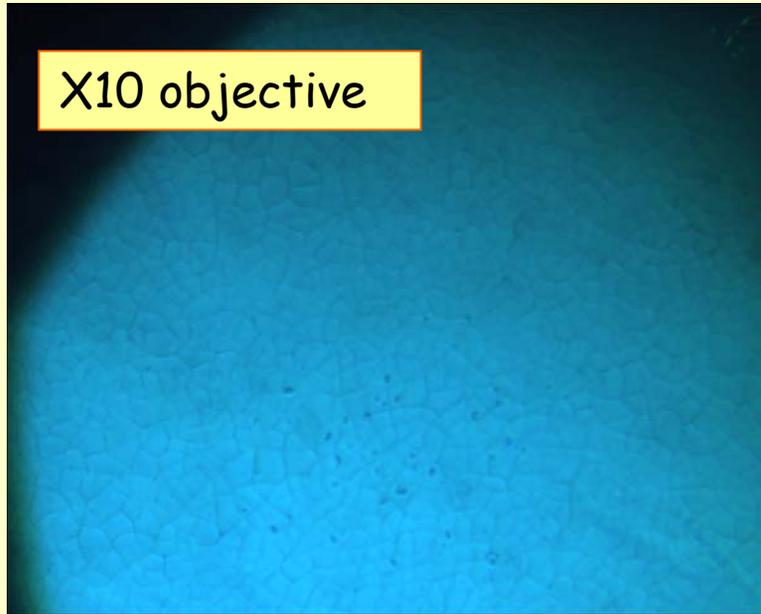
Most of the anode surface looks undamaged, it shows "skin" texture.

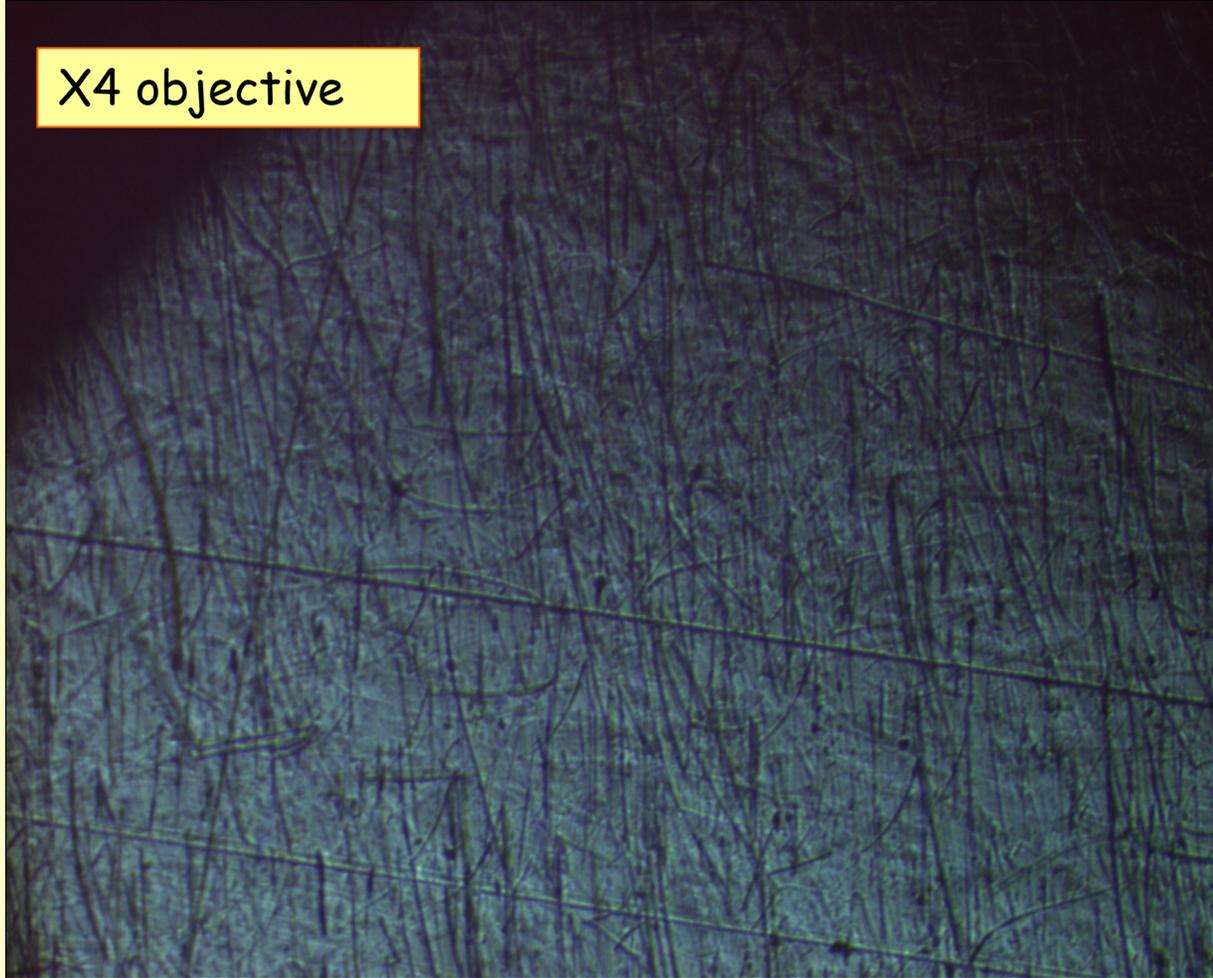
X4 objective

This is a sample from new CMS RPC Bakelite. Compare to BESIII Bakelite sample, much worse surface quality can be seen. There is no similar "skin" structure, which may be related to different material and production procedure.

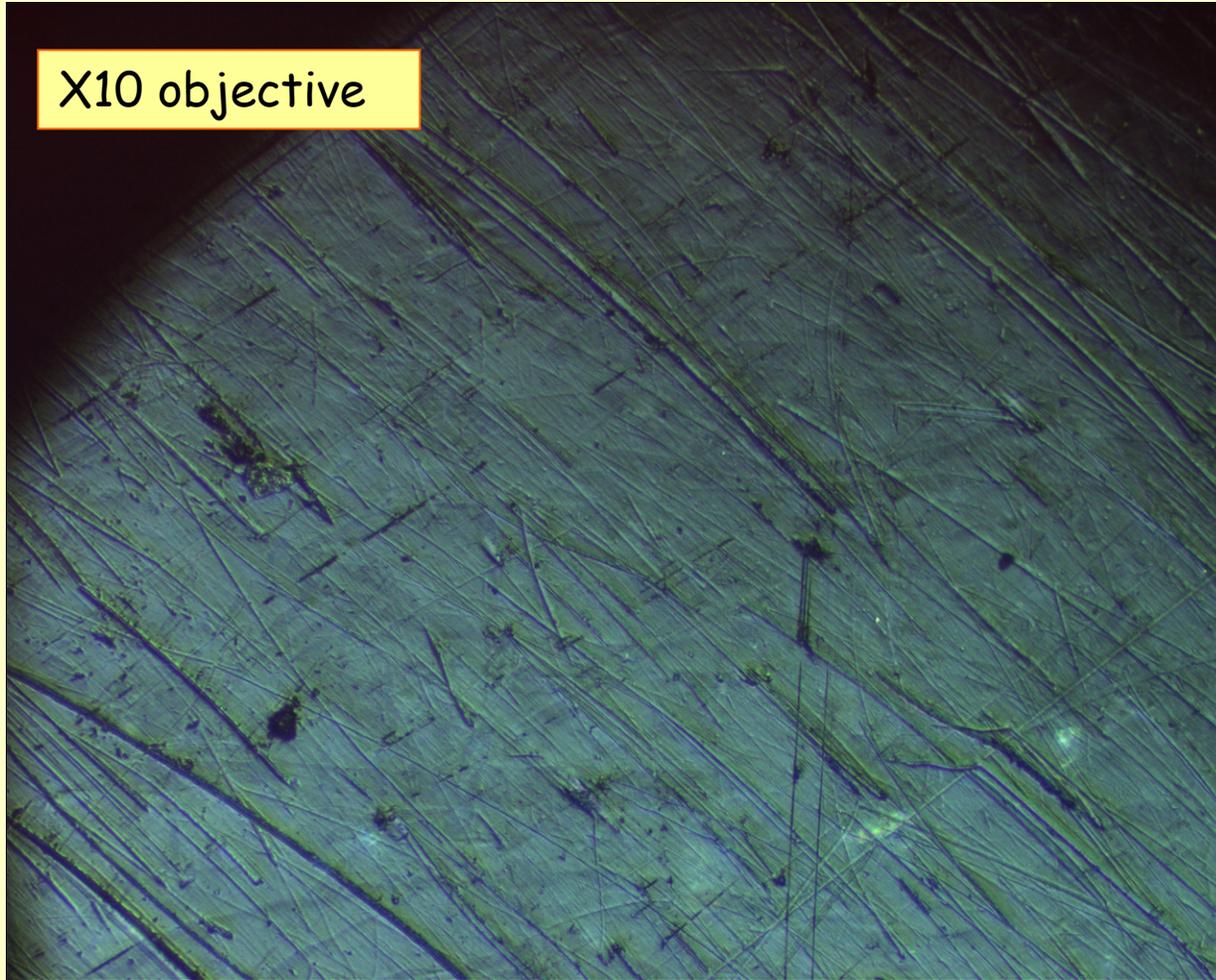
X10 objective

Larger magnification still does not reveal "skin" type structure.

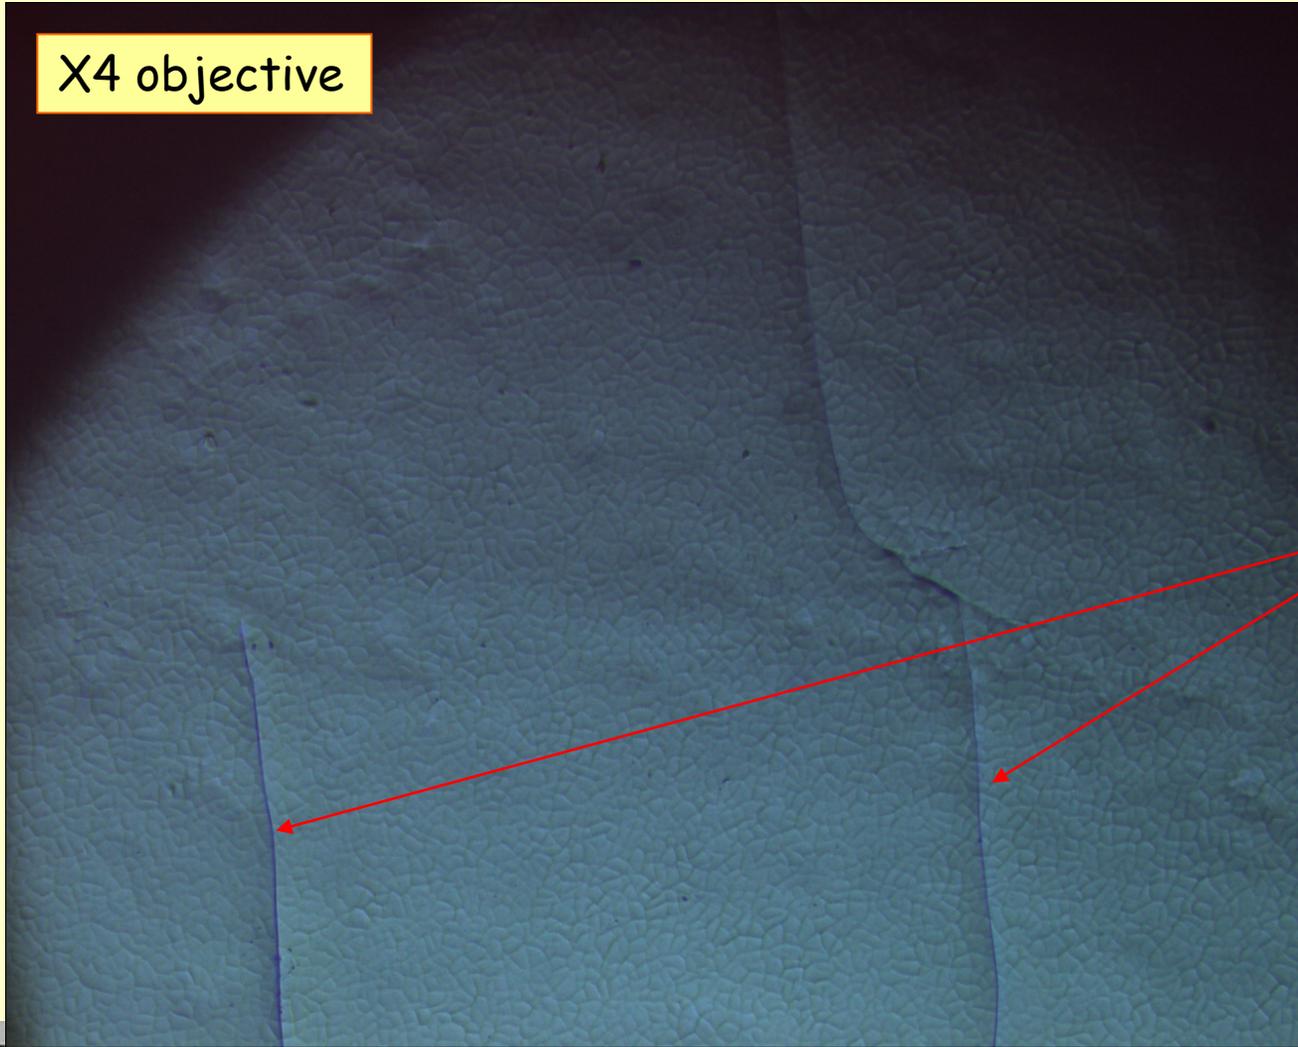
X4 objective

Besides the "skin" structure there is no serious scratch, looks much better than CMS sample, but we see "wrinkle", which is quite unique.

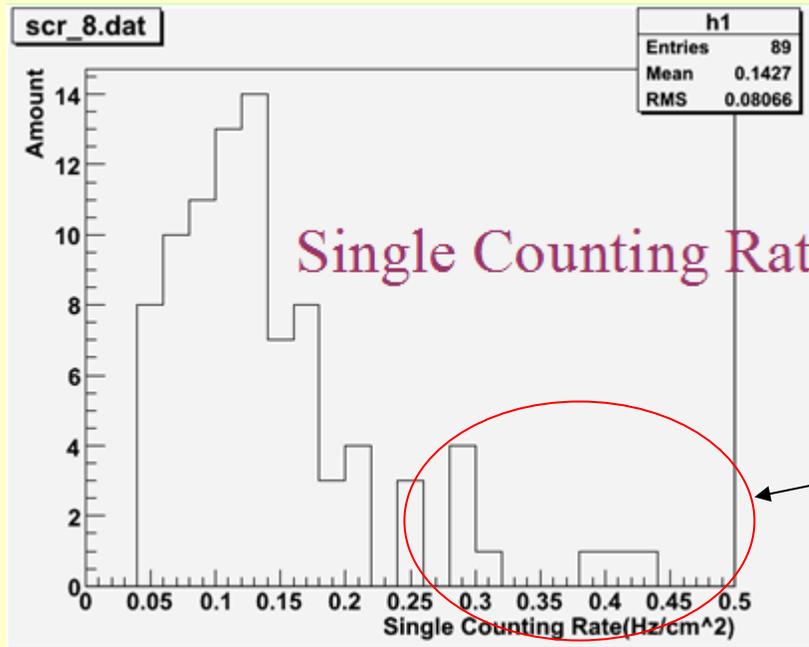
Left is the mass production RPC test results reported by Liehua Ma, Logan Lebanowski, Viktor Pec on 7/2008. Although the majority of the chambers are having low single's rate, but still have non-negligible fraction of RPCs, of which the single's rate is 0.3 - 0.45 Hz/cm<sup>2</sup>.

With Co-60 source the measured counting rate on strip #1 and #2 is  $\sim 5500\text{Hz}/300\text{cm}^2 = 18\text{Hz}/\text{cm}^2$ ,  $\sim 40$  times higher than these RPC's background counting rate (0.45). One month of aging test is about 40 months of normal operation. The aging test results show for the radiated region #1 after one month of aging its efficiency drops from 94% to 40%!! We do need take the aging seriously.

While we are still working on making better Bakelite that has better resistance to the HF corrosion, an existing solution is Linseed oil coating. This is a well developed and proven technique, can greatly improve the performance and aging for the RPC.

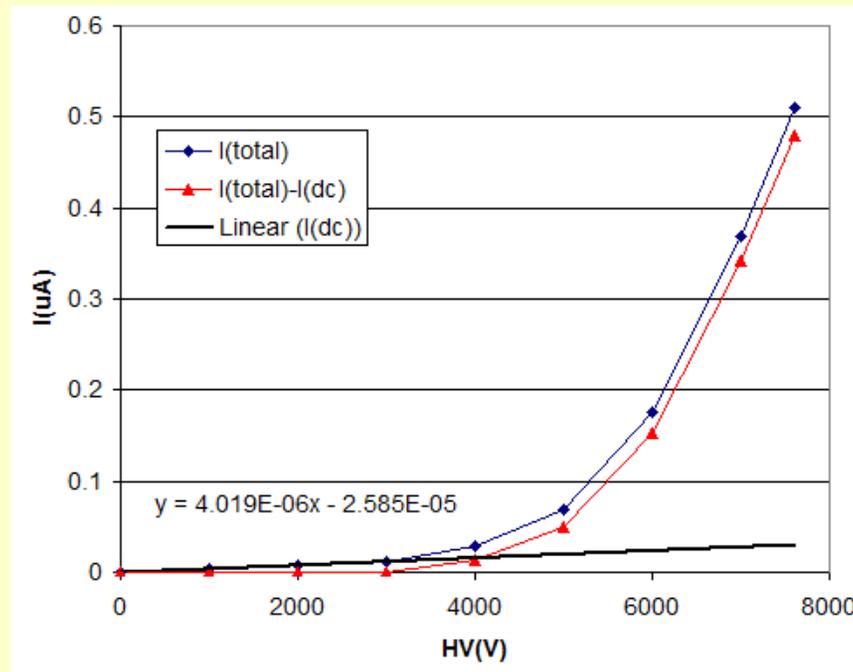
We flow 10 sccm Daya Bay gas mixture through the chamber, measure the dark current vs HV.

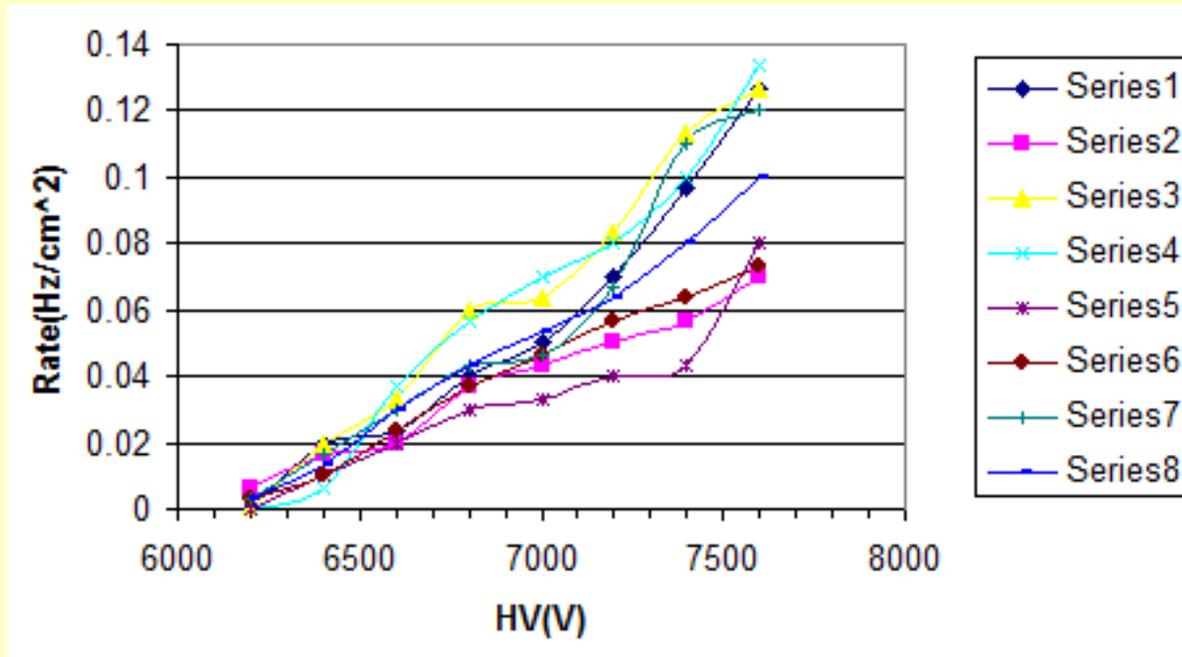
Set threshold at 30mV, we measure the single's rate on 8 strips, which covers the entire chamber.

Compare to the same batch RPCs, the single's rate is 10 - 100 times less.

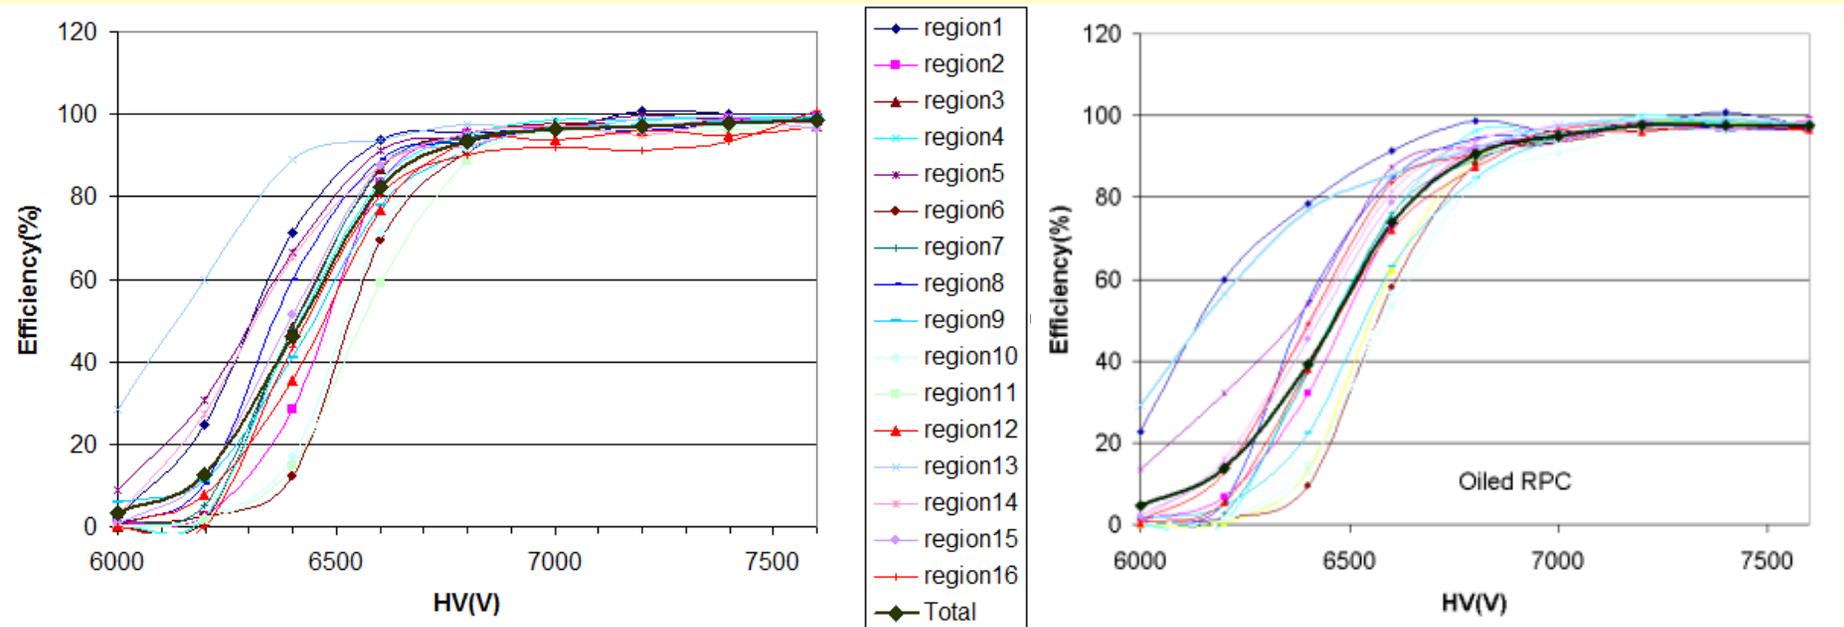
We divide the RPC to 16 regions, measured the efficiency plateaux: above 6800v, all regions reach better than 90% of efficiency. The bold line shows the RPC's overall efficiency, @6800V it reaches 93%.
