Microscope Study of BESIII-type RPC Aging Phenomena

Changguo Lu, Kirk T. McDonald, and A. J. S. Smith

(September 8, 2010)

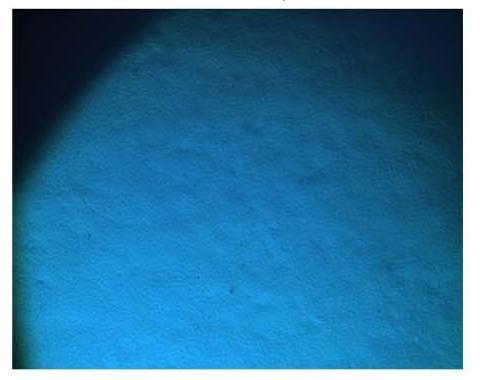
Figure 5. Virgin BESIII-Bakelite surface image under microscope.

Under the microscope we can further reveal the surface change due to the aging. As a reference we first show a virgin BESIII-type Bakelite sample's image in figure 5. The surface shows characterized "skin-like" texture. The total width of this picture is 2.9 mm, so the "wrinkle" scale is $\sim 10 \mu m$.

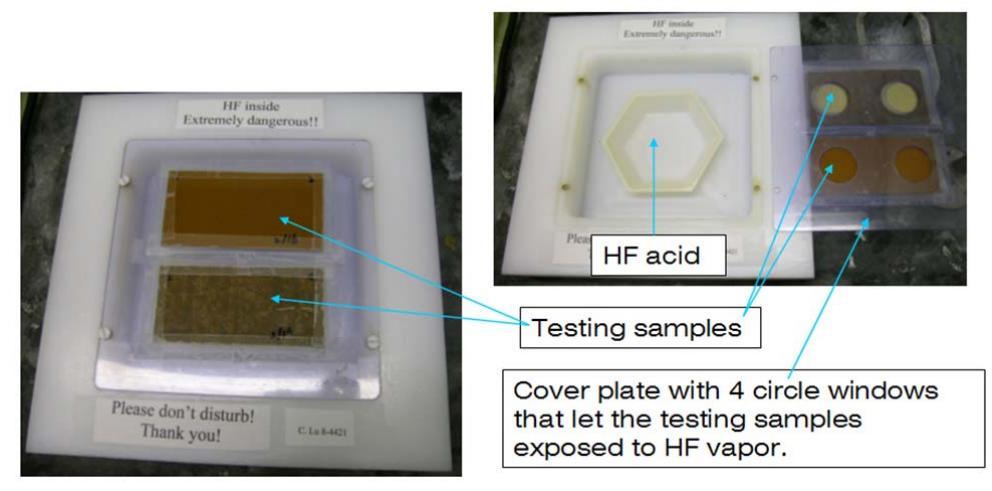
Figure 8. HF vapor test setup.

To make sure if the eroded surface is due to the HF corrosive effect, we made an additional test. The test setup is shown in figure 8. We drop 90 μ L HF (40% of concentration) into the container, then cover the container with the samples/cover plate as shown in the figure. The inner surface of the test samples are then exposed to the HF vapor. The equivalent dose of 90 μ L HF is a $2m^2$ RPC operated at 5 μ A for 12.4 years [2]. After 24 hours the cover is opened, the test sample's surface shows corrosion. In figure 9 we show their microscopic images. Compared to the virgin sample surface the HF vapor exposed surface apparently shows "bumps" and "veins". The bumps are vulnerable to the discharge that may be the origin of the sparking marks we saw on the aged RPC electrode. The "veins" have very similar looking to the aged RPC electrode surface. In figure 9(A) besides the "bumps" and "veins" we still can see the "skin-like" texture for most of the area, but on figure 9(B) there is no such "skin-like" texture leftover, it means that the entire surface has been eroded by HF vapor.
