# MERIT Primary Containment Inspection

MERIT Video Conference  
October 13, 2010

# Mercury Primary Containment Inspection 17 Aug - Viewport 2

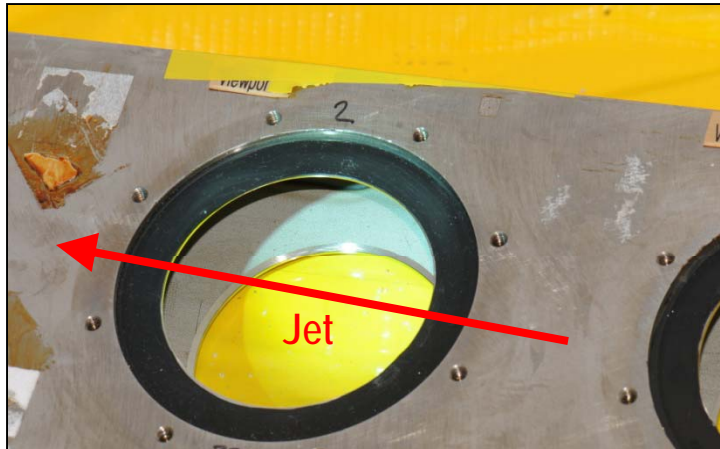
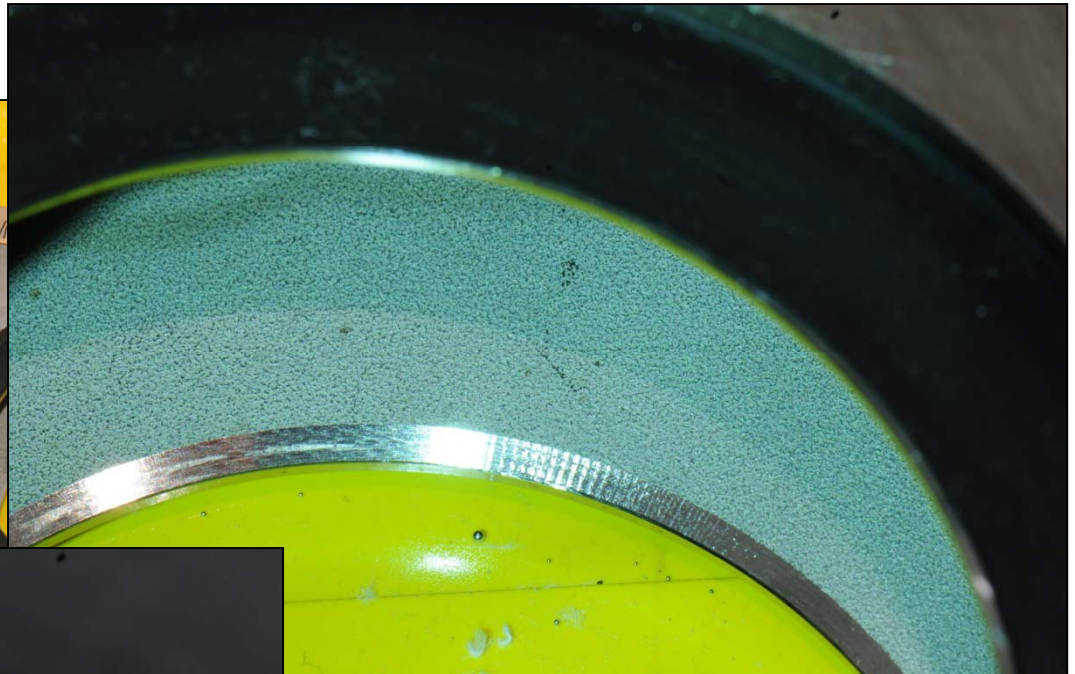
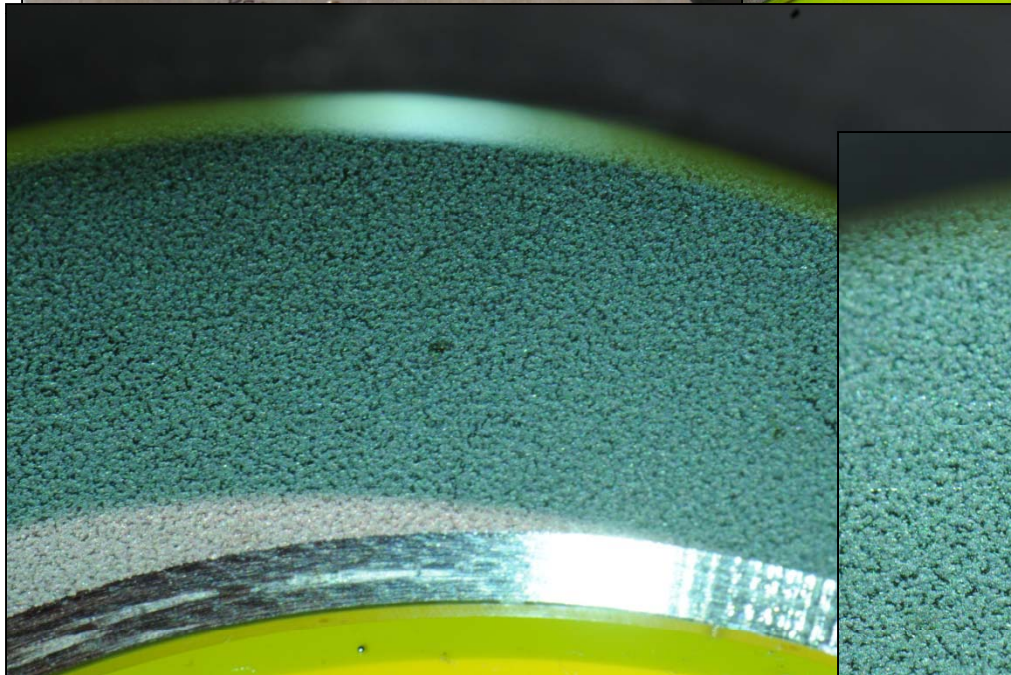
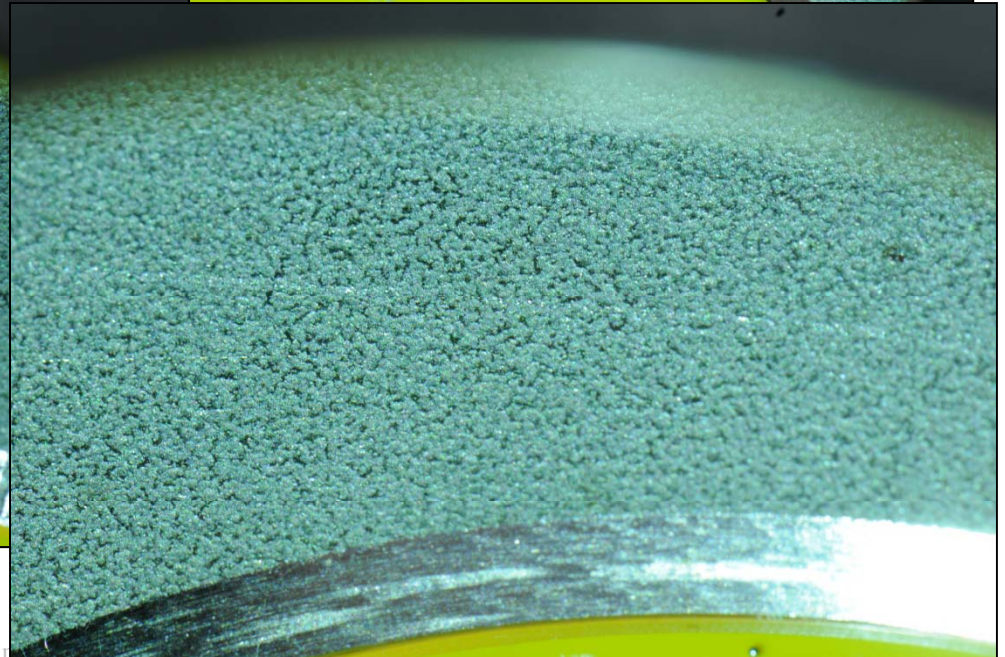
# Viewport 2 Top

- Surface appearance consistent throughout interior of primary containment – standard, un-machined surface texture
- Higher resolution images do not support theory of mercury bead pitting, at least on a macroscopic level
- Further investigation possible by sectioning chamber, decontaminating and viewing pieces with microscope
