Proton Irradiation Damage Assessment of Carbon Reinforced Composites: 2-D & 3-D Weaved Structures

Nick Simos BNL November, 2006

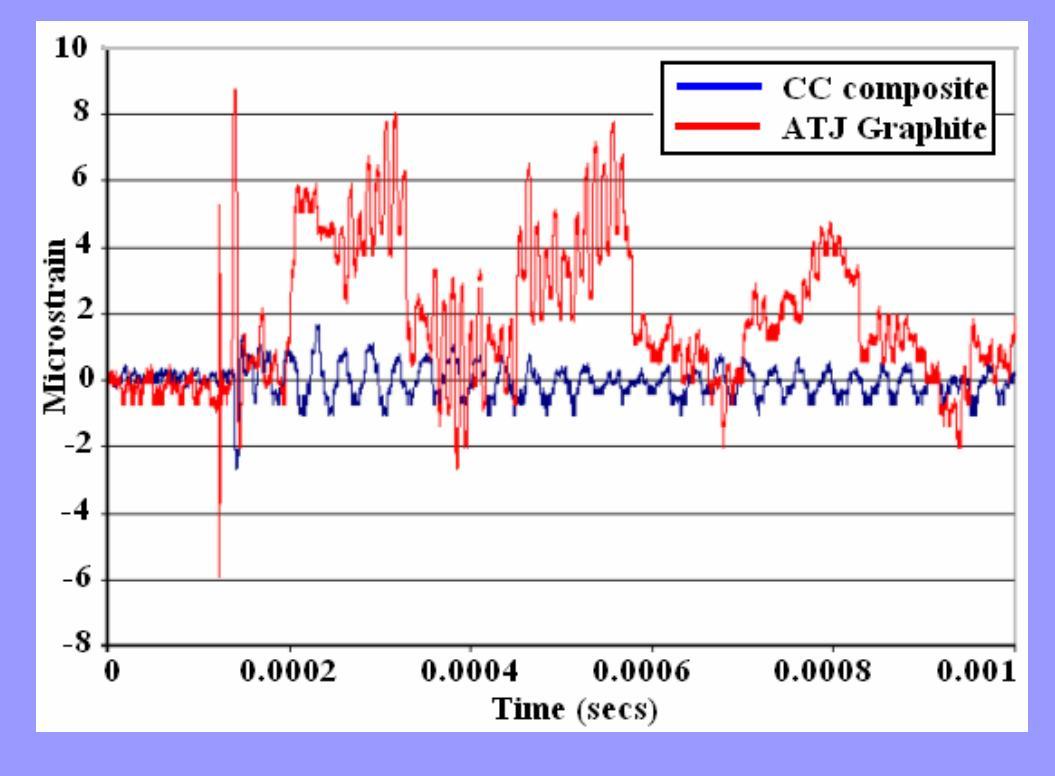
AGS Beam-on-Target tests show clearly that carbon composites are better absorbers of thermomechanical shock. This is attributed to the very low coeff. of thermal expansion (CTE).

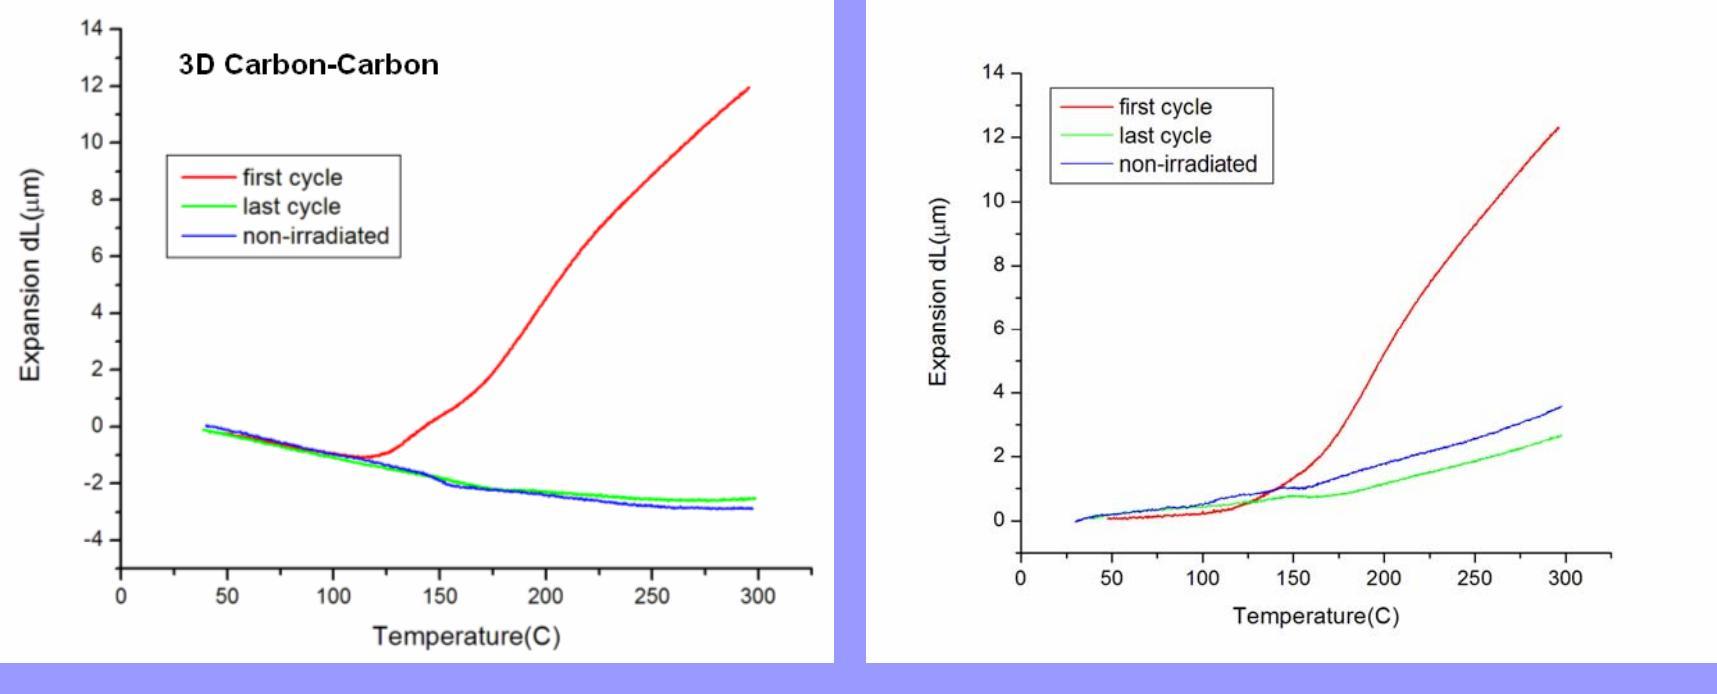
Irradiation damage assessment revealed that the composite can undergo self-healing through annealing (even along its 45-degree orientations that form the weak planes)

45-degree "weak" orientation

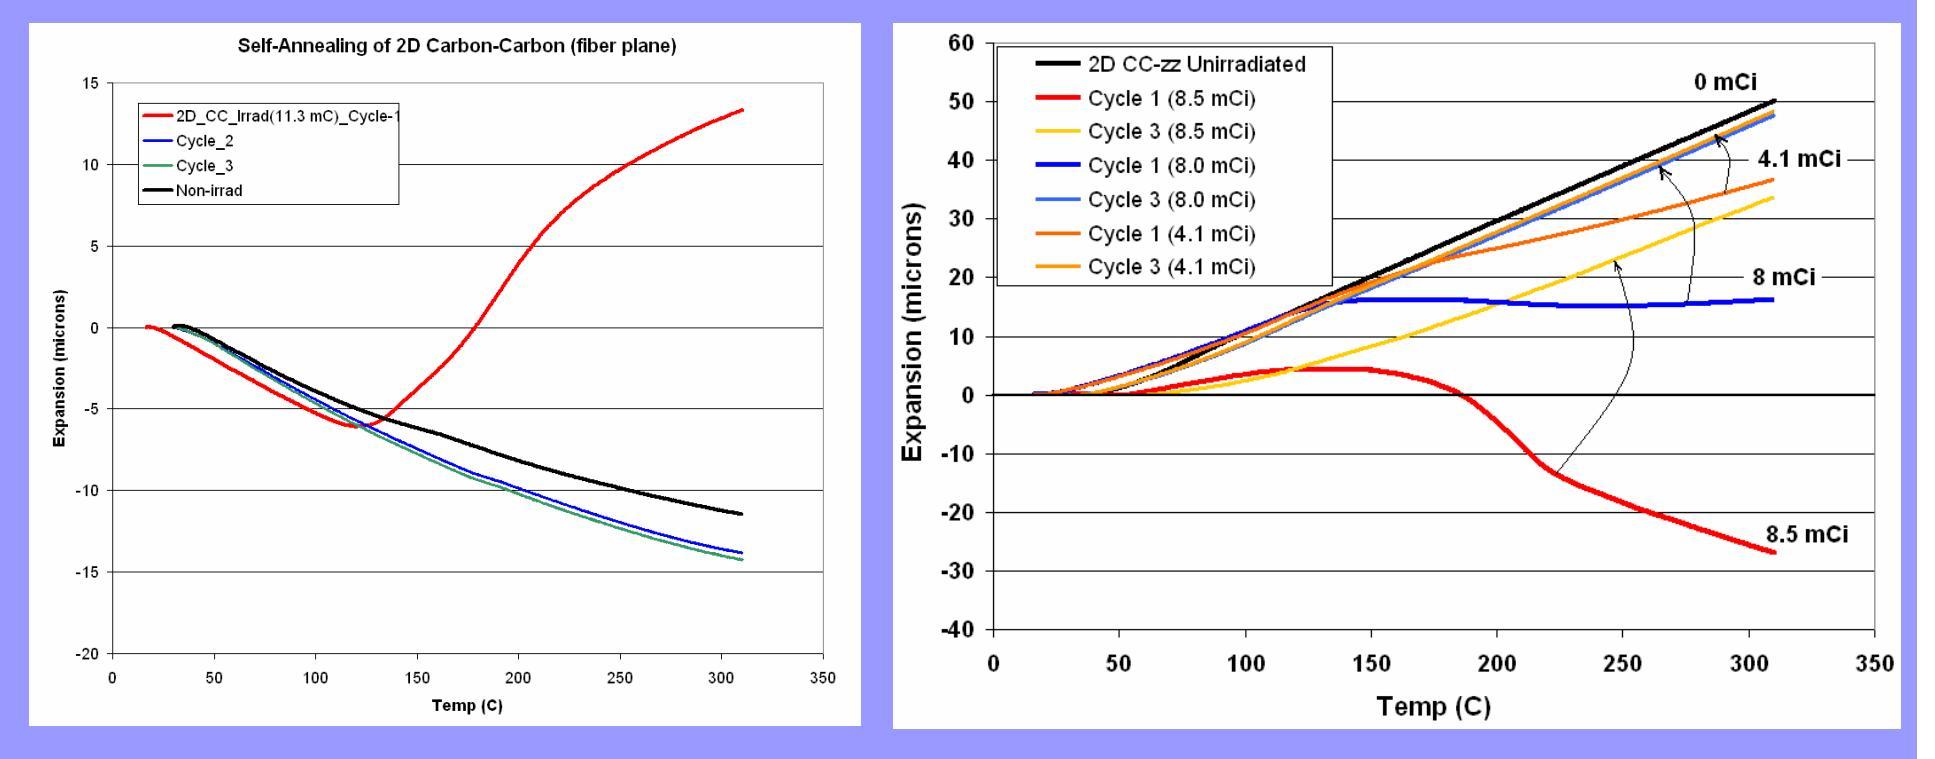
#### Good News: 2D carbon composite exhibits self-healing through thermal annealing (like 3D counterpart)

"strong" orientation

"weak" orientation

Irradiation exposure of different specimens shown in mCi

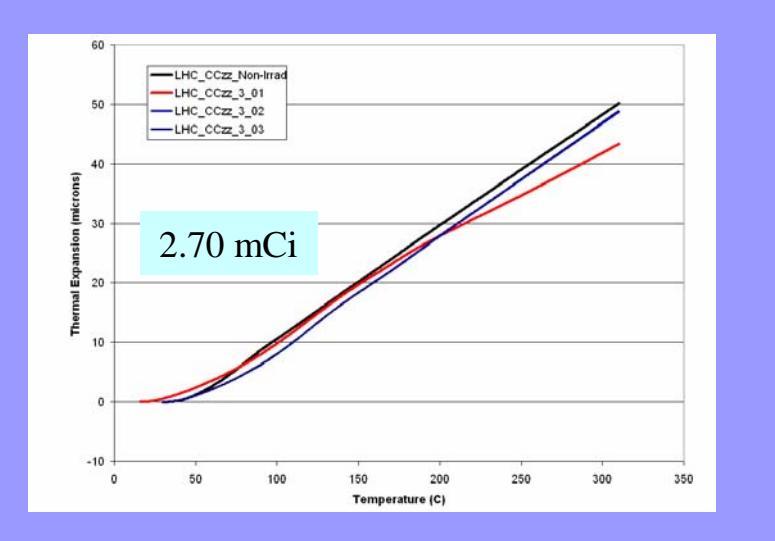
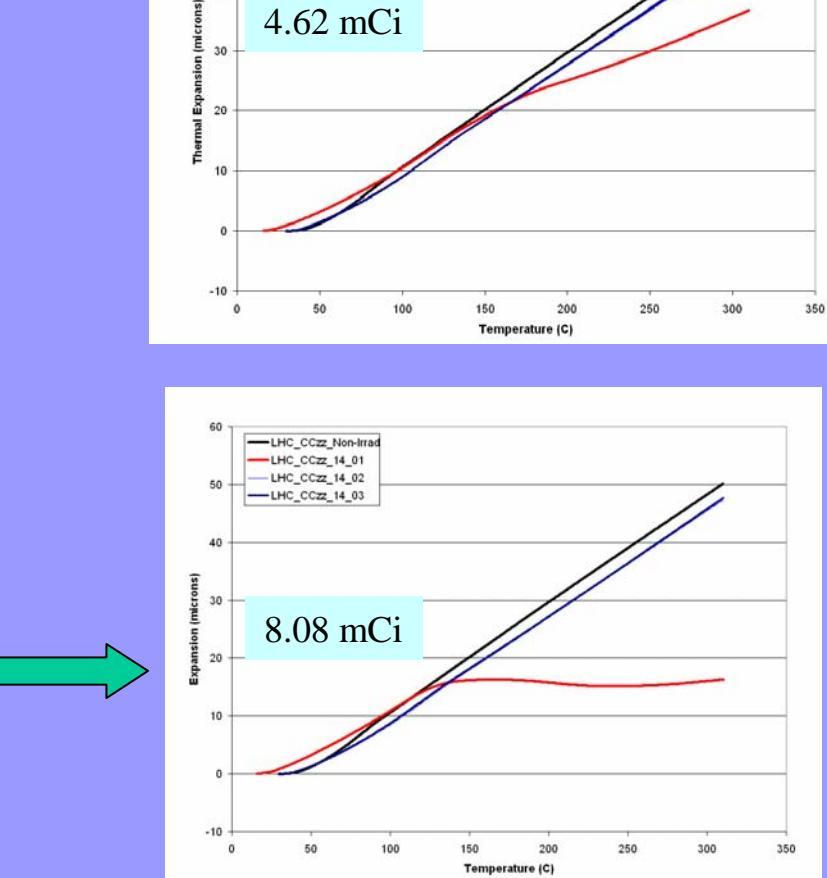
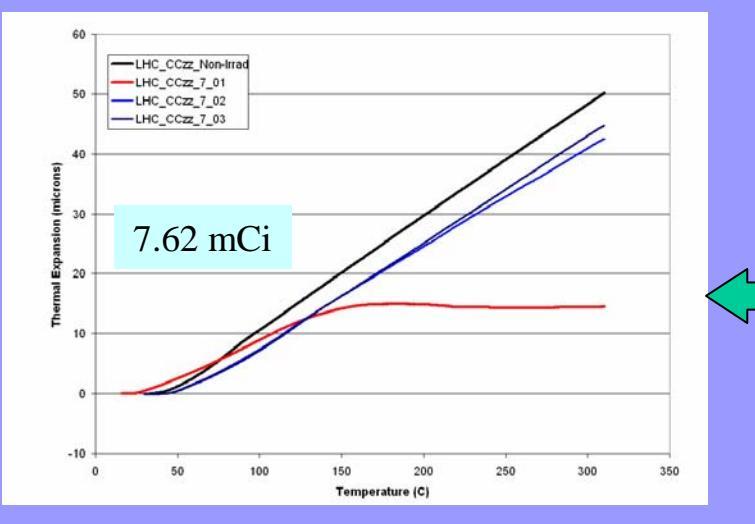
How well is our nanometer-level analysis controlled/stabilized? Observe the tendency of irradiated 2D carbon (weak orientation) to move away from the expansion trend of the un-irradiated material. Also observe that two specimens at different location within the matrix exposed to similar levels have identical irradiation and post-irradiation (annealing) behavior !!!

-LHC\_CCzz\_Non-Irrad

-LHC\_CCzz\_4\_01

-LHC\_CCZZ\_4\_02 -LHC\_CCZZ\_4\_03
