Water Tests of Hg System

Muon Collaboration Friday Meeting

Dec 8, 2006

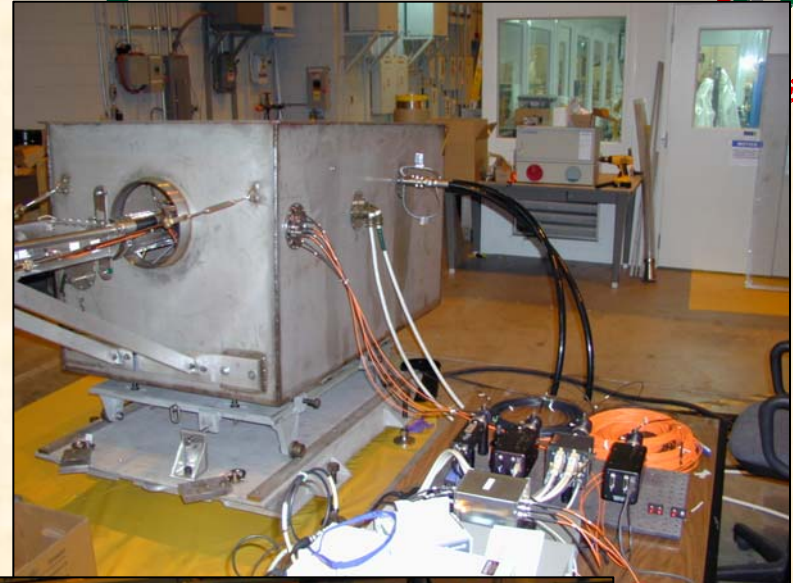
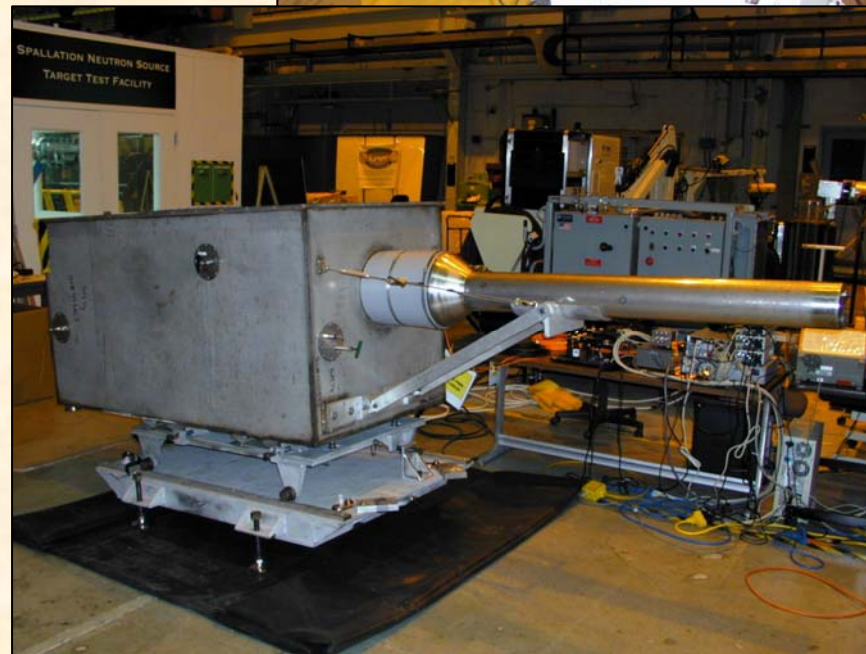
System Assembly Nearly Complete

- **Primary containment completed**
 - Issues with piping resolved, final fit-up completed
- **All sensors and optical diagnostics installed and operational**
- **Final steps to assemble secondary containment underway**

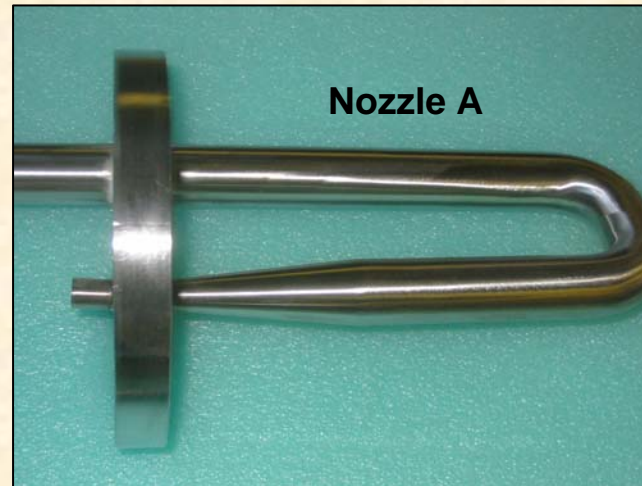
Nozzle A

- **Nozzle A** – diameter reduction after bend, 2.5° nozzle angle
- **Nozzle B** – reduction before bend, 2.5° nozzle angle
- **Nozzle C** – test nozzle with reduction after bend, straight nozzle tip, internally similar to nozzle A
- **Nozzle D** – nozzle A after reaming out the tip

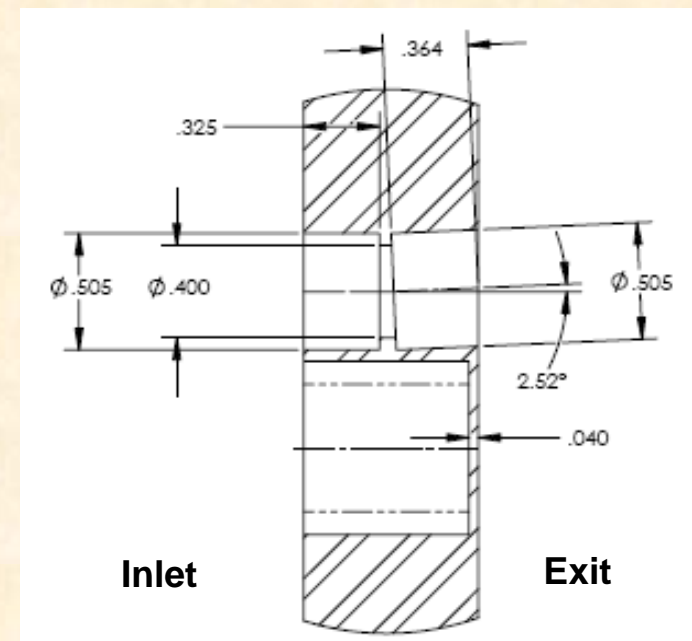
Dimensions in inches

- **Flow path is a three-piece weldment**
 - Inlet tube
 - Nozzle flange
 - Short angled nozzle tip
- **Change in direction required for beam to miss piping geometry**
- **Smooth path requires constant ID**
- **Investigation revealed SS nozzles had step in flow path (flange thru hole smaller than tube IDs)**

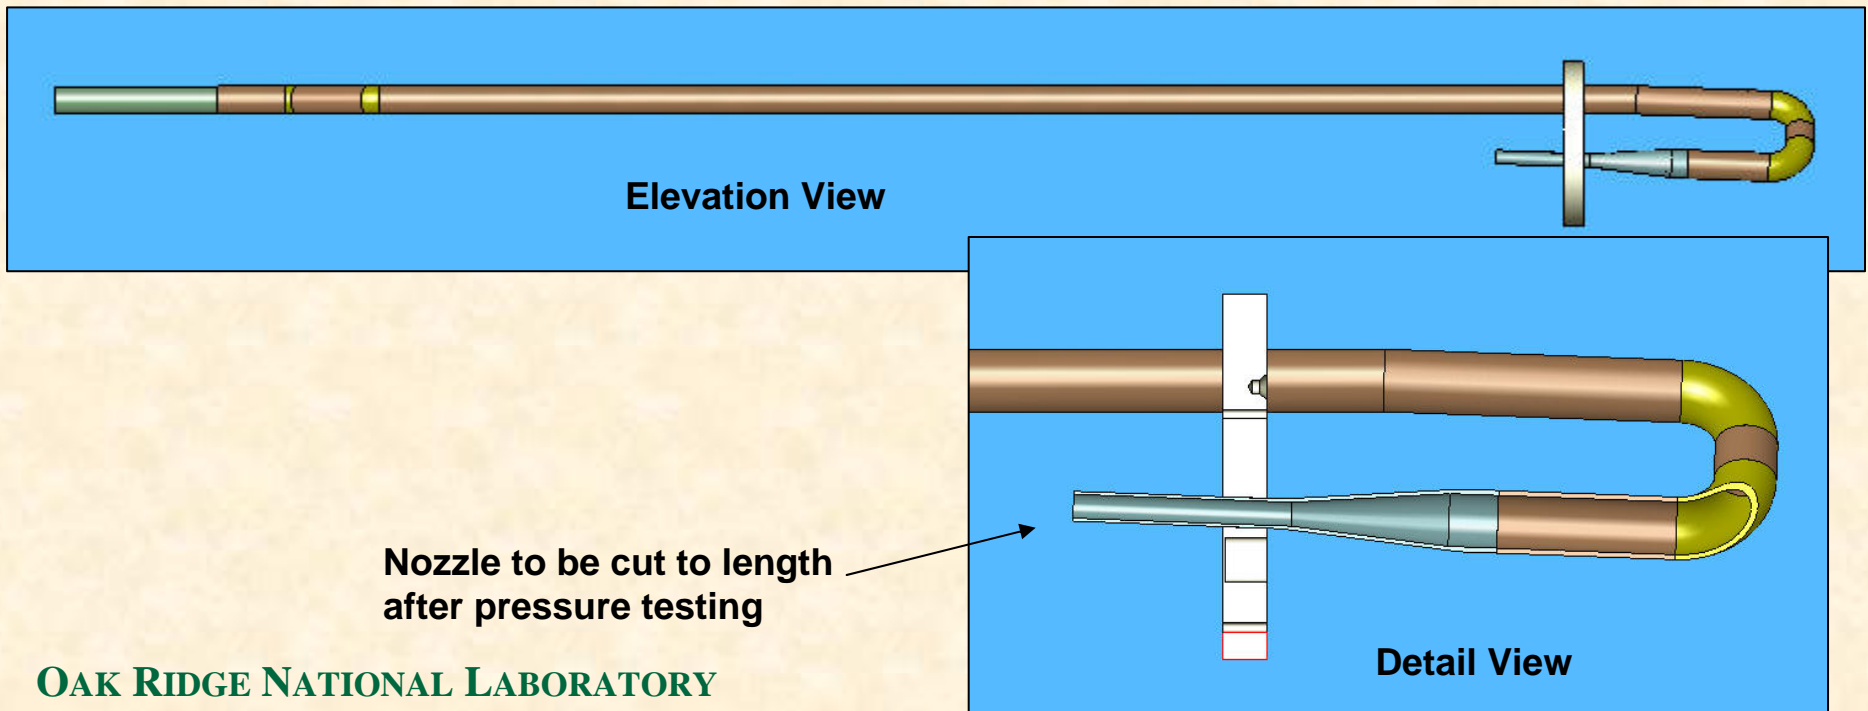
Nozzle E configuration

- Straight flow path after 180deg bend
- "Kink" made prior to bend
- Nozzle angle and elevation being finalized
- Proceed with fabrication ASAP

- **Water test results discussed among MERIT collaboration**
- **Best chance of success is to reproduce straight nozzle C**
 - Changing direction just before nozzle exit has not proven to provide satisfactory results
 - Piping still requires "kink" to avoid beam, but new design will move kink in front of 180deg bend
- **New nozzles will be fabricated with Ti, the actual design material**
 - Enough Ti on hand to produce two configurations
 - Machining and drawings ready for a Ti nozzle A
 - Developing models and drawings for a new nozzle E
